FACILITY CONDITION ASSESSMENT

Lincoln School
1029 North Broadway
Escondido, California 92026

164076.23R000-012.017

September 14, 2023

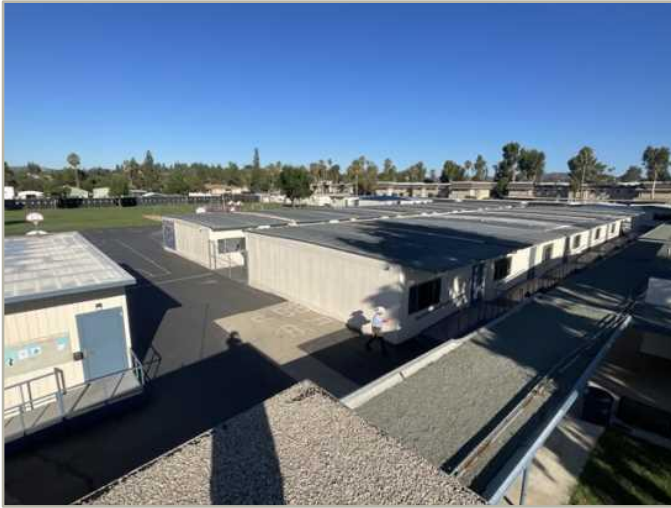
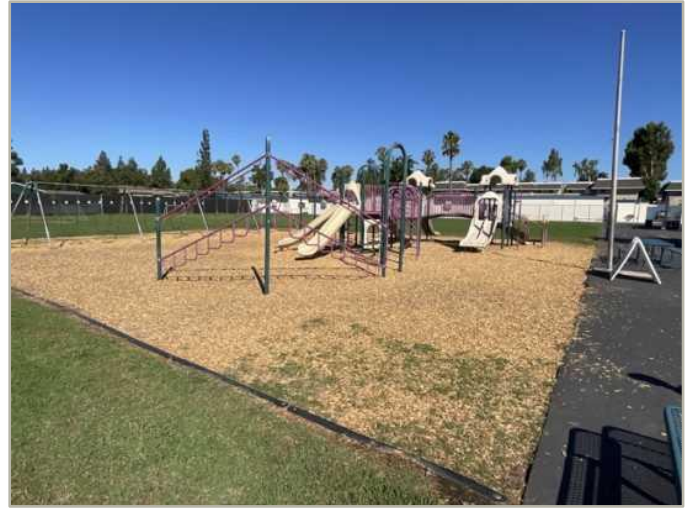
11. Site Summary

Key Issues and Findings	Severe alligator cracking

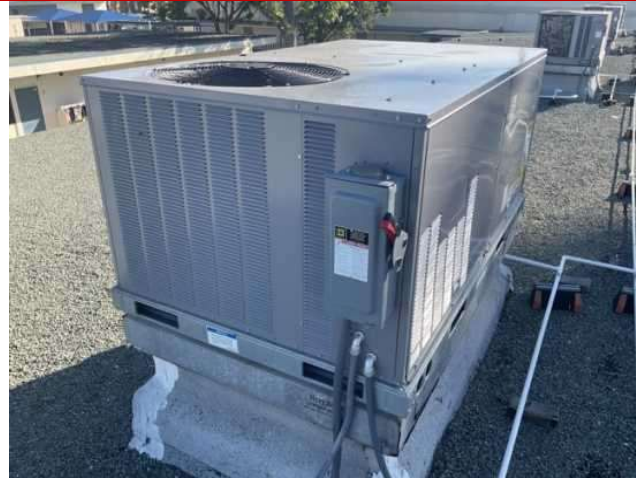
20 - NEWER PACKAGED UNIT

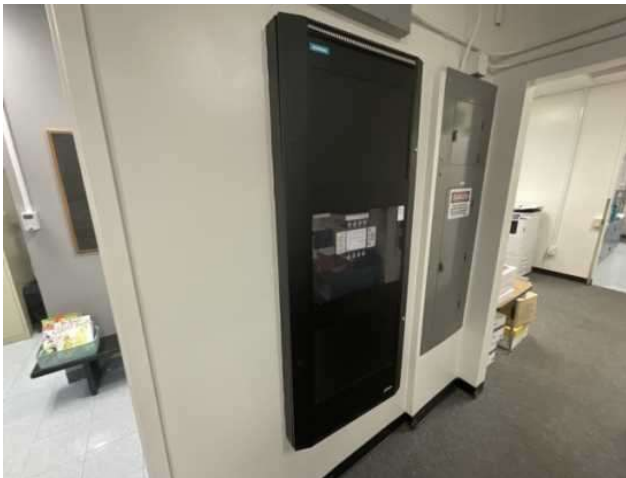
21 - FIRE ALARM PANEL

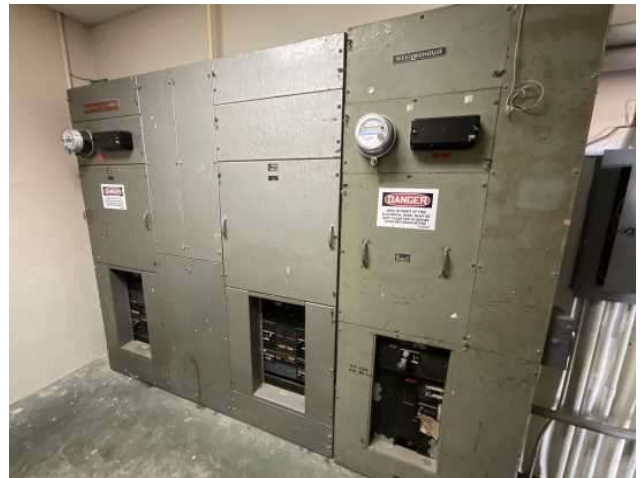
22 - SWITCHBOARD

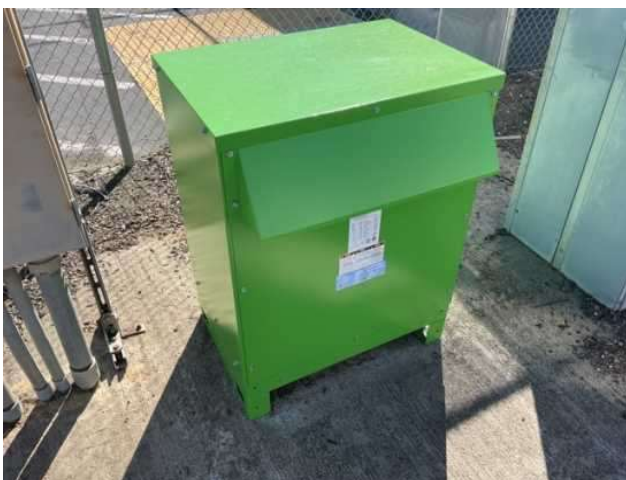
23 - SECONDARY TRANSFORMER

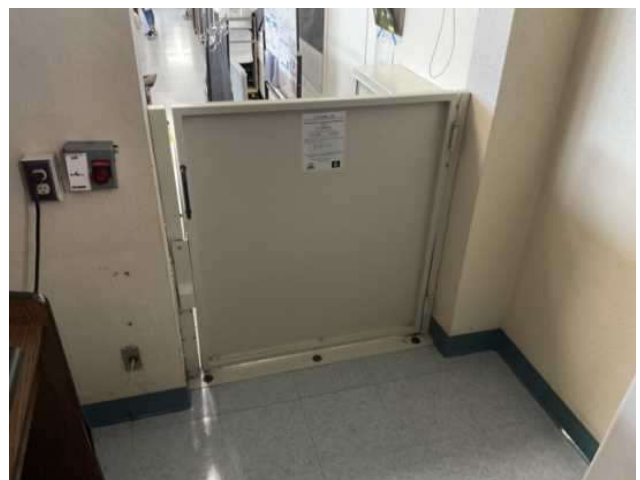
24 - WHEELCHAIR LIFT

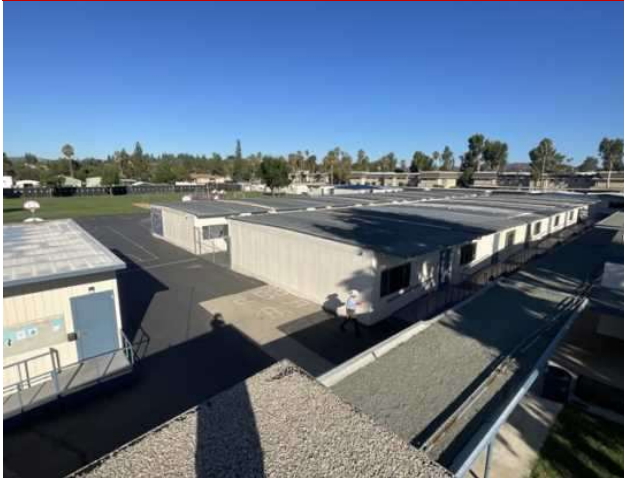
25 - RELOCATABLE BUILDINGS

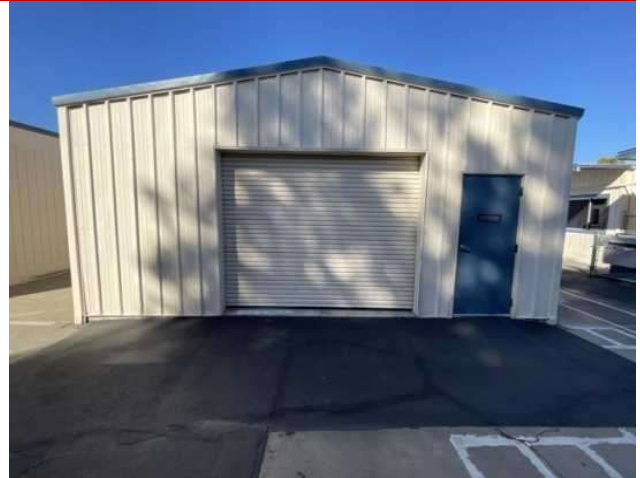
26 - STORAGE SHED

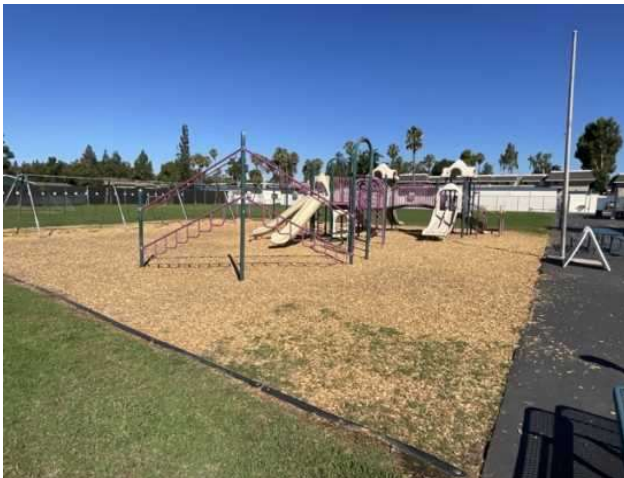
27 - PLAYGROUND

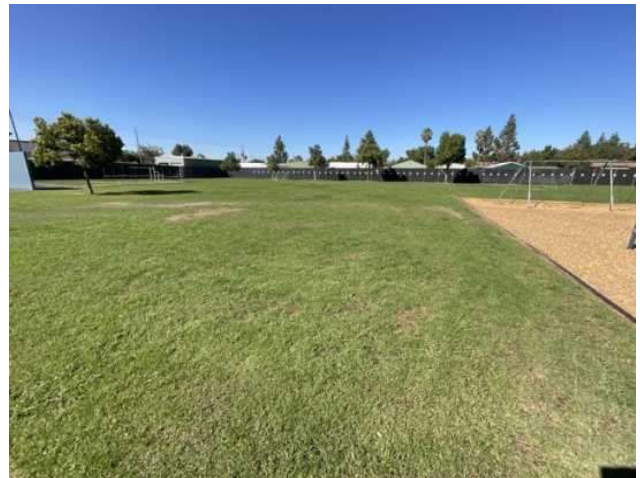
28 - SPORTS FIELD

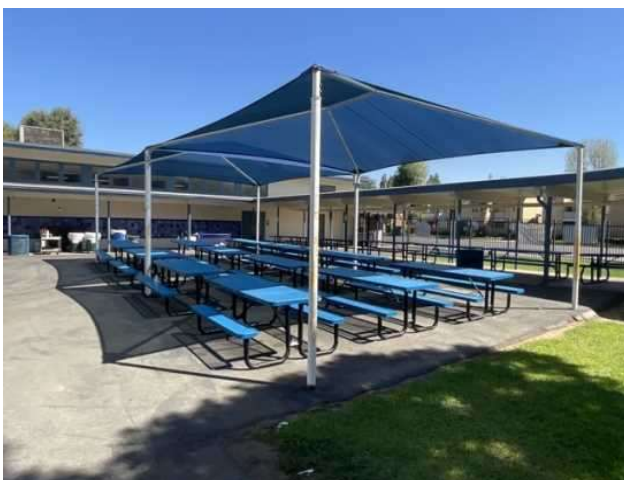
29 - CAFETERIA

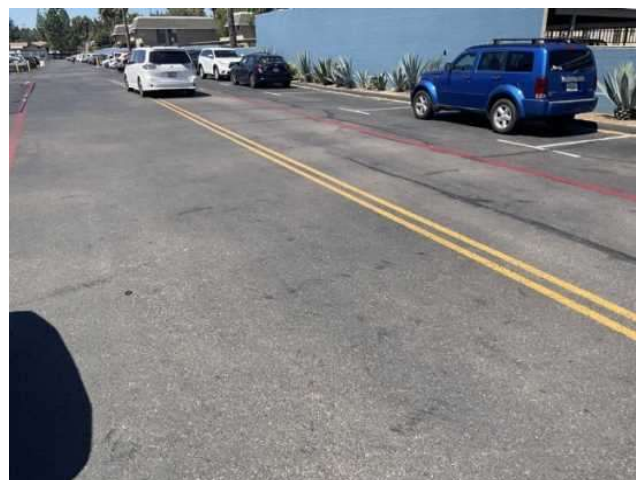
30 - PARKING LOTS
