# FACILITY CONDITION ASSESSMENT

**Fallbrook Union Elementary School District**  
321 North Iowa Street  
Fallbrook, California 92028

Fallbrook STEM Academy  
405 West Fallbrook Street  
Fallbrook, California 92028

*February 4, 2023*

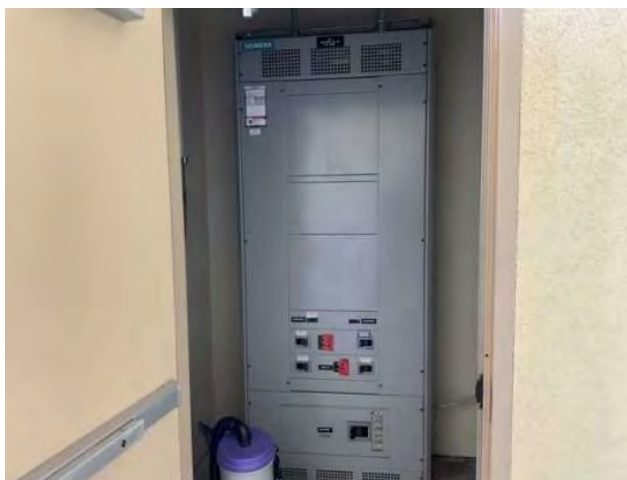
15 - ELECTRICAL SWITCHGEAR

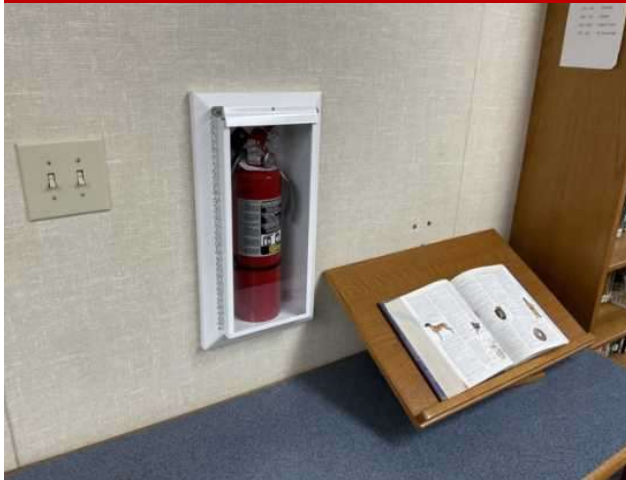
19 - FIRE EXTINGUISHER

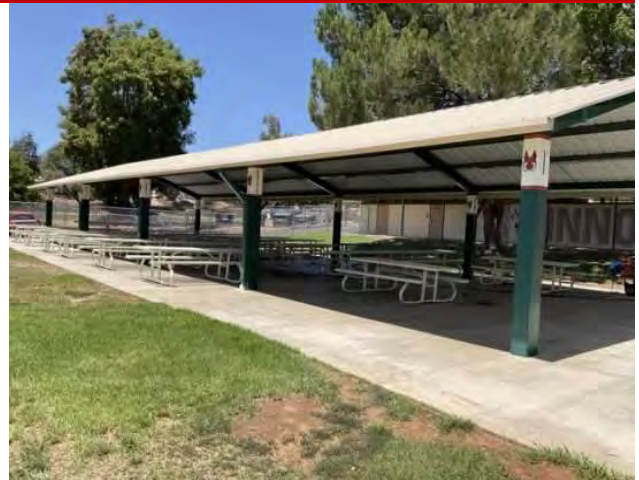
20 - LUNCH SHADE STRUCTURE

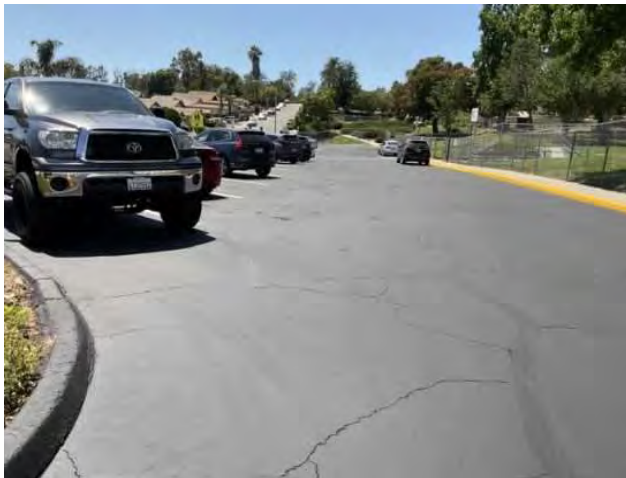
21 - PRIMARY PARKING

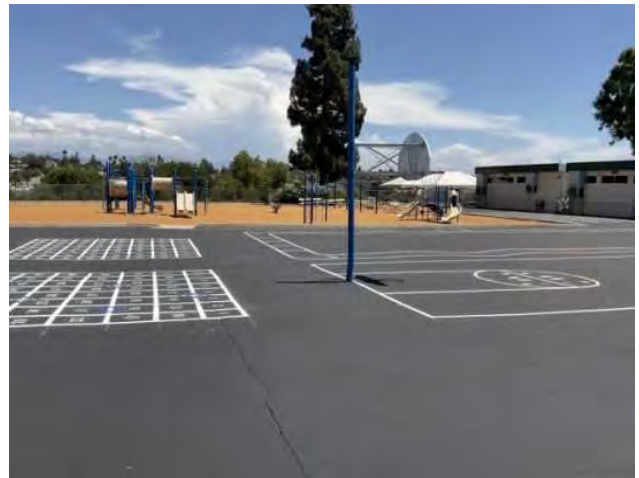
22 - PLAYGROUND

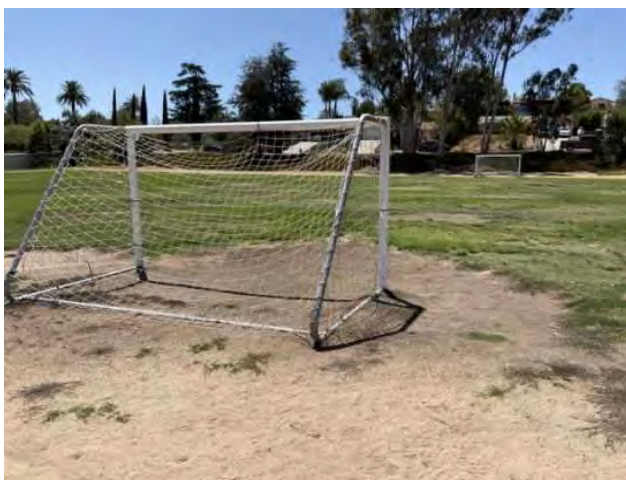
23 - SOCCER

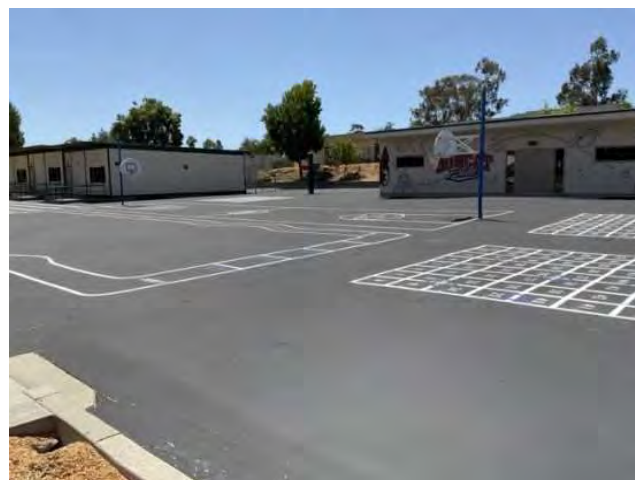
24 - BASKETBALL COURT

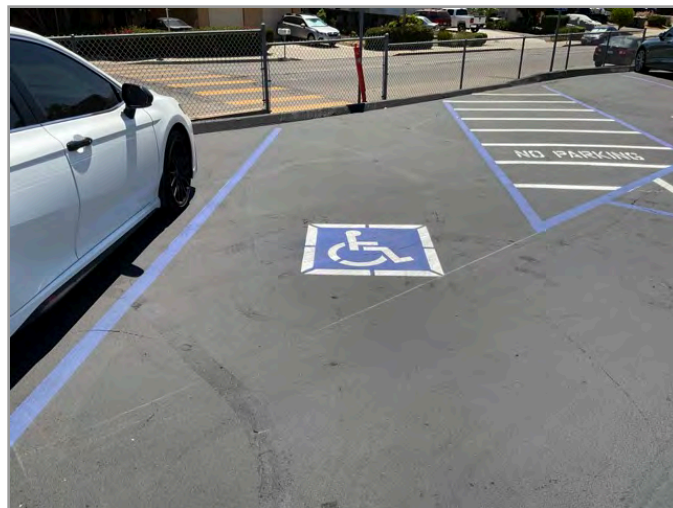
CLOSE-UP OF STALL

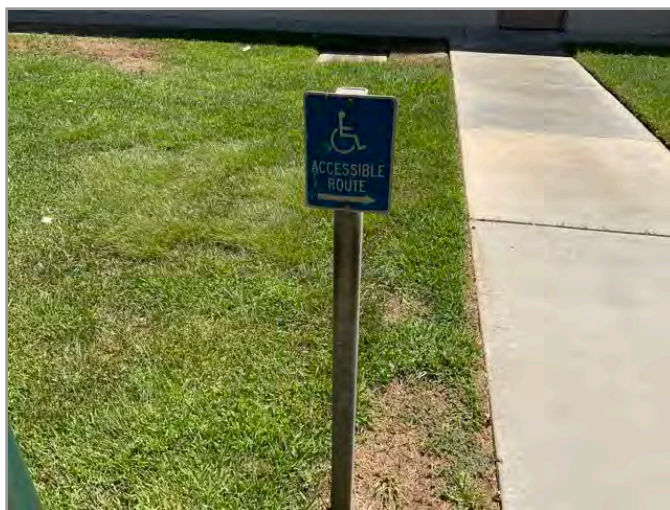
SIGNAGE

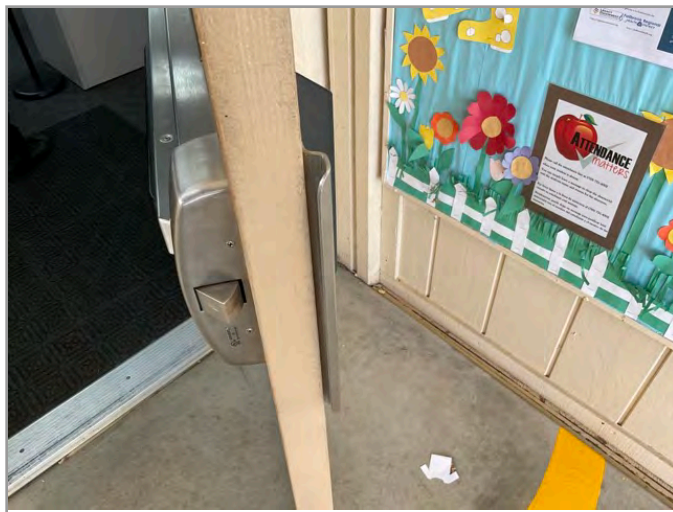
DOOR HARDWARE

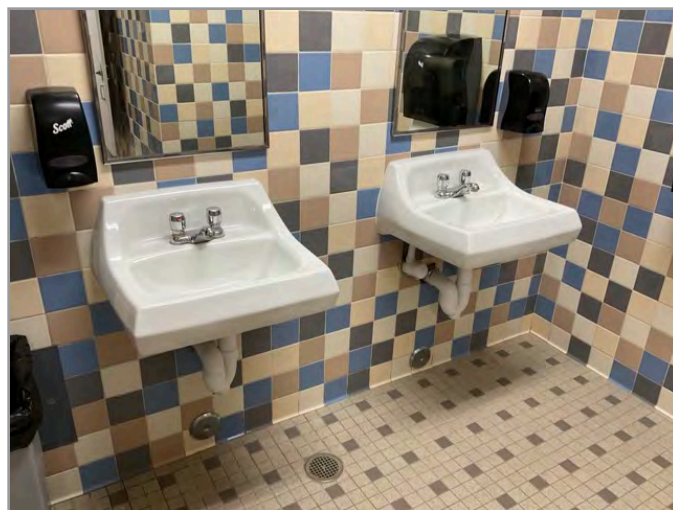
SINK, FAUCET HANDLES AND ACCESSORIES

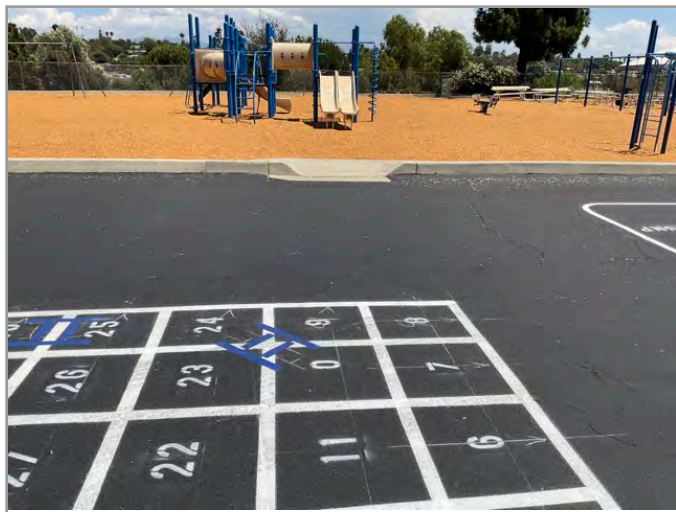
ACCESSIBLE ROUTE TO PLAYGROUND

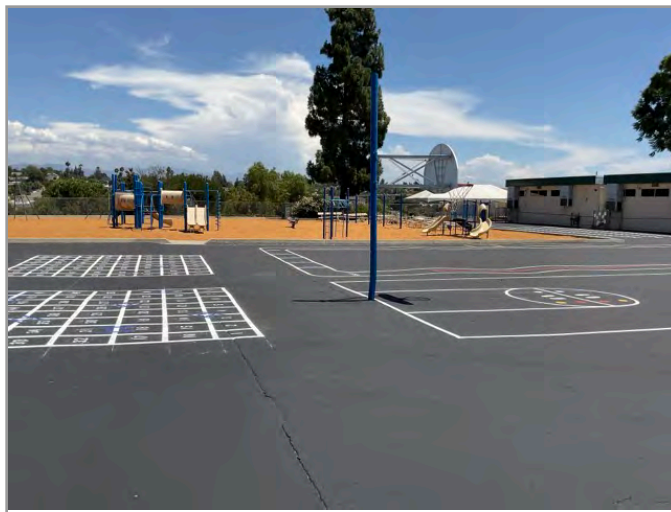
OVERVIEW OF PLAYGROUND
