FACILITY CONDITION ASSESSMENT

Sonora High School
401 South Palm Street
La Habra, California 90631

162347.23R000-005.017

August 21, 2023

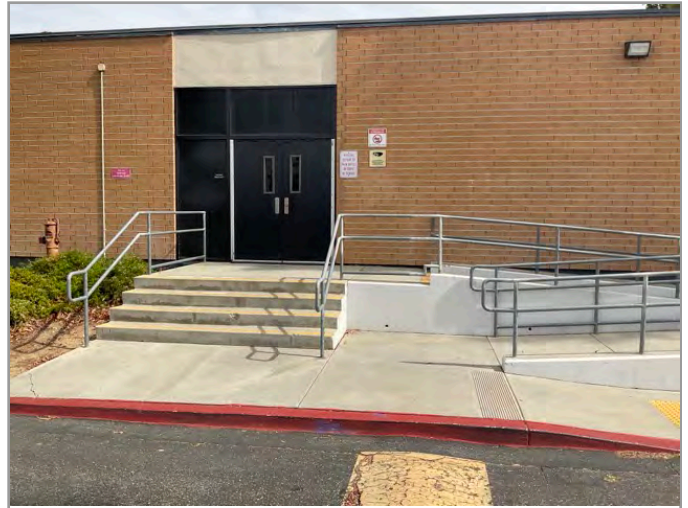
ADDITIONAL ENTRANCE

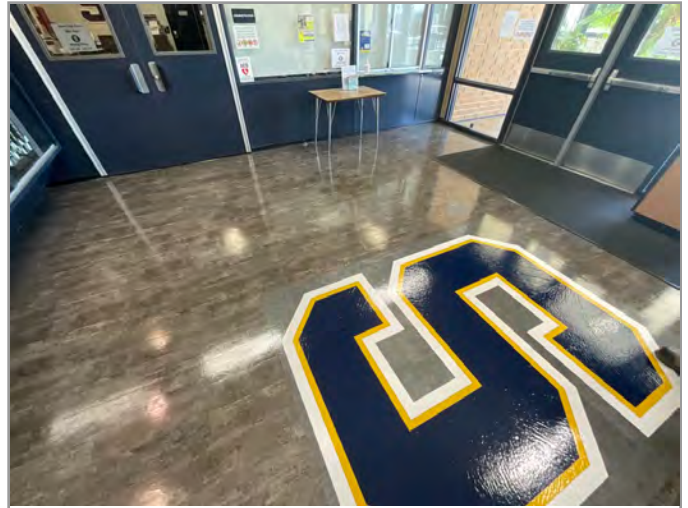
ACCESSIBLE INTERIOR PATH

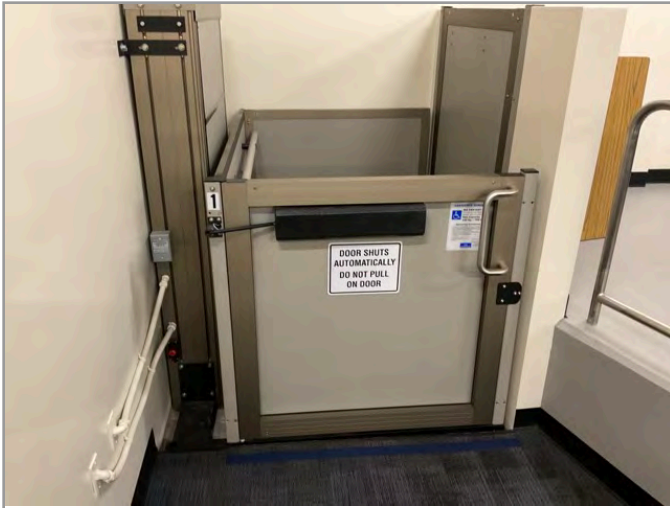
WHEELCHAIR LIFT

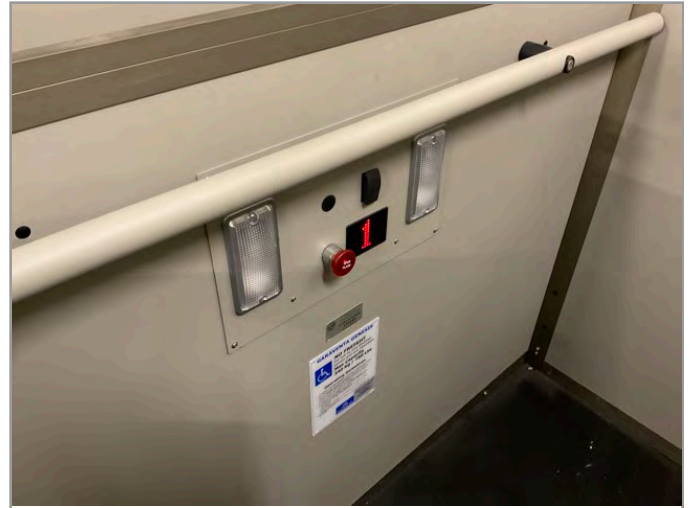
IN-CAB CONTROLS

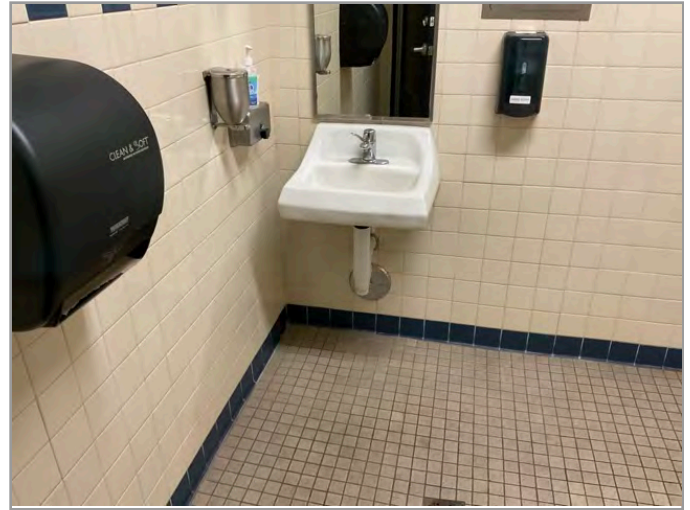
SINK, FAUCET HANDLES AND ACCESSORIES

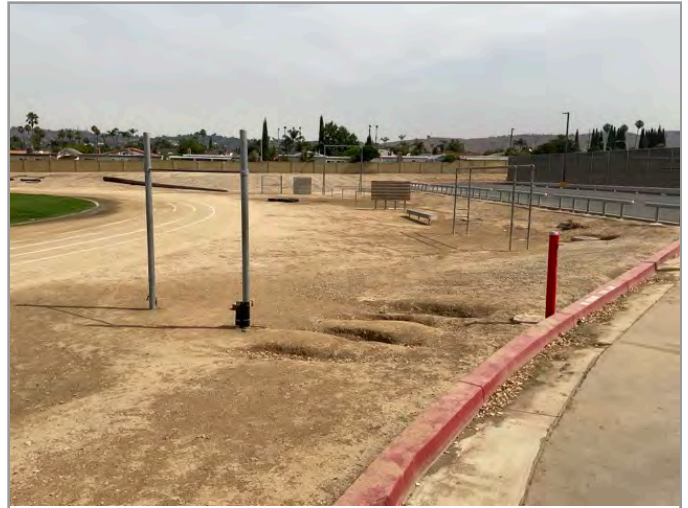
OVERVIEW OF PLAYGROUND
