Hamilton City Council

Ruakiwi Reservoir Detailed Seismic Assessment

22 August 2025

3-39777.00/00DSA

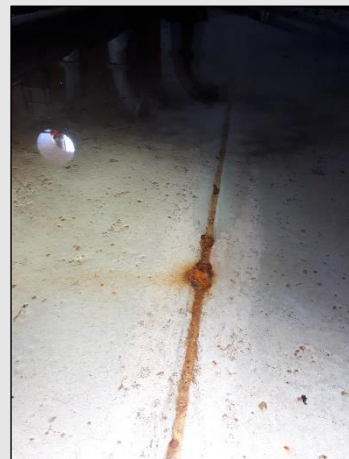
Figure 16 - Floor weld at panel 3 in from 6 o'clock

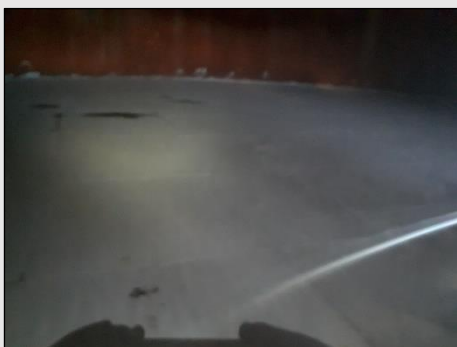
Figure 17 - Floor overview looking at 12.00 o'clock

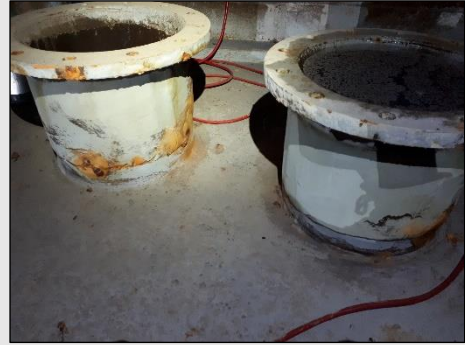
Figure 20 - Pipes stubs
