Preliminary Environmental Site Investigation

Amberfield Subdivision

Peacocke

14280.000.001_18

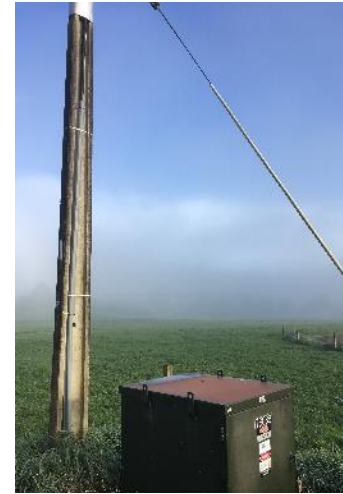
Site Condition	Comments
	<p>461 Peacockes Road:</p> <ul style="list-style-type: none"> Transformer adjacent to new milking shed – the transformer appeared to be relatively new and was located on a concrete footing which was noted to be in good condition (see photograph 2). A burnt rubble pit (approximately 10 m x 8 m) comprising old household goods – refrigerators, old heaters, wood, concrete, carcass, aluminum, chemical containers. The depth of the pit was estimated to be approximately 4 m. Evidence of recent burning observed (ash and blackened soil) (see photographs 25-29). Storage of chemical drums alongside the southern boundary of the new milking shed. These included products such as Aquaklenz (acid detergent), emollients including Hibitane 2 Teat Spray (Chlorhexidine Digluconate-based) and Glycerine and chemicals used for bloat control in dairy cows including Bloatenz (alcohol ethoxylate / propoxylate surfactant) (see photographs 3-5). A septic tank adjacent to the northern side of the new milking shed (see photograph). An area in the southern half of the site which has stockpiled soil comprising bricks, wood, steel and plastic and evidence of filled land. A potential burial pit (e.g. for offal) along the northern side of storage shed A. PACM in soffits of both residential dwellings located on the property (see photographs 44-45). Area of filled ground adjacent to the old milking shed compound. Evidence of brick, tile, wood and concrete fragments observed (see photograph 30). Area of former pond, which has now been infilled. Source of fill unknown. Stockpiled soil adjacent to the old milking shed (approximately 4 m x 3 m) compound comprising orange brown silt and gravel fragments (see photograph 31). Two above ground storage tanks (ASTs) adjacent to the southern side of the old milking shed. One tank appears to be relic and has been replaced by a newer tank constructed in 2015. The ASTs were located on a concrete slab. The slab appears to be in good condition, with very few cracks noted. Evidence of staining on the slab was observed at the time of inspection (see photograph 32). Old milking shed (Shed B on Figure 2C) observed to contain ACM cladding (see photograph 33). Storage of chemical containers and paint drums in and around old milking shed including glycerine, magnesium oxide (powder form), chlorohexidine glyconate, old empty 200l – former contents unable to be identified due to condition (see photographs 33-36). Incinerator adjacent to Shed C which appeared to be used for domestic rubbish (refer Figure 2C).

A transformer was noted adjacent to the new milking shed at 461 Peacockes Road.

Photograph 2: Transformer by milk shed

- **HAIL ID B2: Electrical transformer including the manufacturing, repairing or disposal of electrical transformers or other heavy electrical equipment.**

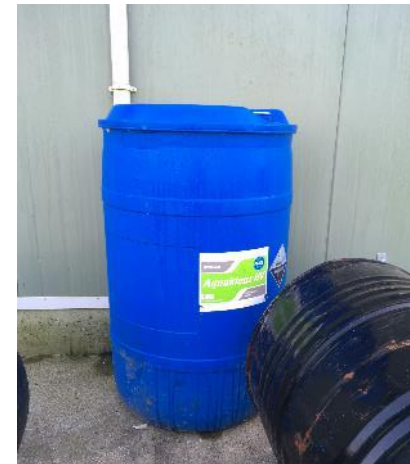
- Chemical containers and drums dumped around the shed located at 361 Peacockes Road.
- Above ground storage tanks located adjacent to the old milk shed at 461 Peacockes Road.
- Storage of empty chemical containers and drums within the old milking shed at 461 Peacockes Road.
- Storage of chemical drums outside the new milking shed at 461 Peacockes Road.
- Chemical containers and drums observed at 523 Peacockes Road.

Photograph 4: Chemical storage around new milk shed

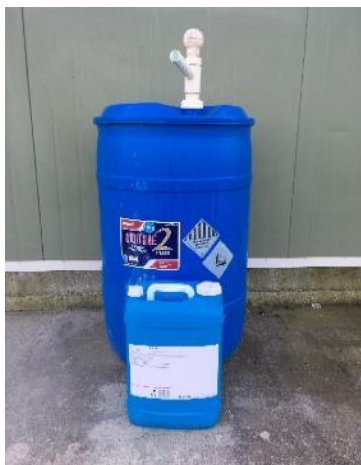
Photograph 5: Chemical storage around new milk shed

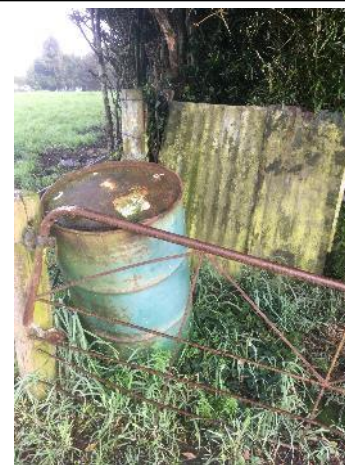
Photograph 12: 523 Peacockes Road - Drum adjacent to southeastern corner of dwelling

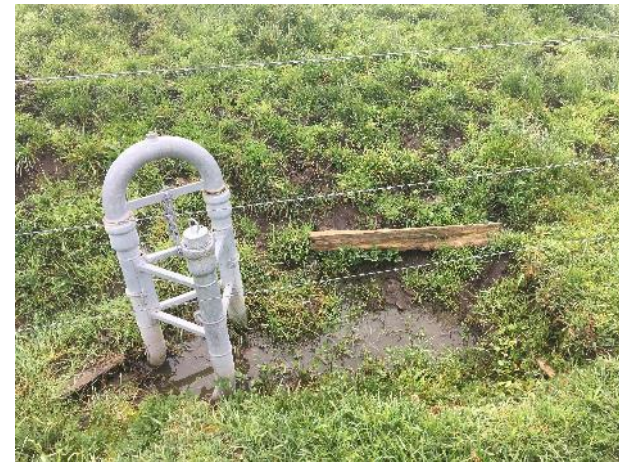
Photograph 16: Bore on 461 Peacocke Road south of new milk sheds

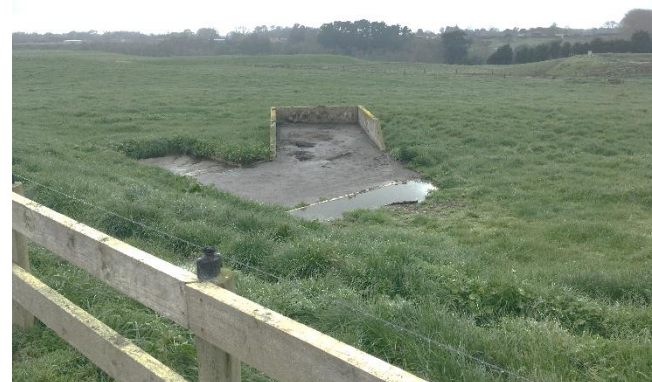
Photograph 18: Unidentified structure located directly east of new milk shed. Likely used for stockpiling and loading of gravel (or similar)

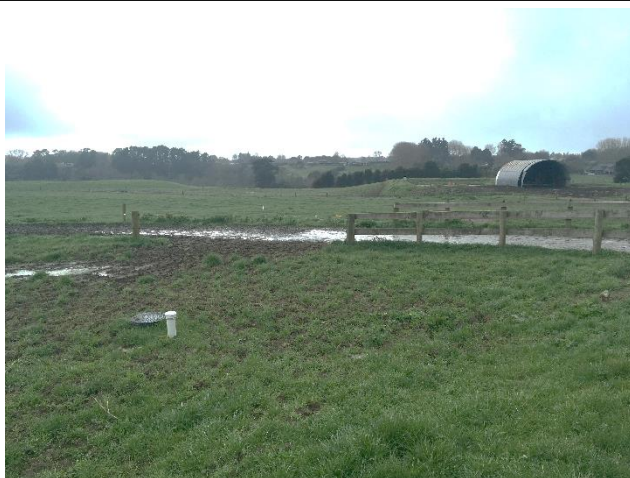
Photograph 19: View looking north from new milk shed at location of underground septic tank

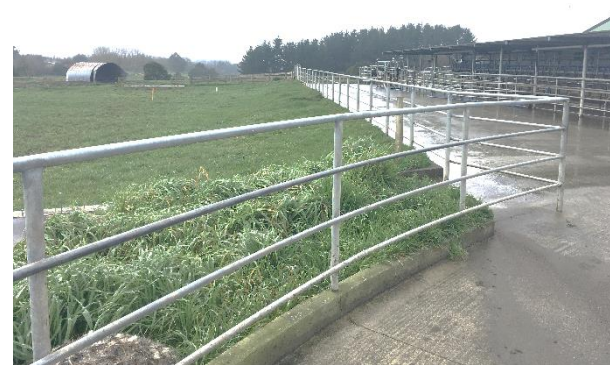
Photograph 20: View looking east at drainage from new milk shed

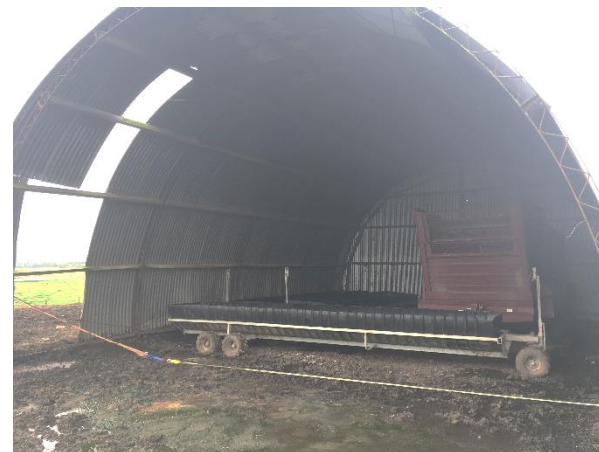
Photograph 22: Storage shed B adjacent to effluent pond

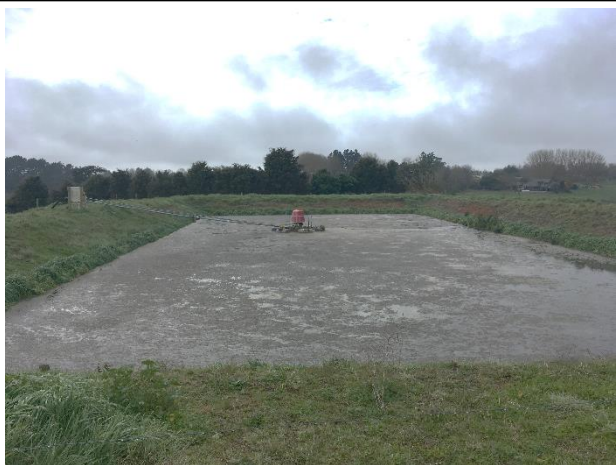
Photograph 23: Effluent pond

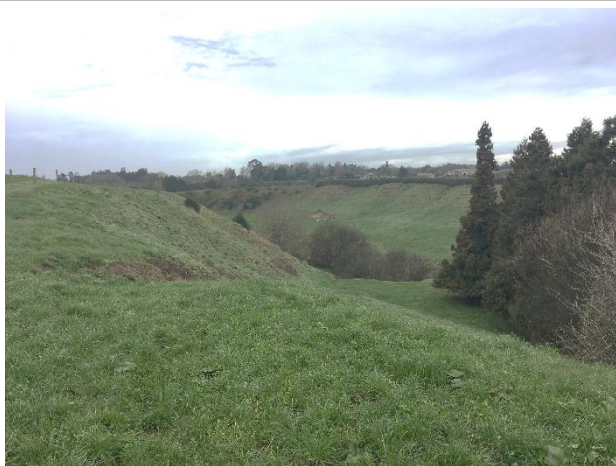
Photograph 29: View looking north-east from ridge line looking at location of buried rubble pit

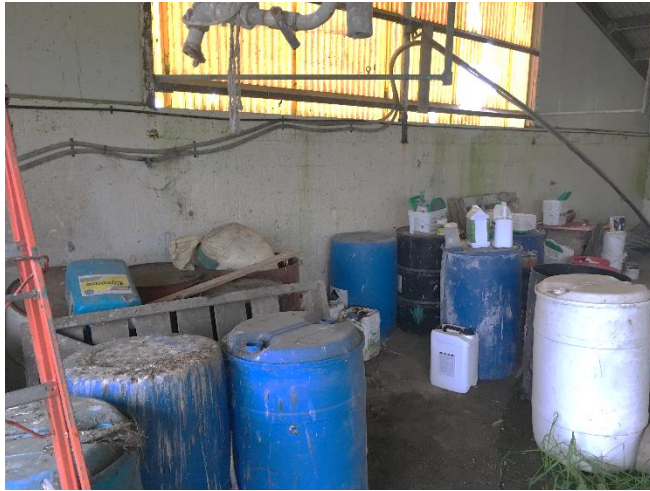
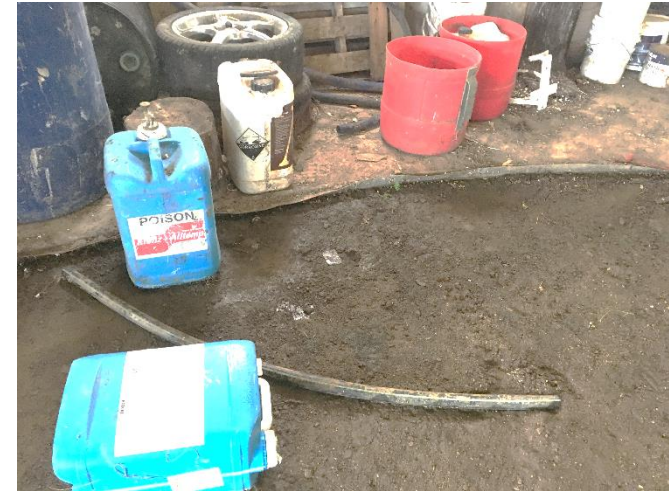
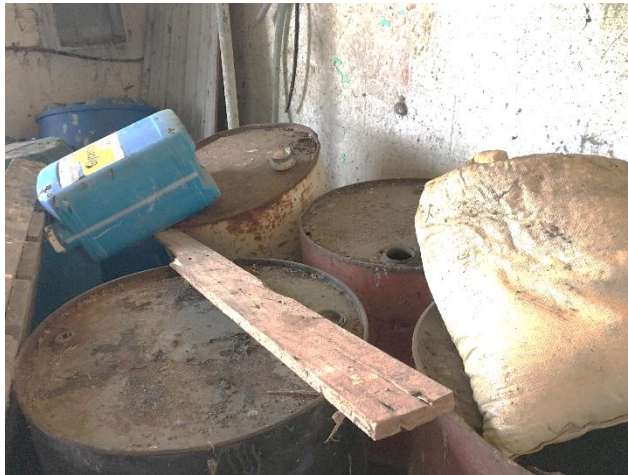
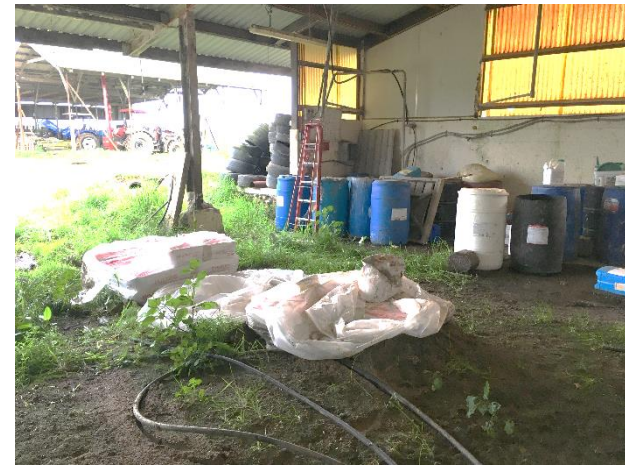
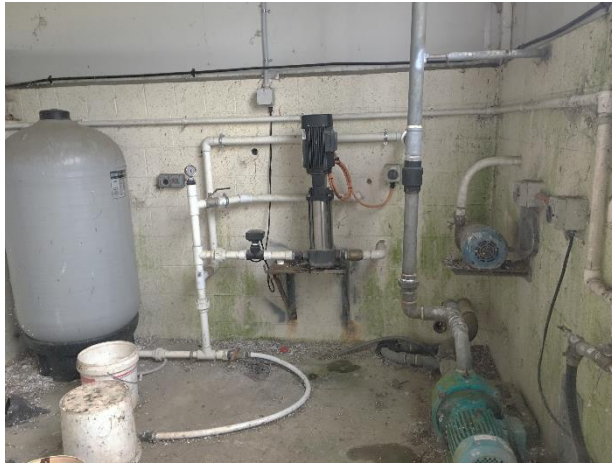
Photograph 33: Interior of old milking shed

Photograph 34: Interior of old milking shed

Photograph 35: Interior of old milking shed

Photograph 36: Interior of old milking shed

Photograph 37: Interior of old milking shed

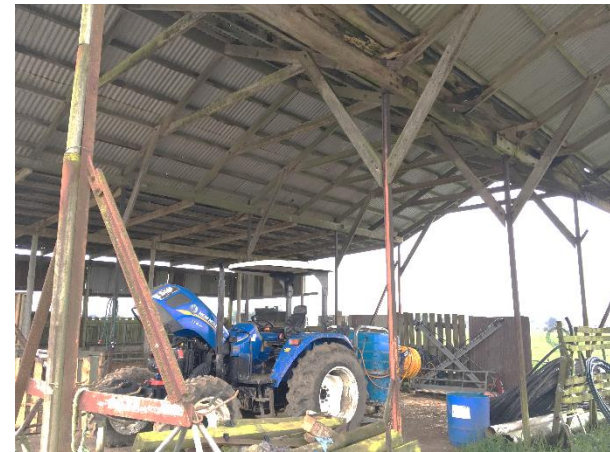
Photograph 38: Interior of Shed C

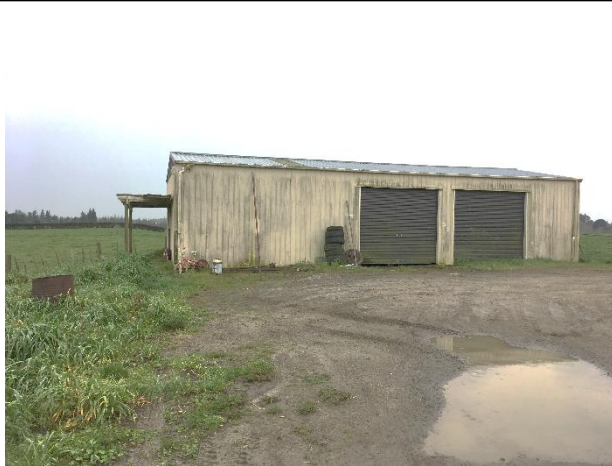
Photograph 39: Exterior of shed D

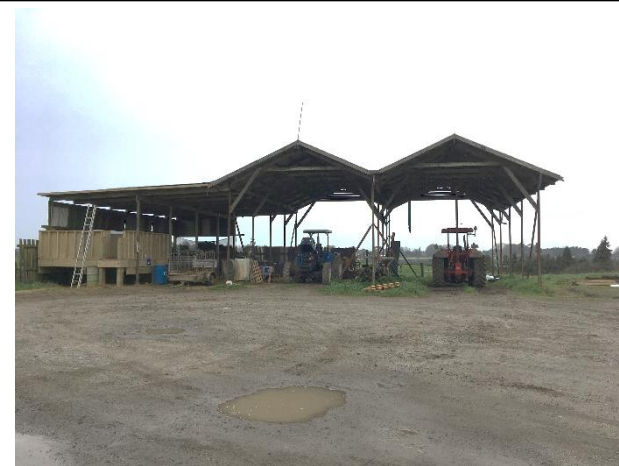
Photograph 40: Exterior of Shed C

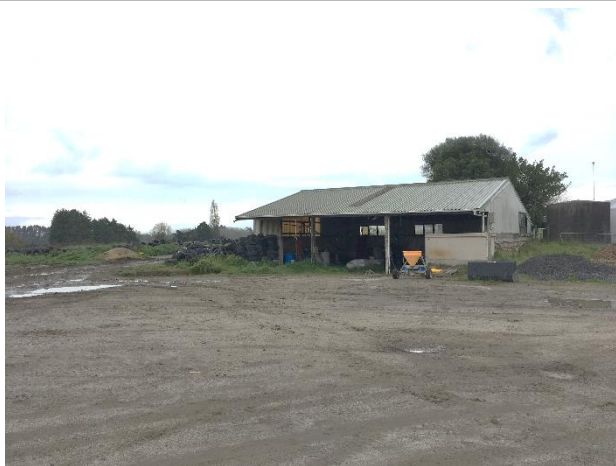
Photograph 41: Exterior of old milking shed (shed B)

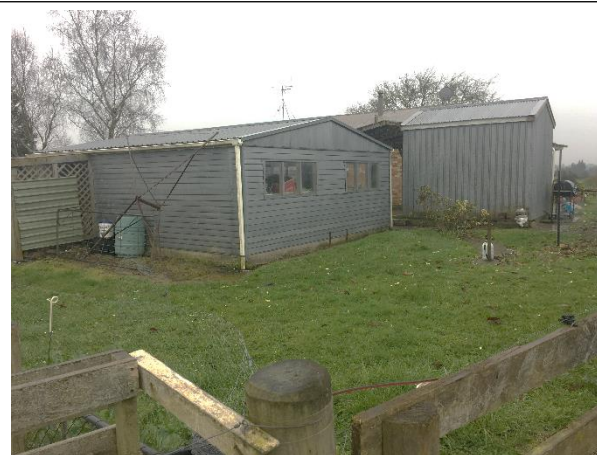
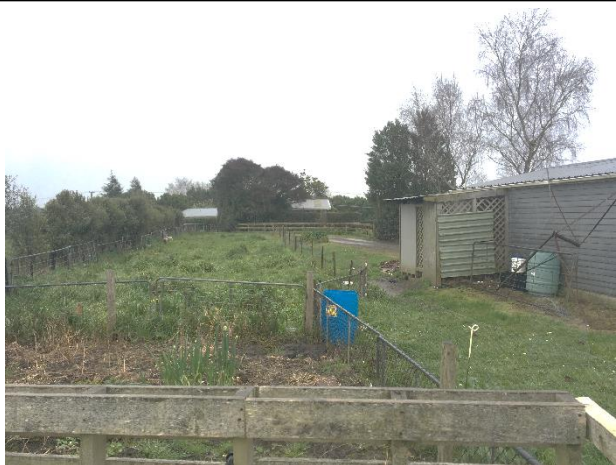
Photograph 42: Sheds adjacent to dwelling at 461 Peacockes Road

Photograph 43: Sheds adjacent to dwelling at 461 Peacockes Road

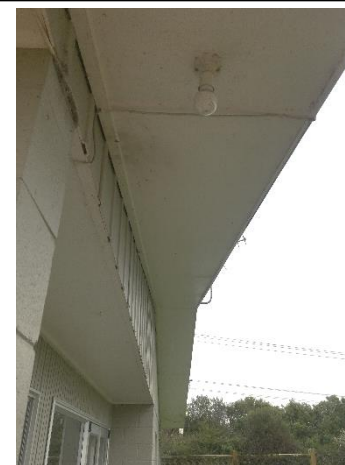
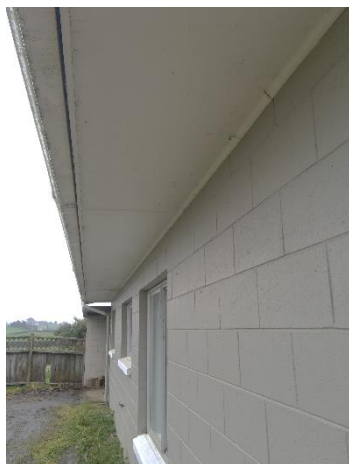
Photograph 44: Potential asbestos on dwelling at 461 Peacockes Road

Photograph 45: Potential asbestos on dwelling at 461 Peacockes Road

Lead paint: Samples for lead analysis should be collected from soil directly surrounding buildings where paint is noted to be in a deteriorated condition.

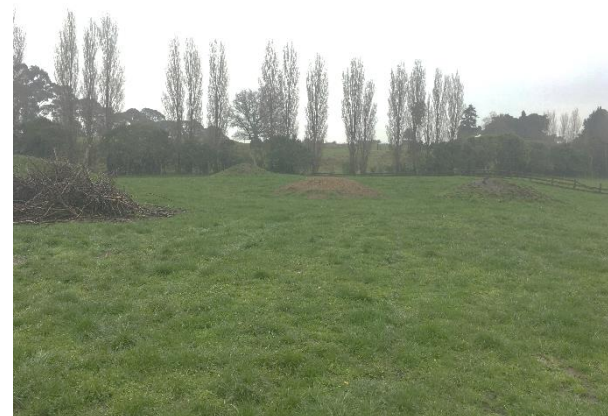
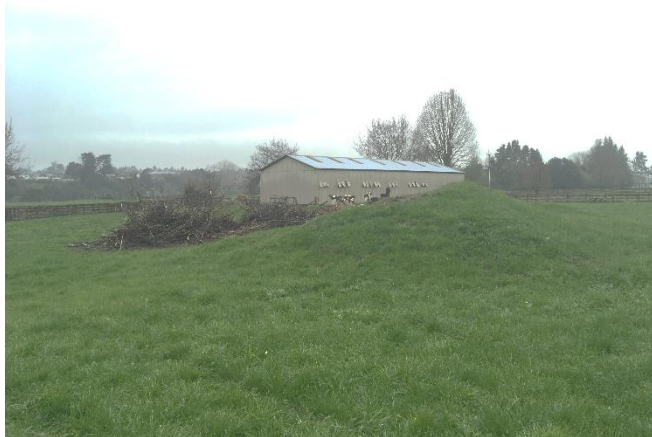
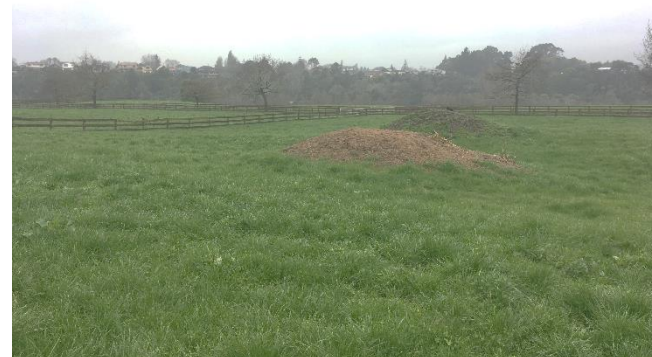
Photograph 48: Stockpiles - 337 Peacockes Road

Photograph 49: Stockpiles - 337 Peacockes Road

Photograph 50: Stockpiles - 337 Peacockes Road

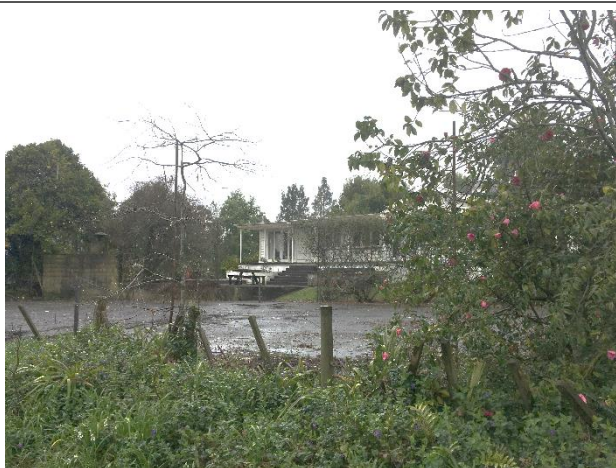
Photograph 53: Dwelling - 361 Peacockes Road

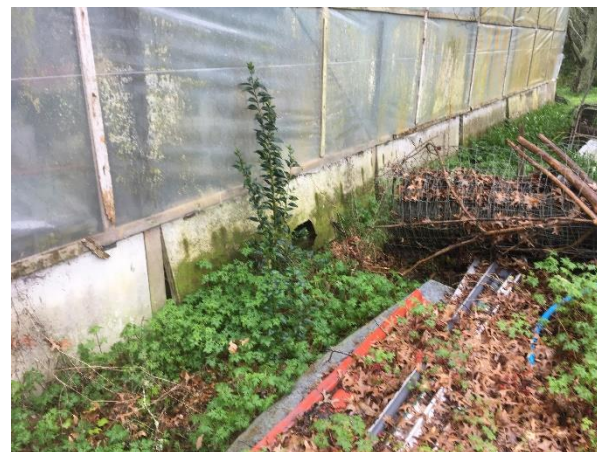
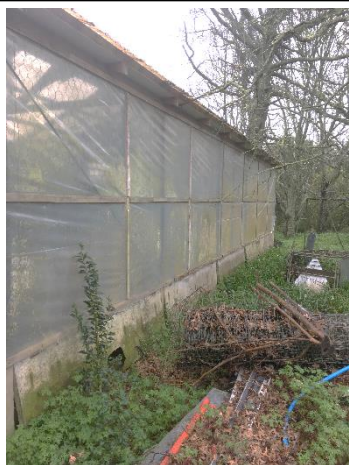
Photograph 54: Asbestos cladding on shed - 361 Peacockes Road

Photograph 55: Asbestos cladding on shed and surrounding stockpiled materials - 361 Peacockes Road

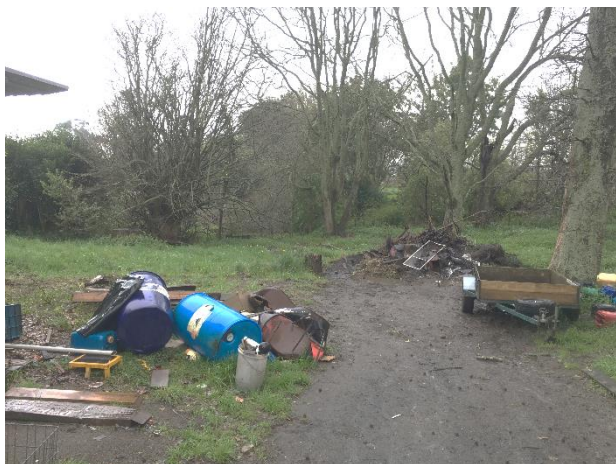
Photograph 61: View looking south adjacent to shed at 361 Peacockes Road

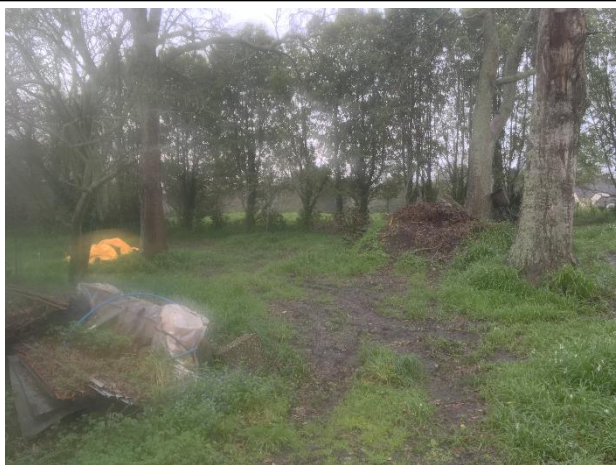
Photograph 63: View looking east adjacent to shed at 361 Peacockes Road

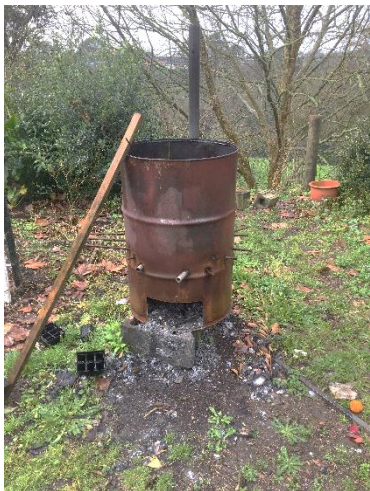
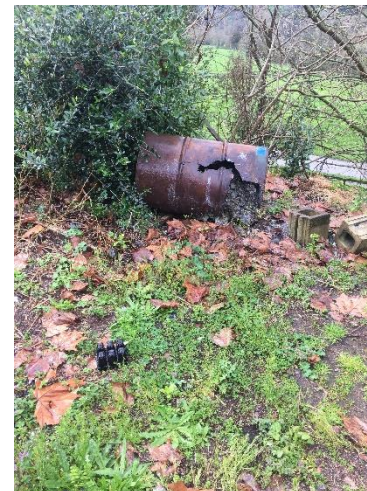
Photograph 65: Incinerator adjacent to dwelling at 337 Peacockes Road

Photograph 66: Disused incinerator adjacent to dwelling at 337 Peacockes Road

Evidence of burning activities: Samples should be collected from soil directly impacted by burning activities (i.e. where ash and blackened soil is observed). All samples should be tested for heavy metals and PAHs.

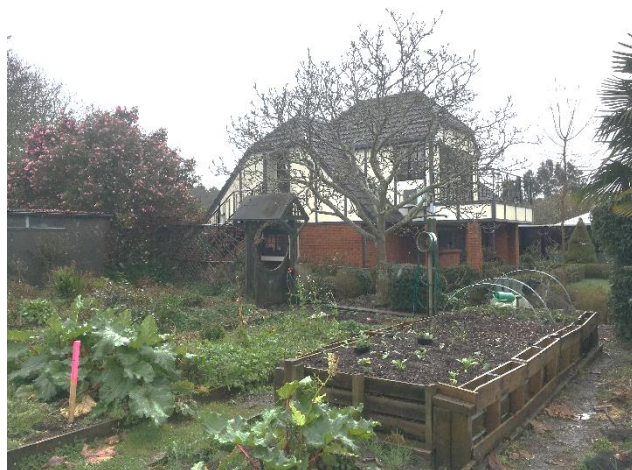
Photograph 67: Dwelling at 337 Peacockes Road

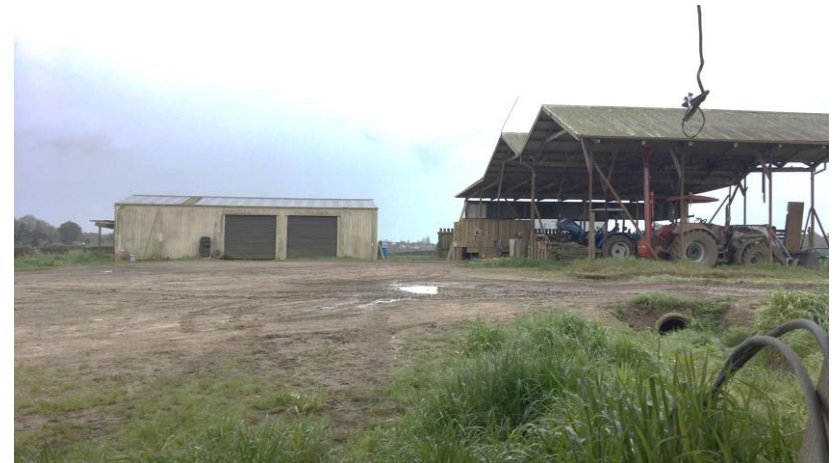
Photograph 72: Exterior of Shed C and D
