The Village of
Saranac Lake
New York

Emergency Services
Facilities Assessment
(ESFA)

September 24, 2012

Historic Building Condition Assessment Report of the **SARANAC LAKE FIRE STATION**

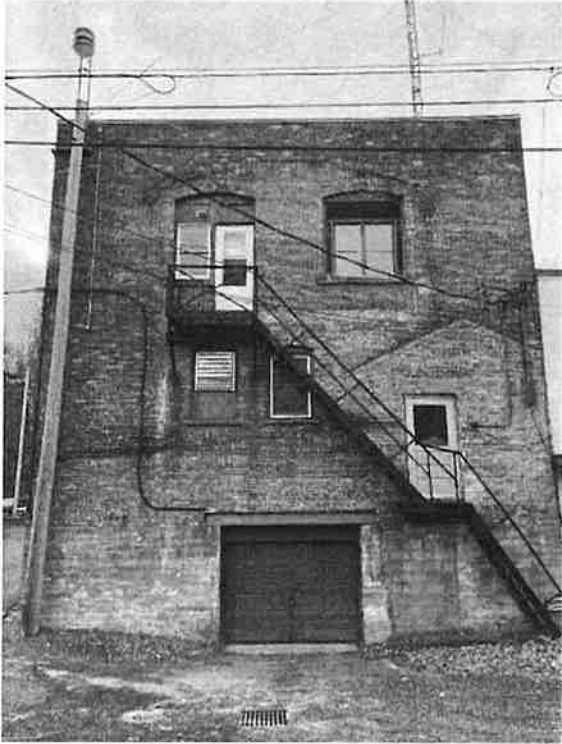
Rear east elevation with ghost lines of former 2nd floor bay window and gabled roof of NE addition.
