Feasibility Study for

Village of Saranac Lake Emergency Services Facility

Saranac Lake, NY

October 11, 2023

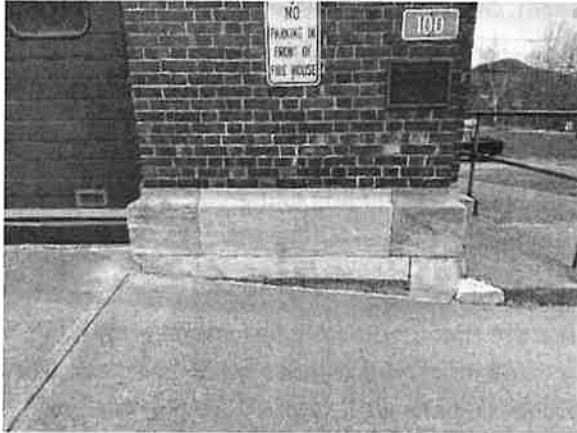
Cut & dressed marble foundation.

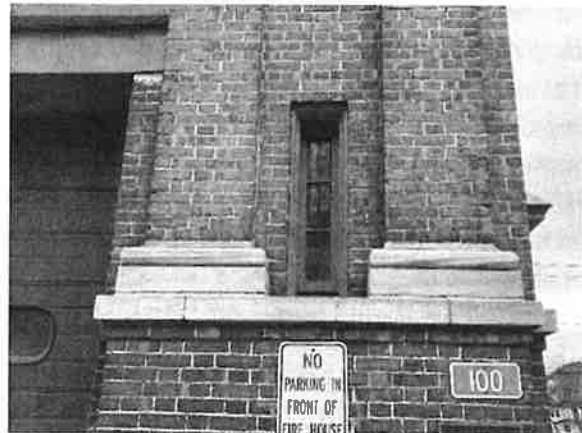
Dressed & carved limestone trim.

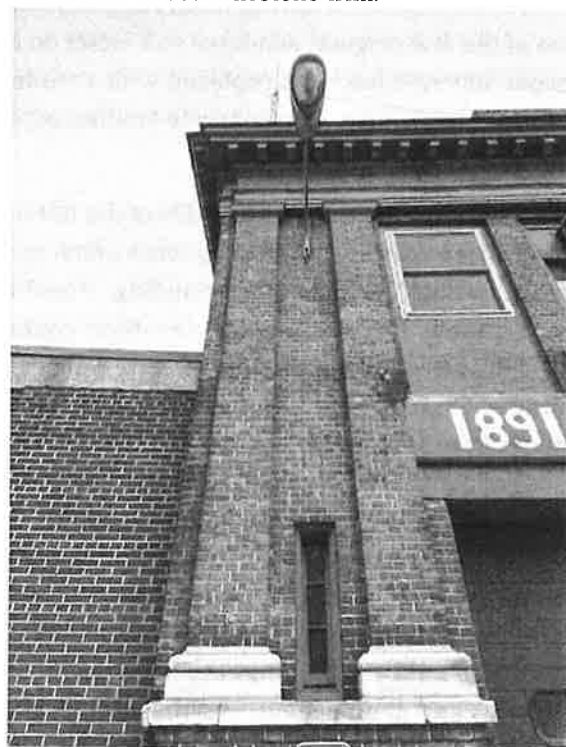
Pressed metal entablature/cornice painted red. Note stone pilaster capitals also painted red.

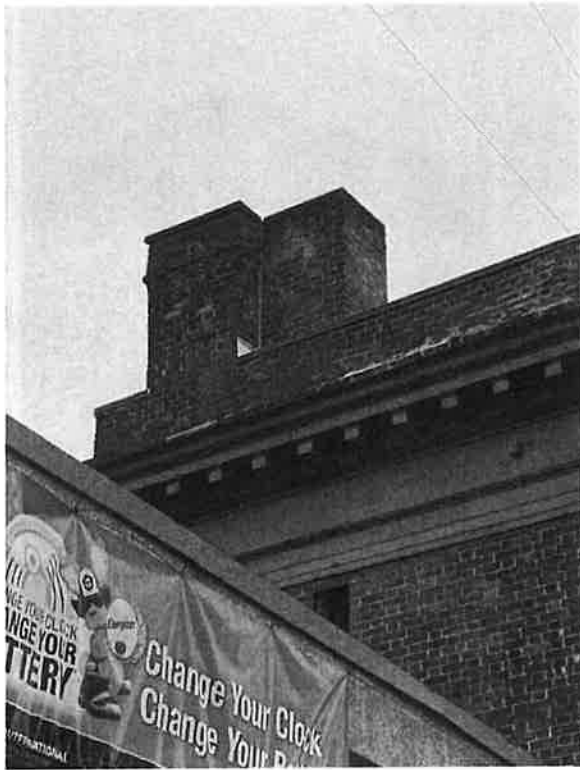
Metal entablature returned on north elevation. Note brick parapet & orig. chimney with new boiler chimney added next to it.

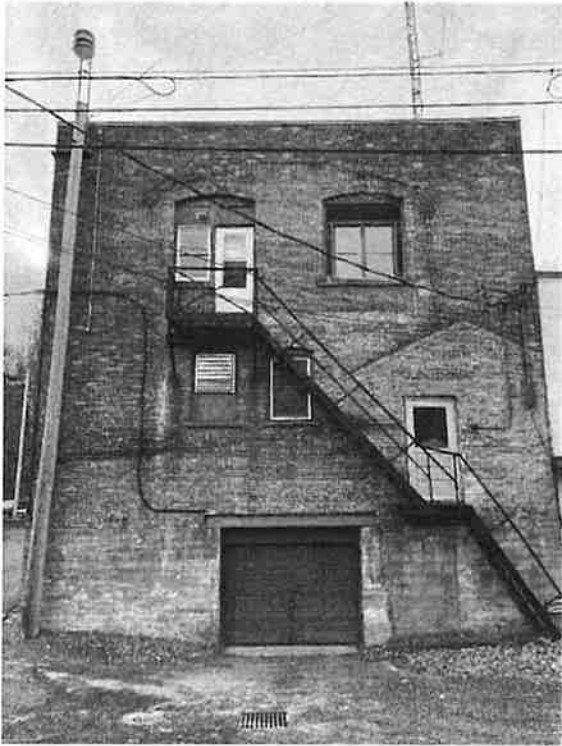
Rear east elevation with ghost lines of former 2nd floor bay window and gabled roof of NE addition.

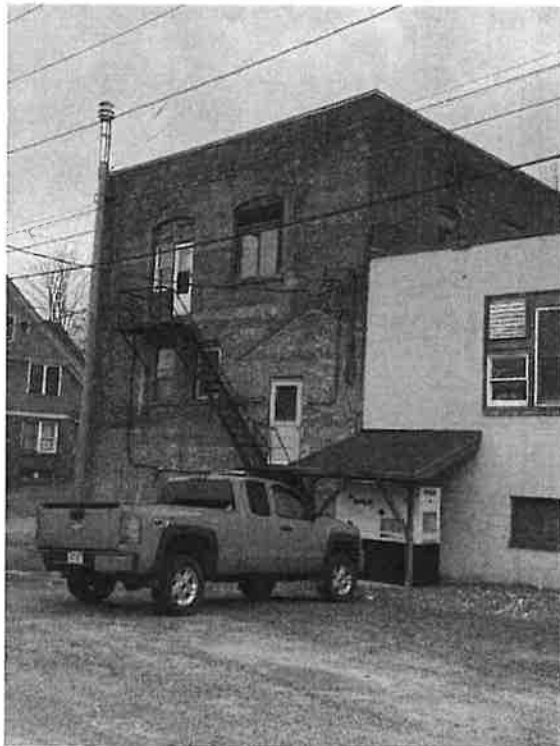
View of north elevation showing altered window openings and c.1960s CMU addition.

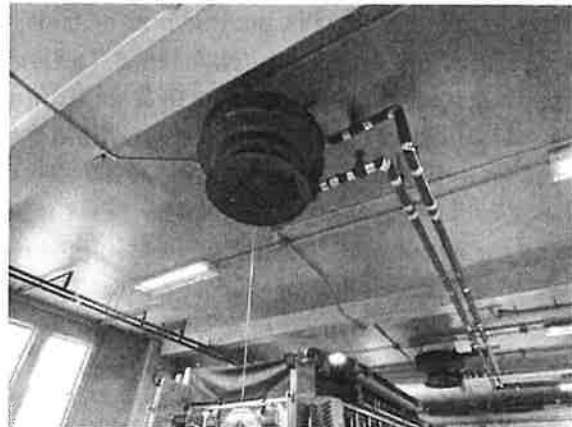
Note exposed electric, piping and equipment attached to ceiling.

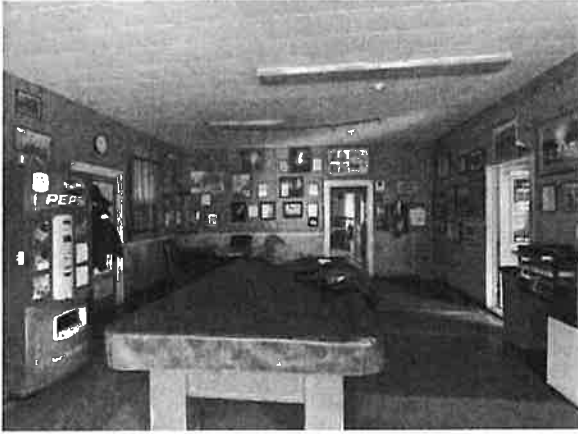
2nd floor Day Room with modern (mid 20th c) wall, ceiling & floor finishes.

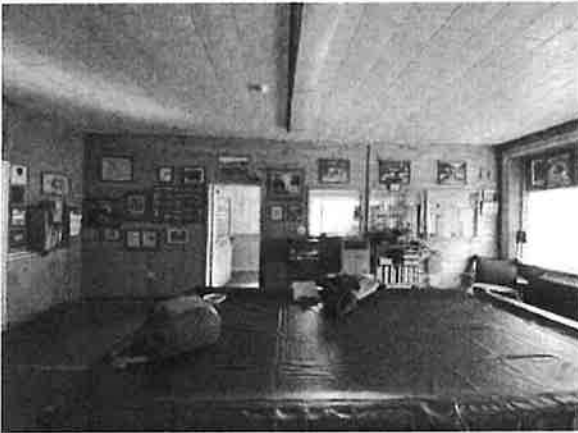
Modern south partition wall of Day Room constructed of knotty pine boards & fixed windows – out of character of orig. finishes.

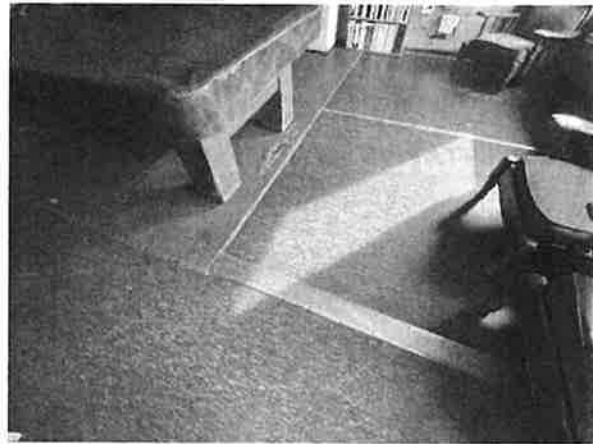
Linoleum sheet flooring pieced together with stainless steel threshold strips. Likely over orig. wood flooring.

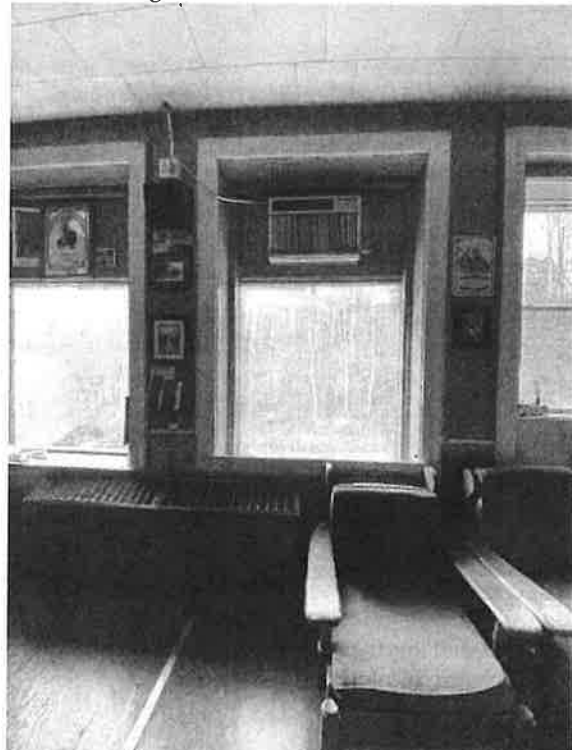
View of centered windows on front wall of Day Room with plywood infills and fixed window units replacing orig. double hung sash.

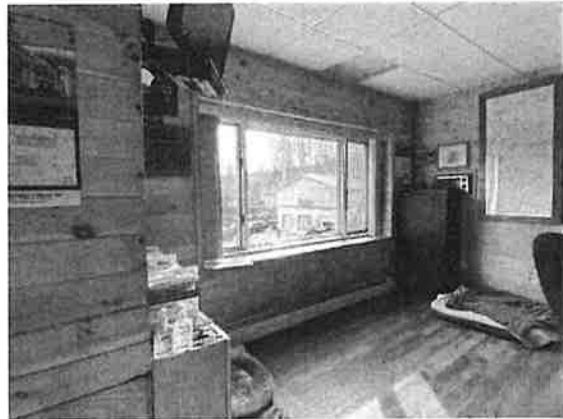
Large original window opening infilled & framed down with smaller plate glass and casement windows.

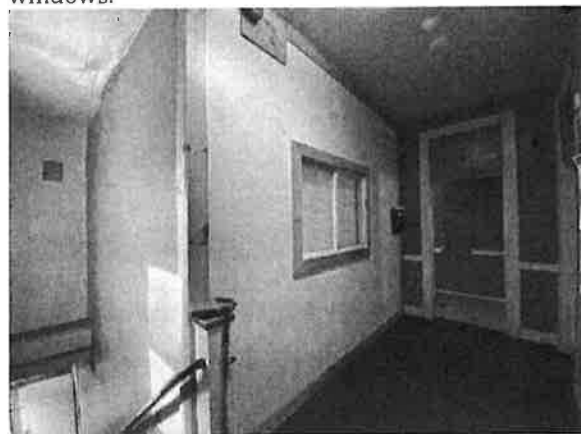
Modern finishes on west wall of stair hall – out of character with orig. finishes.

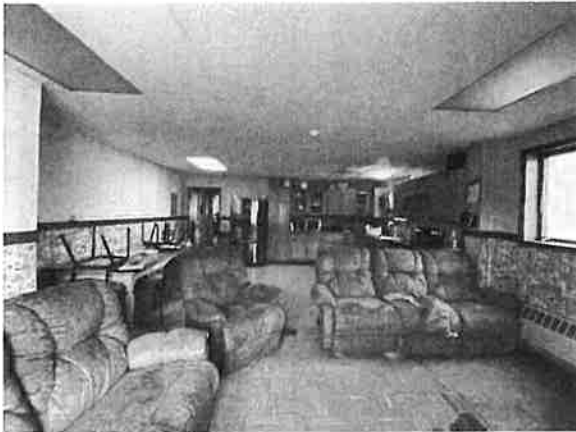
2nd floor Kitchen/Lounge space with mid 20th c. wall, ceiling and floor finishes. Cabinetry is 21st century and in good condition.

On the second floor, the most remarkable condition is the numerous layers of outdated and low quality finishes. The relatively new cherry veneer kitchen cabinetry in the Kitchen/Lounge stands out in stark contrast with the c. 1960s paneled and wallpapered walls, varnished pine trim, dropped acoustical ceilings, fluorescent lighting and worn vinyl floor tile. Interior finishes in a public/civic space generally should attempt to avoid current trends (wallpaper patterns, trendy paint colors, the latest fashionable flooring or lighting styles) as they quickly grow out of date and out of fashion. Instead, it is strongly recommended that classic, timeless finishes be chosen for public spaces that reflect the building's original construction date rather than a remodeling/renovation date and with the focus on long-lasting, maintainable materials and an overall comfortable atmosphere. Given that most of the finish layers were applied over the original surfaces/finishes and date from the 1960s-1980s, some or many of these materials may require careful abatement, such as the 9"x9" vinyl composition floor tile which likely contains some extent of asbestos. Acoustical ceiling tiles are also suspected to contain some extent of hazardous material. Often times, these materials were simply installed over original surfaces and finishes as a method to avoid making repairs such as cracked plaster, peeling paint, worn wood floors or addressing settlement cracks in the walls or ceilings. On the exterior perimeter walls, these wall

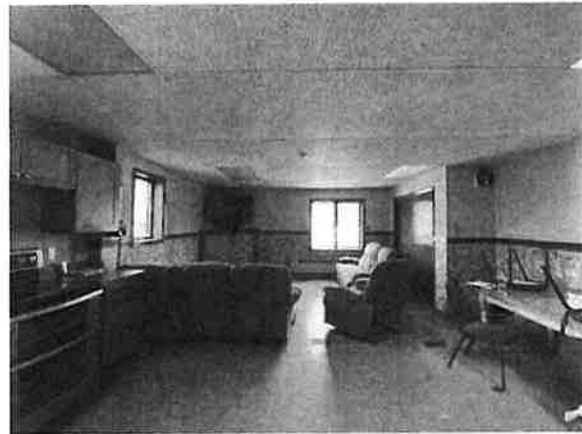
Kitchen finishes, aside of cabinetry dates to the 1960s renovations after neighboring fire.

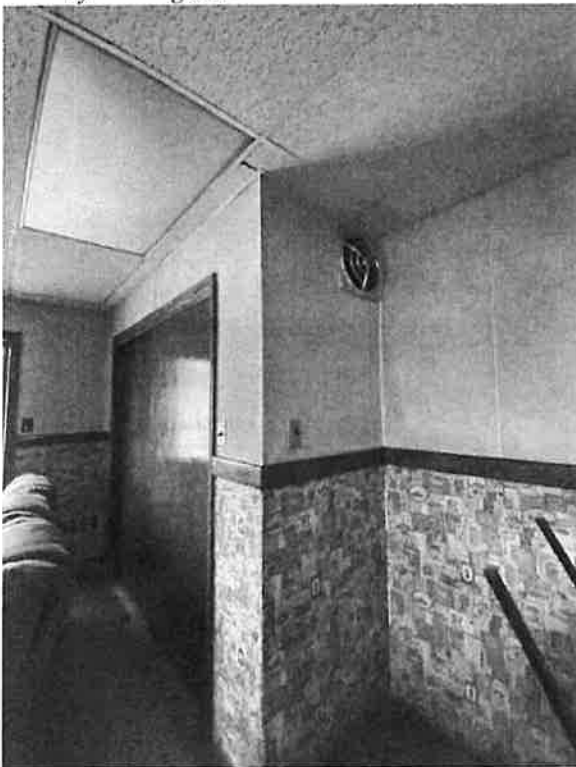
Closet built into SE corner of Kitchen is modern with hollow core sliding doors. Masonite paneling covered with wallpaper.

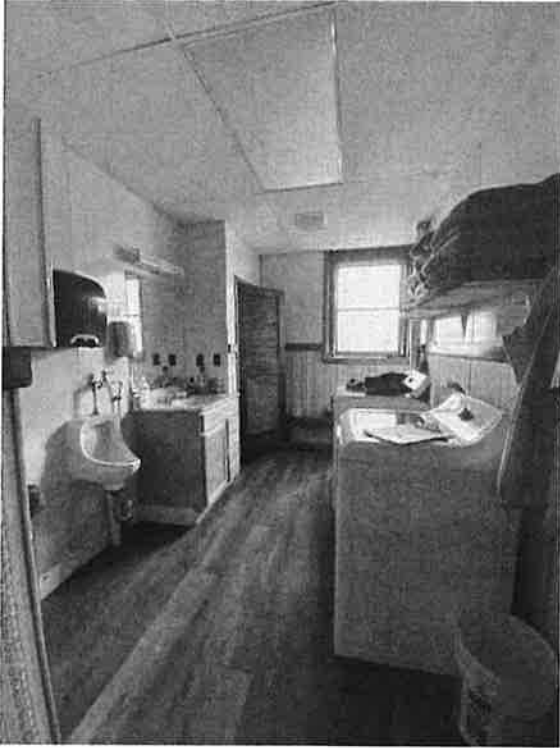
Bathroom/shower/laundry facilities on 2nd floor positioned along north wall. Window is framed down from original openings size.

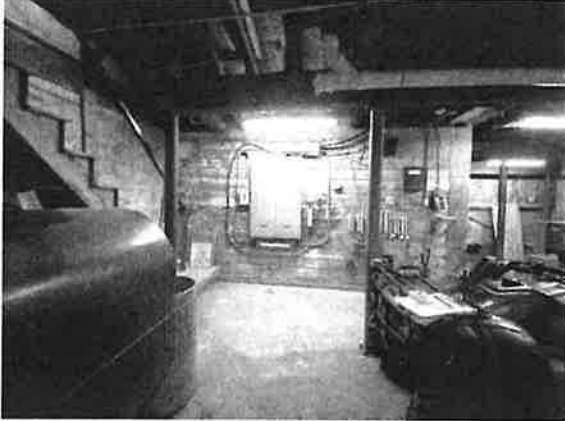
Shiplap board partition wall at bottom of stairs in SW corner – former coal bin. Note new elect. panel.

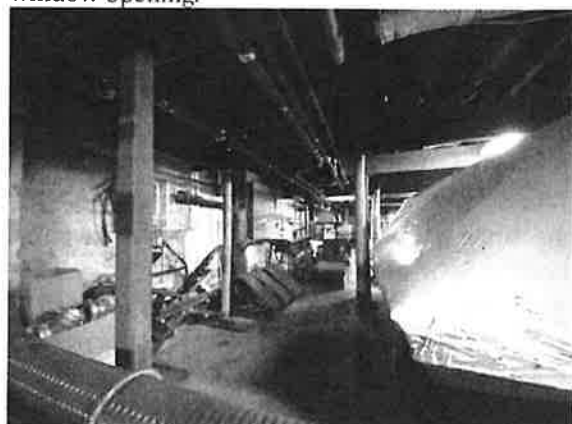
View of parged foundation wall on north side of basement with former window openings to crawl space of 1960s addition infilled with plywood.

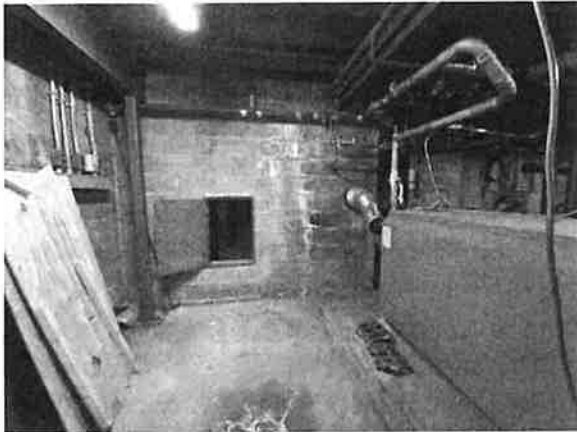
View of wall of hose tower with access door. Note new boiler exhausts into new chimney built within hose tower.

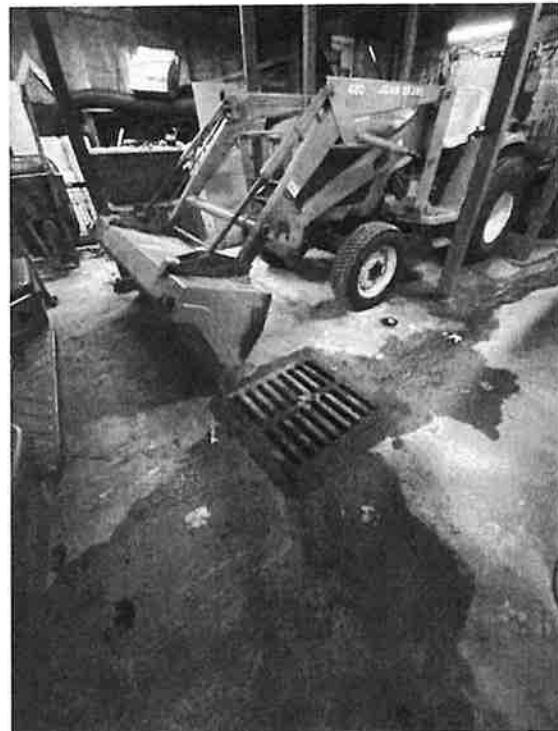
Large drainage grate positioned in center of basement floor for site water from rear yard.
