# Town of Alta

## Facilities Master Plan

AUGUST 2025

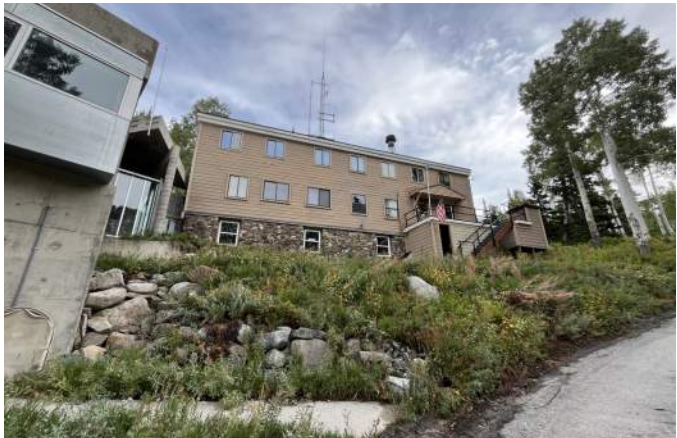
## Alta Central / Marshals Office

The building is not built to withstand or protect occupants from avalanches, and it is presumably exposed to significant avalanche hazard.

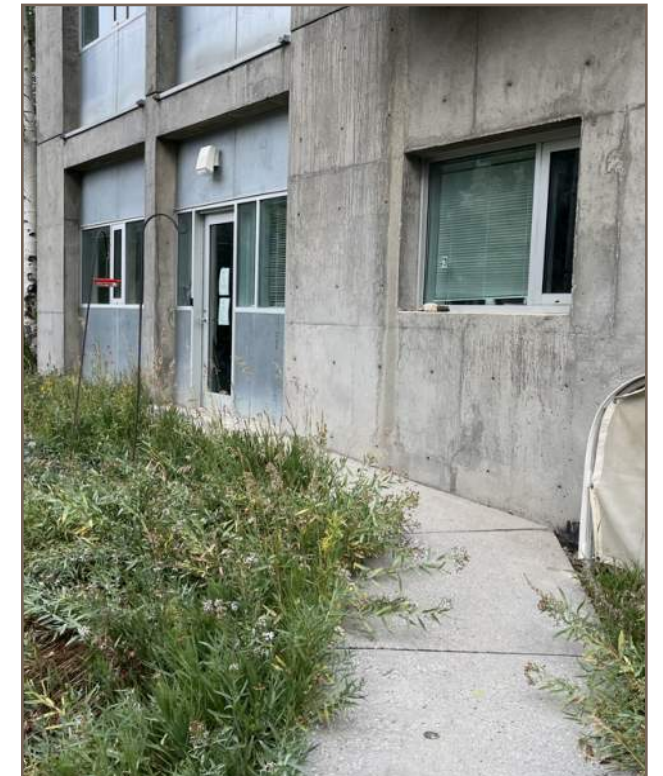
The west wall acts as a partial retaining wall as the slope of the hill progress from front (south) to rear (north). This wall has one punched opening filled with metal panel and a window, similar to the south wall.

The north wall is acting as a retaining wall and only the top of the wall is exposed to view. The hill slopes gently from east to west and the wall exposure increases from about four (4) feet to about seven (7) feet as the slope extends to the west.

**Good** – Periodic pressure wash cleaning and inspection of the foundation and retaining walls. Periodic inspection of the sealant at the metal panel to concrete interface.

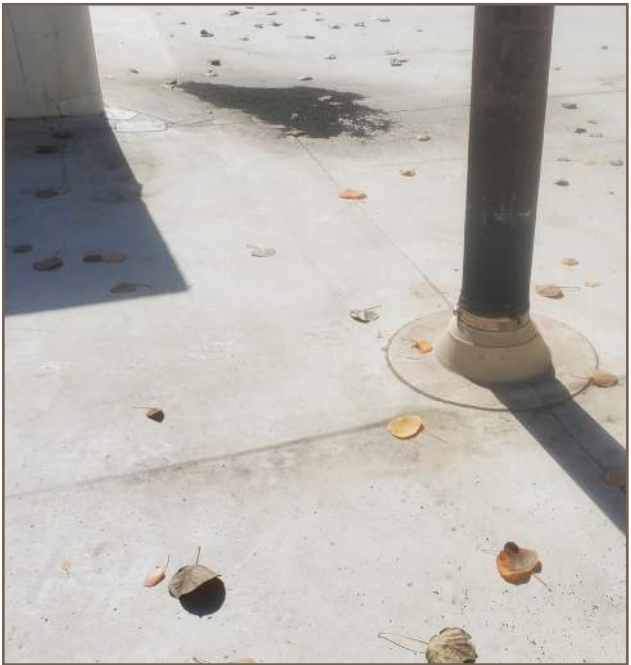
Only the main roof and the concrete canopy roofing were readily accessible for visual inspection. The roofing membrane appears to be a white TPO. The roofing may be PVC, but the typical dark colored line at the membrane seams is missing. The membrane installation is assumed to be a 20-year warranty system as vertical surface termination bar lacks the usual counter flashing required for a 30-year installation warranty. There is no obvious visual indication of exposed scrim, pinholes or seam separation and no obvious signs of roof leaks inside the building. The membrane appears to be in good condition, but based on the age of the building, this is likely the original roof membrane and plans should be made for replacement in the next five (5) years.

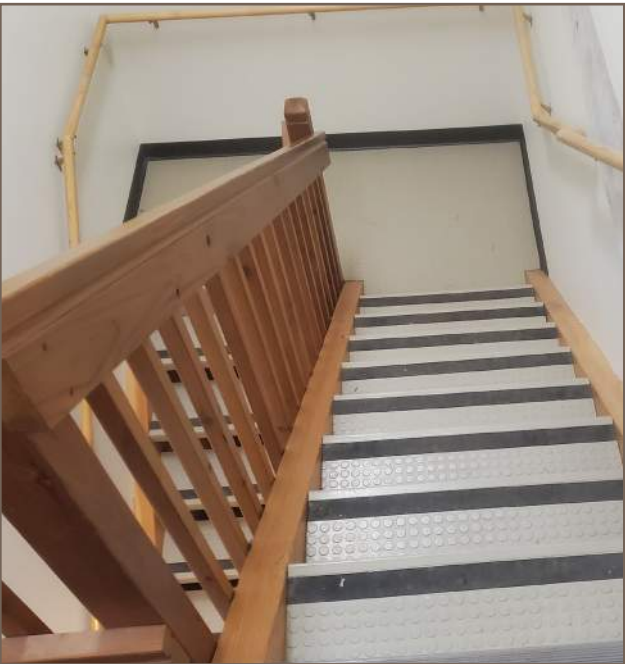
The handrail and guardrail in the interior stair are wood. The outside of the stair has a code compliant unfinished wood handrail, while the interior is a "bread loaf" railing that is not compliant with the current building code. The rail does not continue around the intermediate landing newel post un-interrupted, nor does the rail extend the required distance at the top and bottom of the stair.

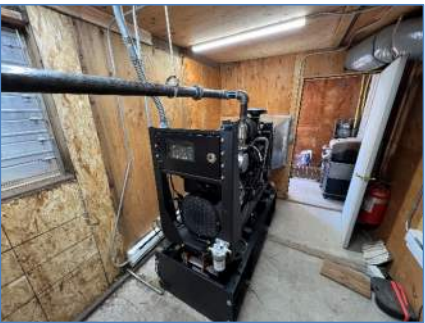
Exhibit 6 – Standby generator in the Marshall Building

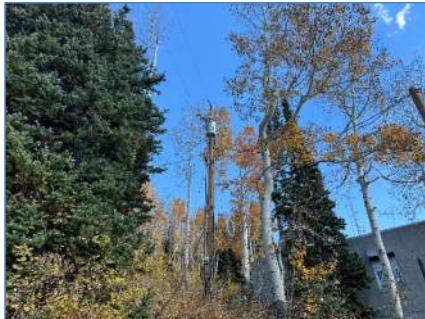
- a. Electrical service is provided by Rocky Mountain Power (RMP).
- b. We have made the following **assumption** about the Marshall Building electrical service: **The building is fed from a nearby pole mounted, single-phase tub transformer (Exhibit 1) and Office Building meter/disconnect (Exhibit 2).** This assumption to be confirmed by the Owner.
- c. The meter (meter # 50 823 601) and main service disconnect are located outside the Office Building. The as-built drawings indicate the service disconnect size to be 200A, but we have observed a 150A (120/240V, 1ph, 3w) breaker during the site visit.

Exhibit 1 – Utility transformer (assumed) for Town Office and Marshall Building electrical service

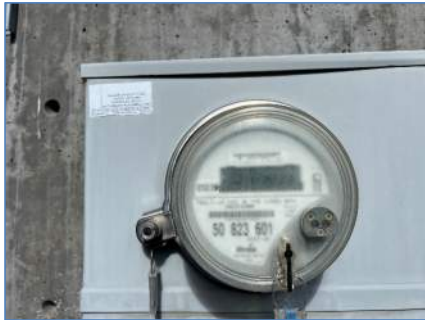
Exhibit 3 – Town Office and Marshall Building electrical service meter

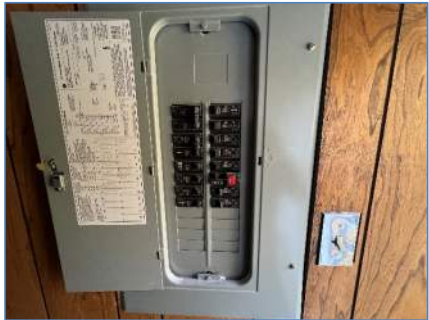
- f. The main panelboard is located at the upper level, and it feeds a subpanel located in the furnace room. Both panels are outdated, past their useful life, and should be replaced. There is a third panelboard located in the generator room. This panelboard is in good conditions and can be reused.

Exhibit 5 – Main panelboard

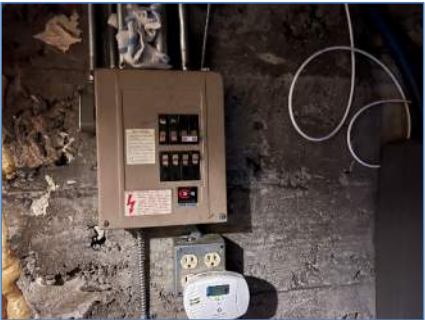
Exhibit 6 – Subpanel located in the furnace room

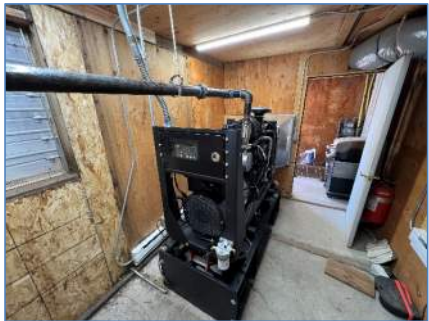
renovations, additions, or large loads (such as elevator and similar loads) are planned in the future, the generator size should be checked again at that time.

Exhibit 7 – Standby generator

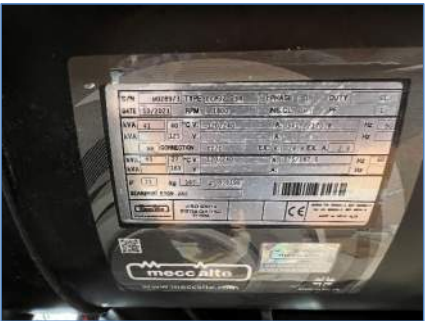
Exhibit 8 – Generator nameplate

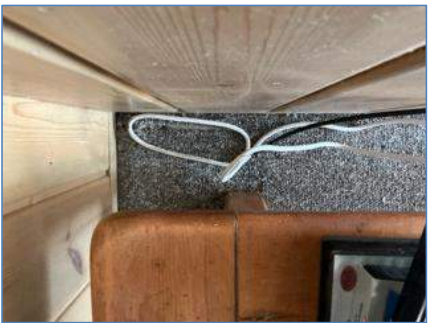
- a. Satellite Cable TV distribution system consists of coax cables run on the outside of the building, punched through external walls, and floors to TVs through the building. Some sleeping rooms do not have distribution.

Exhibit 15 – Coax cable punched through floor

</div><div>ENVISION<sup>™</sup> ENGINEERING</div></div> <div>Town of Alta Facilities – Marshall Building Electrical Assessment Report</div>		
Audio/Video System 1	<ul style="list-style-type: none"><li>Replace Current Satellite TV System with an IP based system with Wired Data jacks at each device location to reduce bandwidth strain on Wireless Networks.</li><li>Remove Satellite Receiver from roof.</li></ul>	2
Audio/Video System 2	<ul style="list-style-type: none"><li>Update Commons Display to larger smart TV (65"). Add Blu-Ray Player, and Data connections.</li></ul>	2

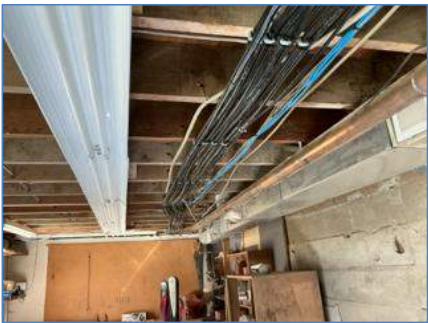
Exhibit 18 – Cable Distribution in basement

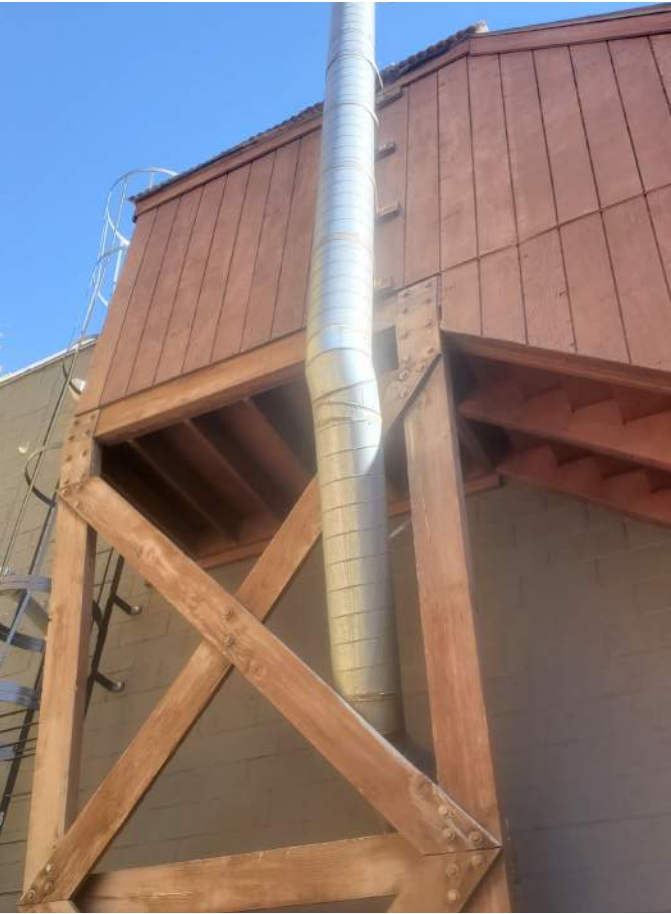
Post office and stair to the second floor addition is separating from the building and creating gaps in the building envelope which will allow energy leakage and water infiltration. The separation is particularly evident while climbing the east stair to the second floor. As one approaches eye-level with the top landing, daylight can be seen through a large gap between the wall and landing. The landing is obviously sloping from a high point on the west to a low point on the east. Building occupants have indicated that maintaining a comfortable temperature is difficult in the post office, which is below the area of the separation.

Both the post office addition on the east and the residential addition to the west overhang the original garage and are supported by a timber brace that is painted to match the T1-11 siding. The braces appear to be in good condition.

**Good** – Touch-up the peeling or flaking paint along the base of the west wall. Clear the large rocks away from the building to form a 3’-0” wide buffer zone along the building foundation on the north and west sides of the building. Repaint the northern portion of the east side of the second-floor addition.

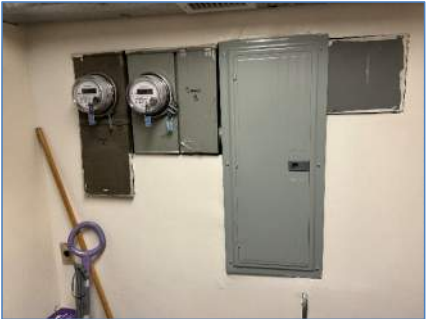
- c. There are two meters at the upper level: meter # 50 823 587 (service A) and meter # 50 823 586 (service B). It appears that service A feeds the lower level (panelboard A is in the high bay area at the lower level) and service B feeds the upper level (panelboard B is located next to the meter). There is also a note on panelboard B (*Exhibit 4*) that panel “contains feeders for panel A.” An E01 error (*Exhibit 2*) was displayed at the service A meter during the time of the site visit. This is typically an initialization error, meaning the meter has not been initialized. Also, we have only received the demand data for the service B meter. Considering all the above, ***we have assumed that the service B meter is active, the service A meter is inactive, and both panelboards (A and B), are fed from the service B.*** This assumption to be confirmed by the Owner.

Exhibit 1 – Service A and B meters and panelboard B

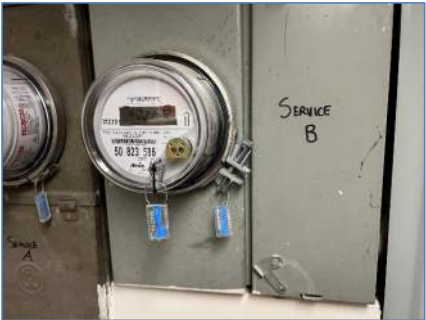
Exhibit 3 – Service B meter.

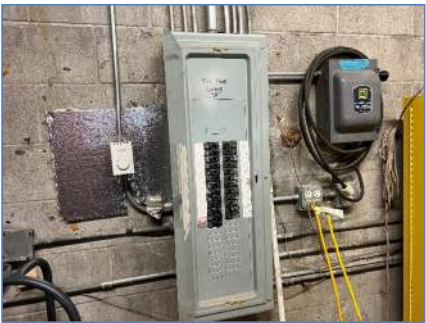
Exhibit 5 – Panelboard A.

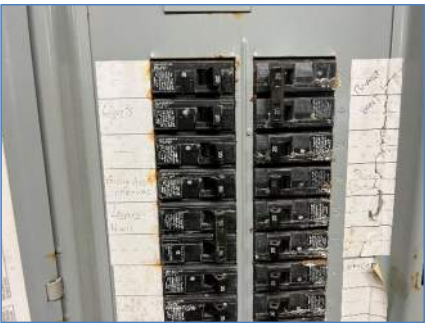
Exhibit 6 – Panelboard A interior

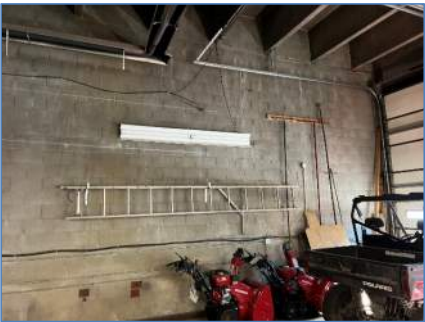
Exhibit 8 – Fluorescent linear utility light – lower level

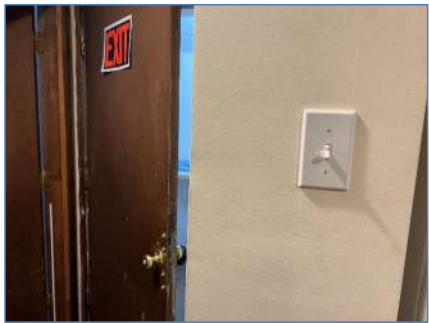
Exhibit 9 – Toggle switch

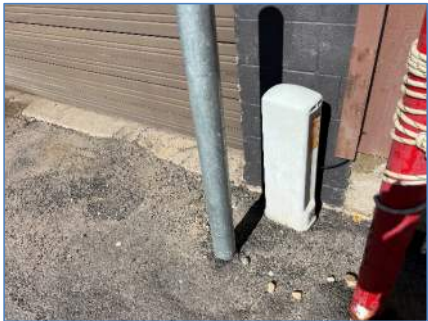
Exhibit 12 – Telecom pedestal

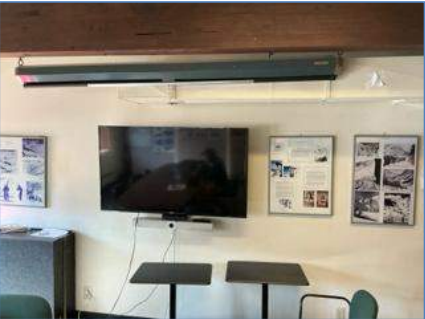
Exhibit 14 – Display, VC Bar, and projector screen.

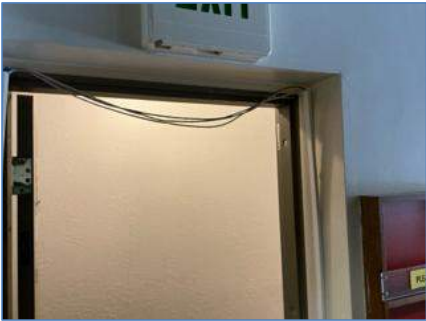
Exhibit 15 - Exposed cables above doorway.

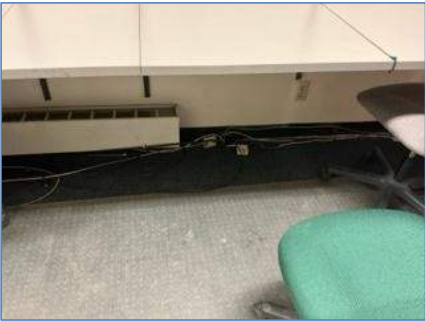
Exhibit 16 – Exposed cables below desks.
