# TOWN OF CLARKTON - SEWER ASSET MANAGEMENT PLAN

October 2025

NC DEQ Project No. AIA-W-ARP-0065

WR Project No. 02200415.02

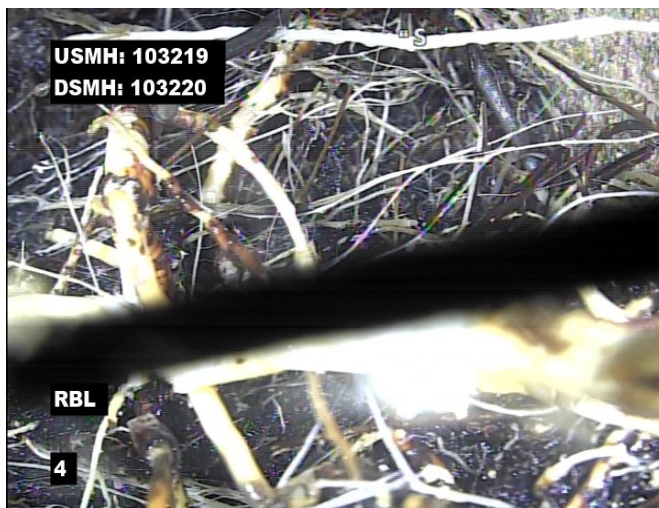
Distance: 4.0 ft. Grade: 4  
 Condition: RBL-Roots Ball Lateral  
 Remarks: N/A

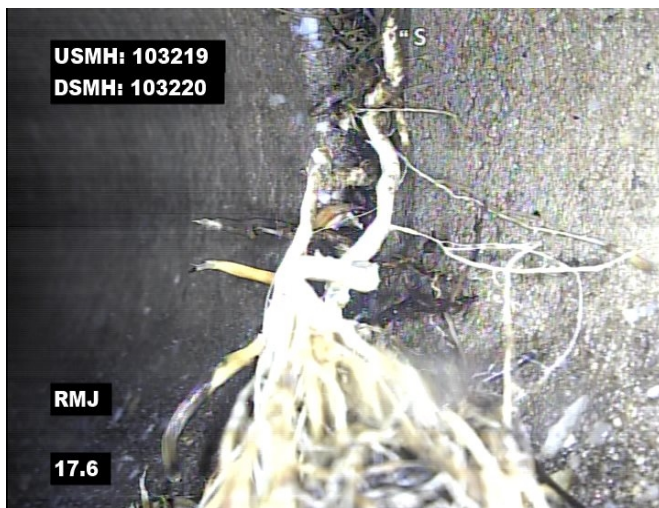
Distance: 17.6 ft. Grade: 3  
 Condition: RMJ-Roots Medium Joint  
 Remarks: N/A

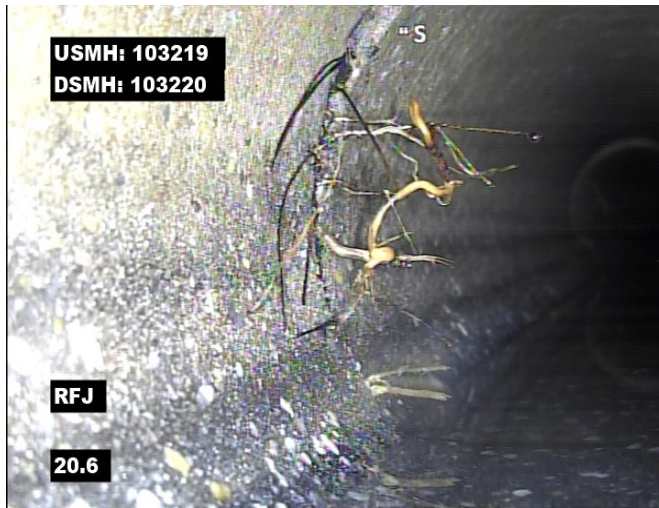
Distance: 20.6 ft. Grade: 1  
 Condition: RFJ-Roots Fine Joint  
 Remarks: N/A

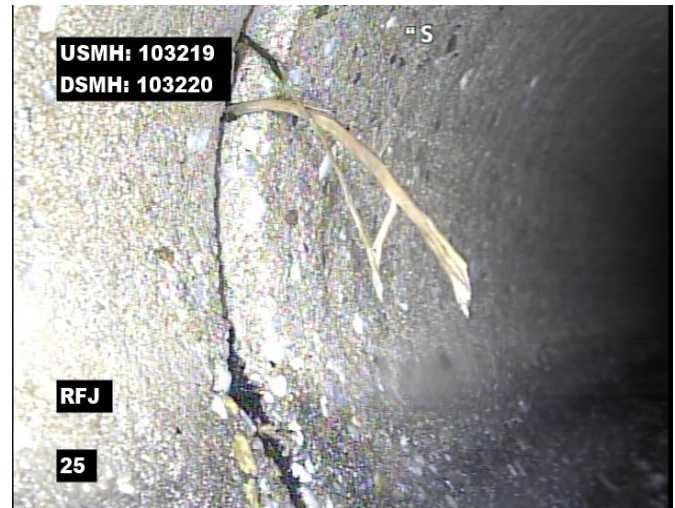
Distance: 25.0 ft. Grade: 1  
 Condition: RFJ-Roots Fine Joint  
 Remarks: N/A

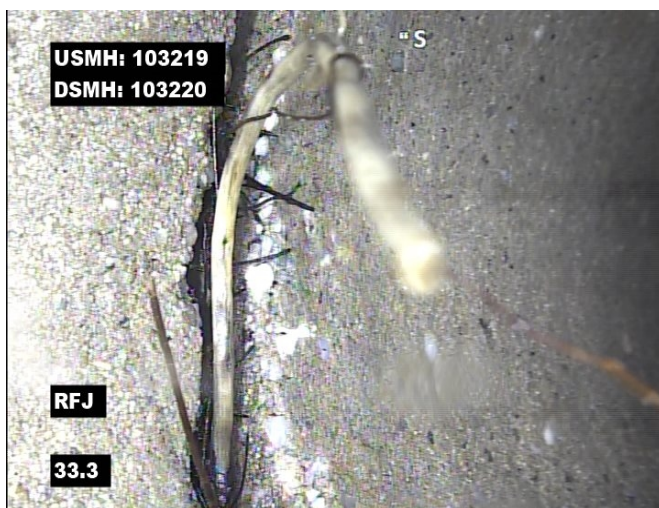
Distance: 33.3 ft. Grade: 1  
 Condition: RFJ-Roots Fine Joint  
 Remarks: N/A

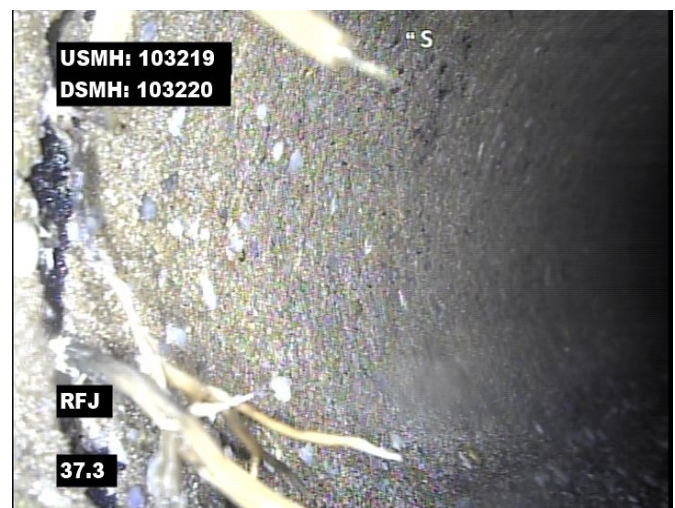
Distance: 37.3 ft. Grade: 1  
 Condition: RFJ-Roots Fine Joint  
 Remarks: N/A

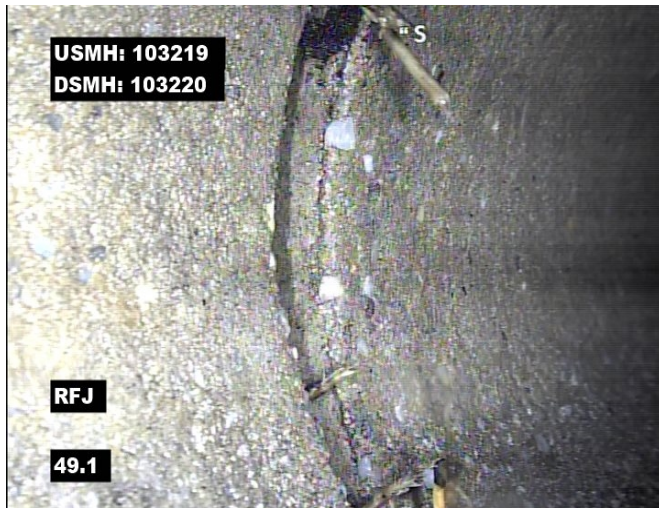
Distance: 49.1 ft. Grade: 1  
 Condition: RFJ-Roots Fine Joint  
 Remarks: N/A

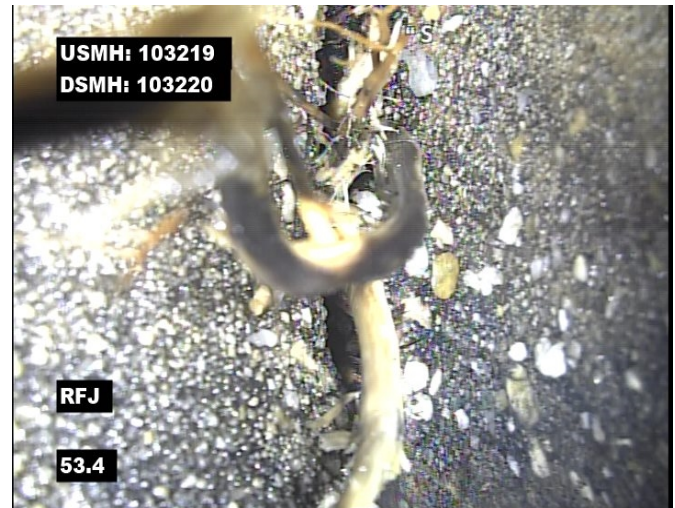
Distance: 53.4 ft. Grade: 1  
 Condition: RFJ-Roots Fine Joint  
 Remarks: N/A

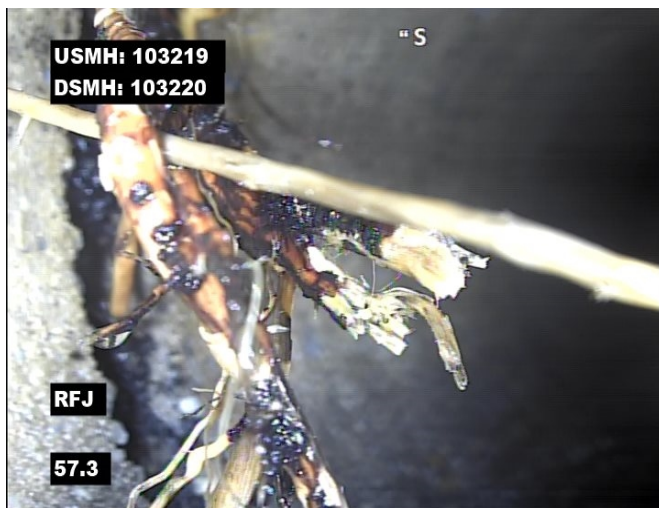
Distance: 57.3 ft. Grade: 1  
 Condition: RFJ-Roots Fine Joint  
 Remarks: N/A

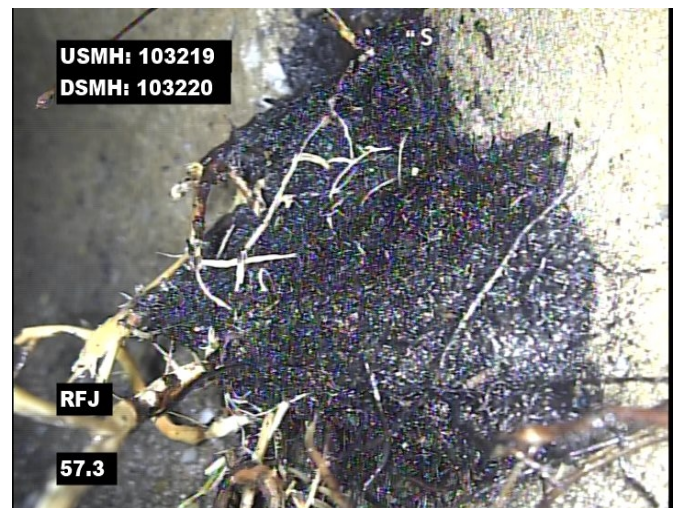
Distance: 57.3 ft. Grade: 1  
 Condition: RFJ-Roots Fine Joint  
 Remarks: N/A

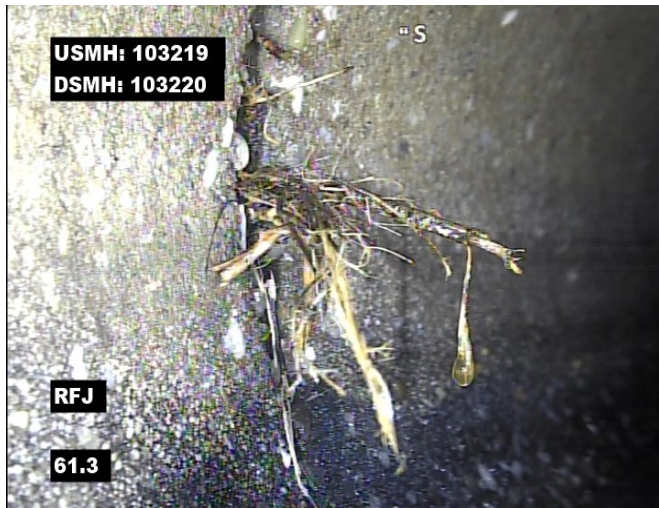
Distance: 61.3 ft. Grade: 1  
 Condition: RFJ-Roots Fine Joint  
 Remarks: N/A

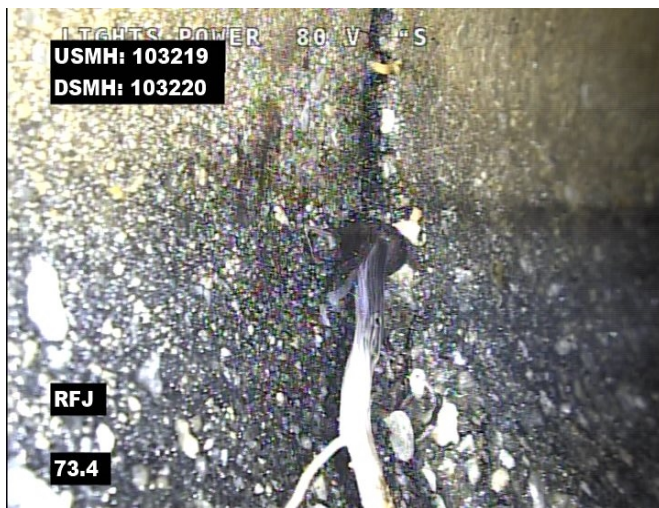
Distance: 73.4 ft. Grade: 1  
 Condition: RFJ-Roots Fine Joint  
 Remarks: N/A

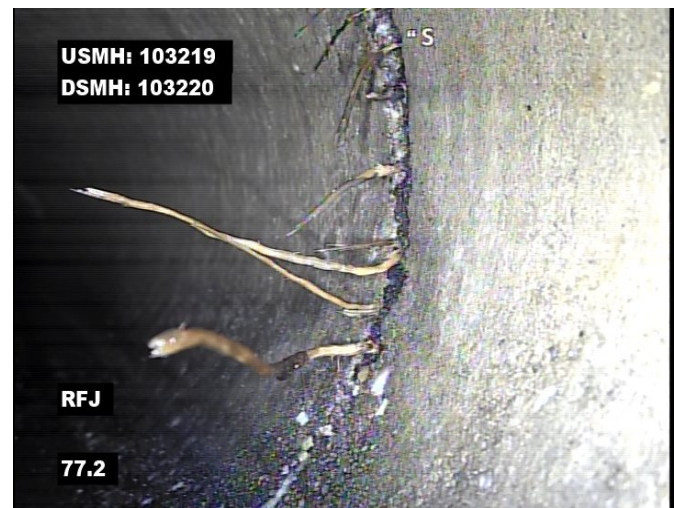
Distance: 77.2 ft. Grade: 1  
 Condition: RFJ-Roots Fine Joint  
 Remarks: N/A

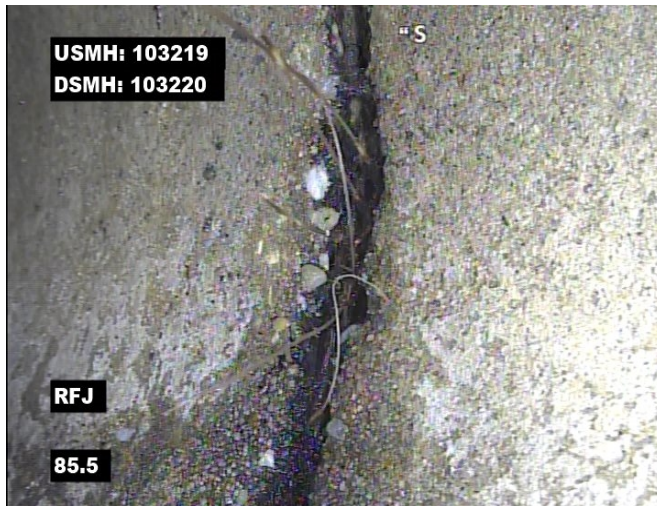
Distance: 85.5 ft. Grade: 1  
 Condition: RFJ-Roots Fine Joint  
 Remarks: N/A

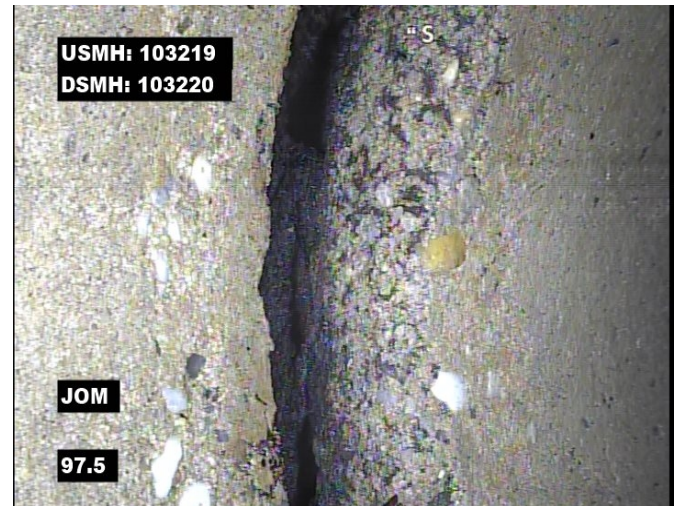
Distance: 97.5 ft. Grade: 3  
 Condition: JOM-Joint Offset Medium  
 Remarks: N/A

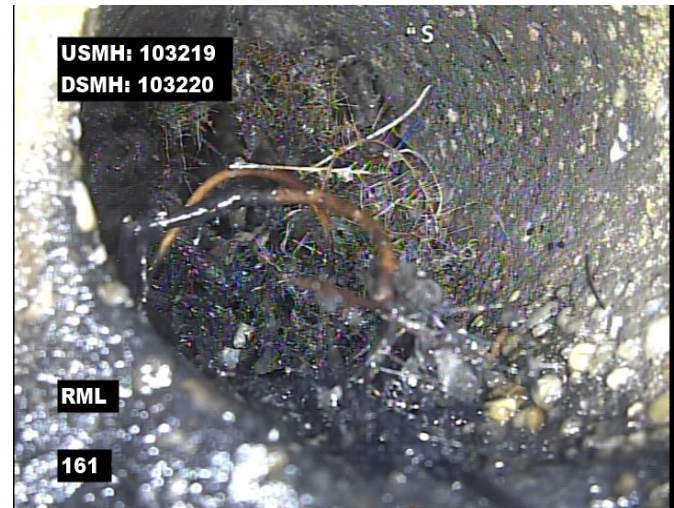
Distance: 161.0 ft. Grade: 3  
 Condition: RML-Roots Medium Lateral  
 Remarks: N/A

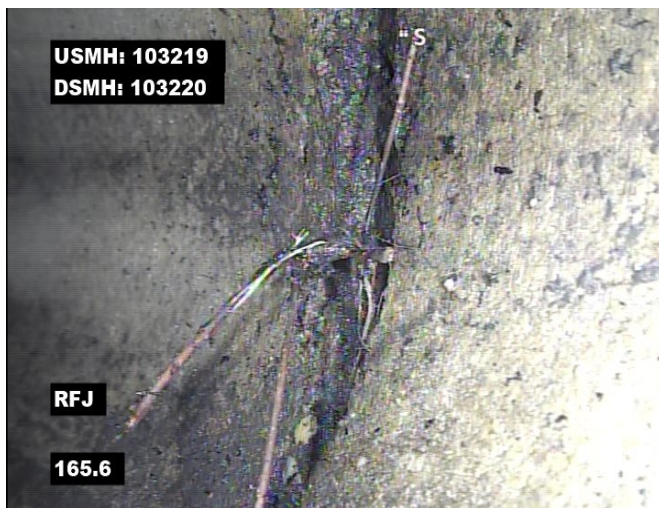
Distance: 165.6 ft. Grade: 1  
 Condition: RFJ-Roots Fine Joint  
 Remarks: N/A

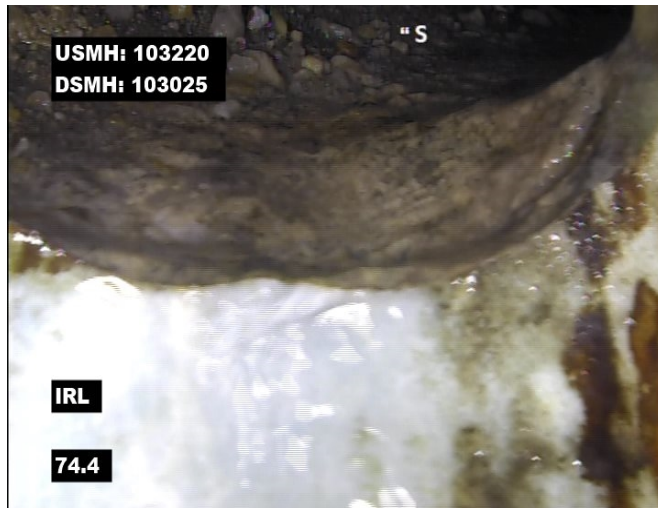
Distance: 74.4 ft. Grade: 4  
Condition: IRL-Infiltration Runner Lateral  
Remarks: N/A

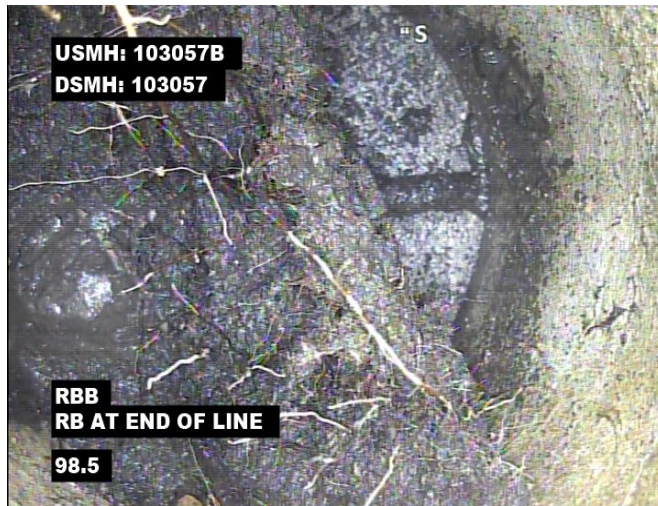
Distance: 98.5 ft. Grade: 5  
 Condition: RBB-Roots Ball Barrell  
 Remarks: RB AT END OF LINE

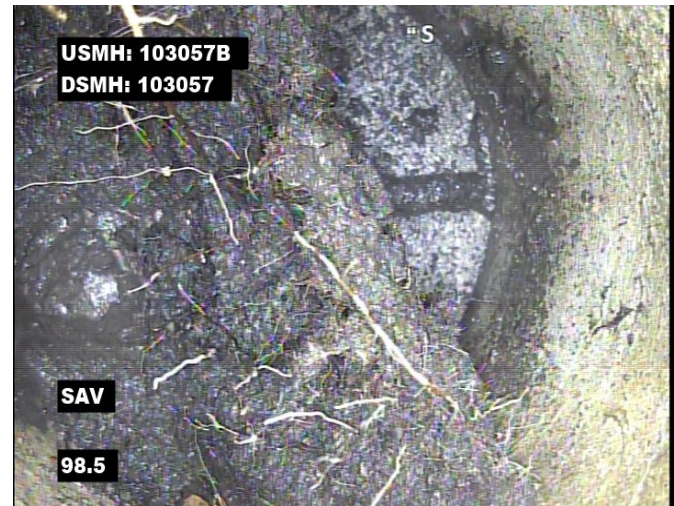
Distance: 98.5 ft. Grade: 2  
 Condition: SAV-Surface Damage Aggregate Visible  
 Remarks: N/A

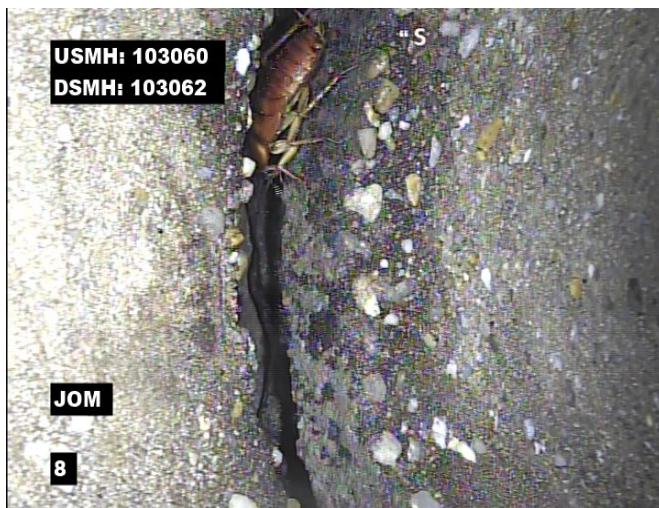
Distance: 8.0 ft. Grade: 3  
Condition: JOM-Joint Offset Medium  
Remarks: N/A

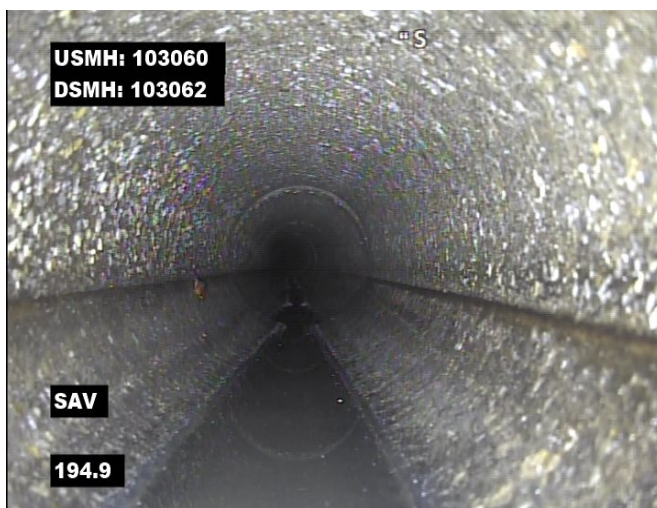
Distance: 194.9 ft. Grade: 2  
 Condition: SAV-Surface Damage Aggregate Visible  
 Remarks: N/A

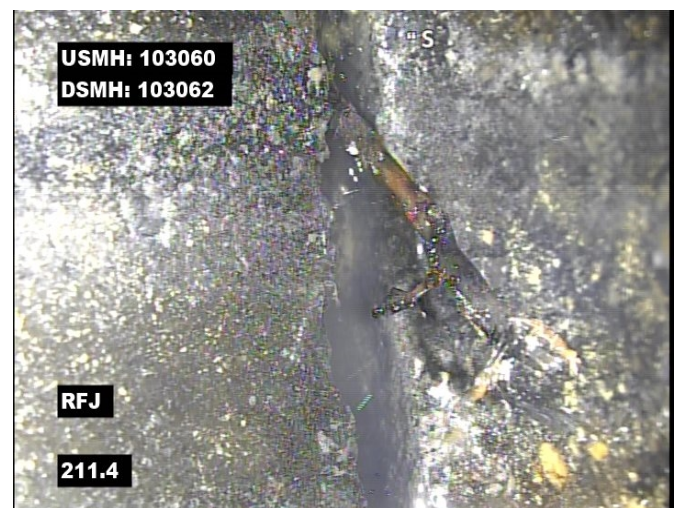
Distance: 211.4 ft. Grade: 1  
 Condition: RFJ-Roots Fine Joint  
 Remarks: N/A

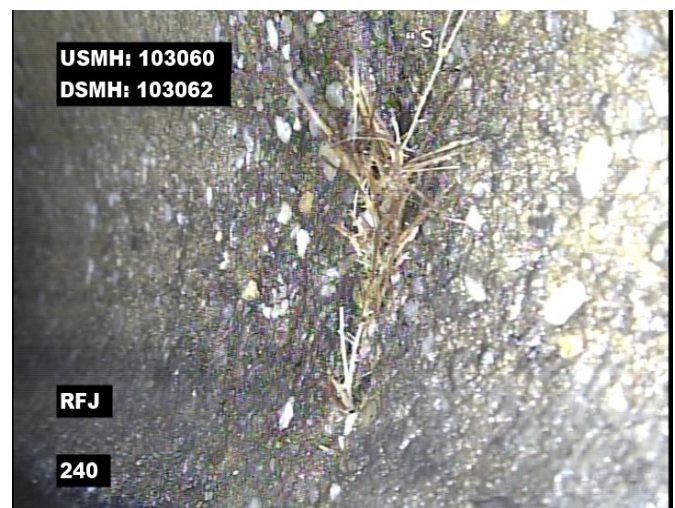
Distance: 240.0 ft. Grade: 1  
Condition: RFJ-Roots Fine Joint  
Remarks: N/A

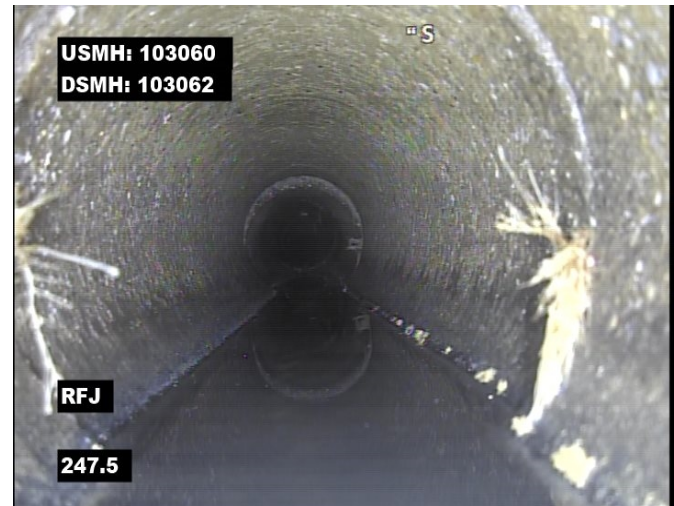
Distance: 247.5 ft. Grade: 1  
 Condition: RFJ-Roots Fine Joint  
 Remarks: N/A

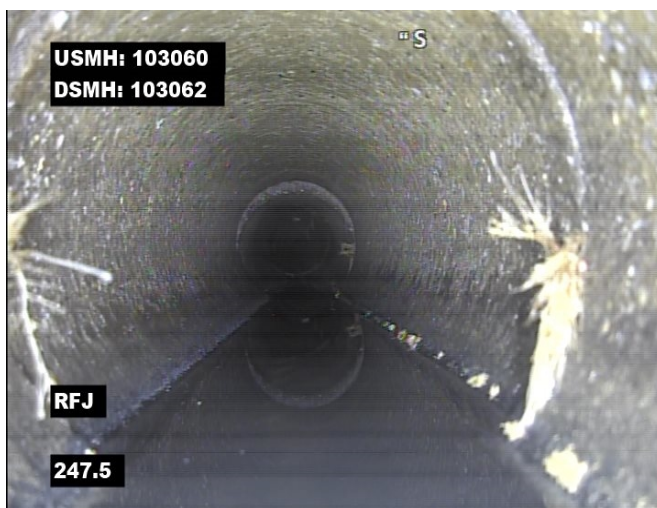
Distance: 247.5 ft. Grade: 1  
 Condition: RFJ-Roots Fine Joint  
 Remarks: N/A

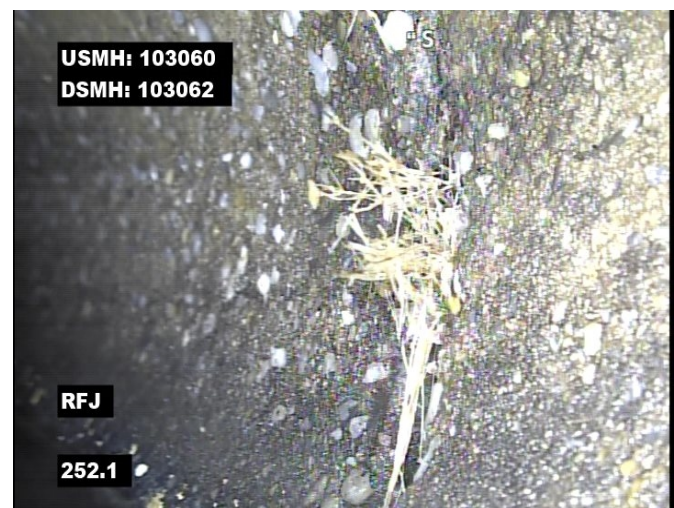
Distance: 252.1 ft. Grade: 1  
 Condition: RFJ-Roots Fine Joint  
 Remarks: N/A

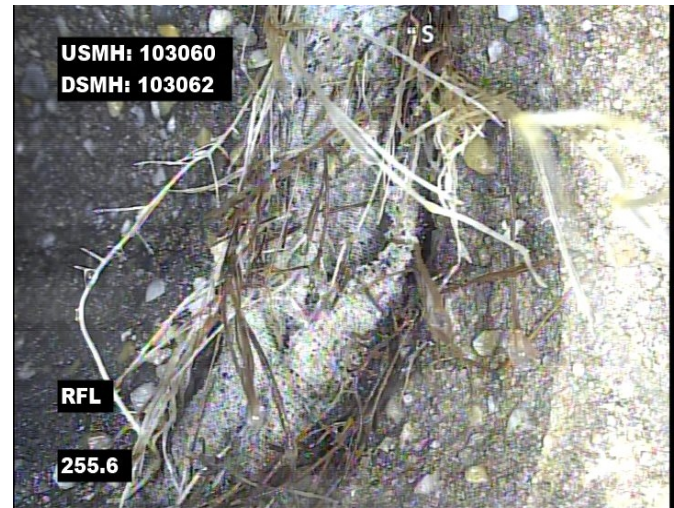
Distance: 255.6 ft. Grade: 1  
 Condition: RFL-Roots Fine Lateral  
 Remarks: N/A

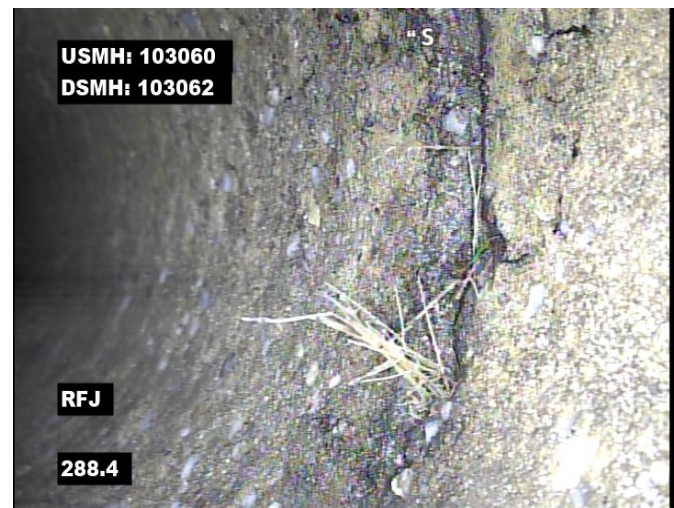
Distance: 288.4 ft. Grade: 1  
 Condition: RFJ-Roots Fine Joint  
 Remarks: N/A

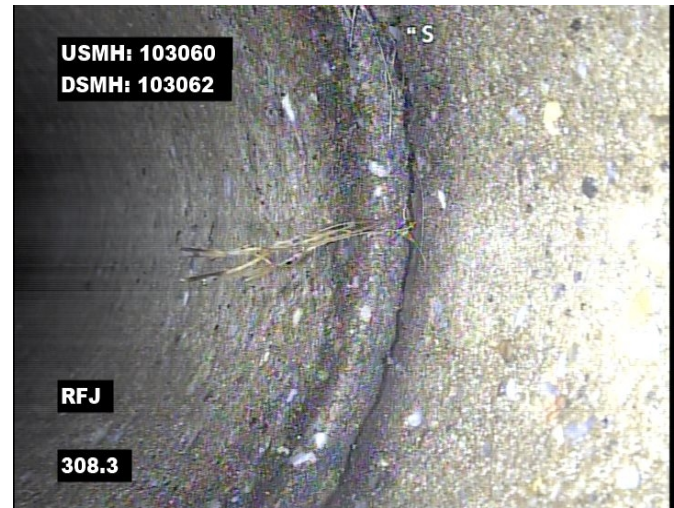
Distance: 308.3 ft. Grade: 1  
 Condition: RFJ-Roots Fine Joint  
 Remarks: N/A

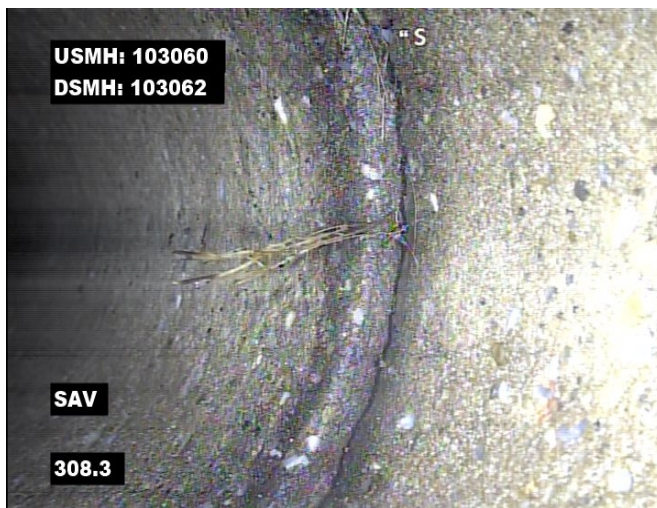
Distance: 308.3 ft. Grade: 2  
 Condition: SAV-Surface Damage Aggregate Visible  
 Remarks: N/A

308.3 ft. SAV-Surface Damage Aggregate Visible - F01

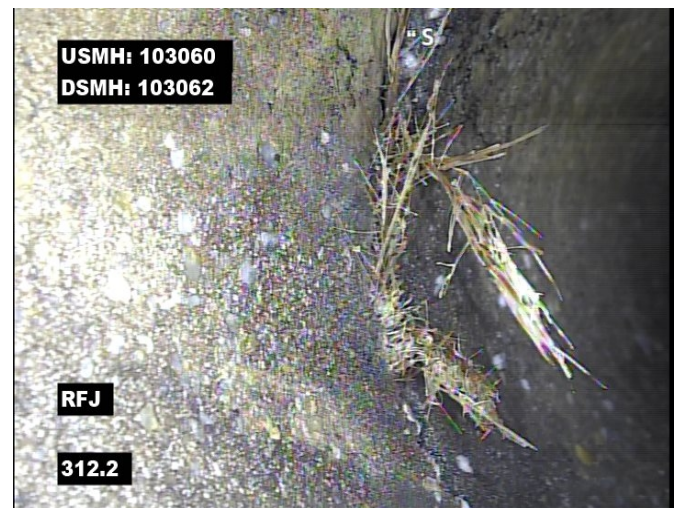
Distance: 312.2 ft. Grade: 1  
 Condition: RFJ-Roots Fine Joint  
 Remarks: N/A

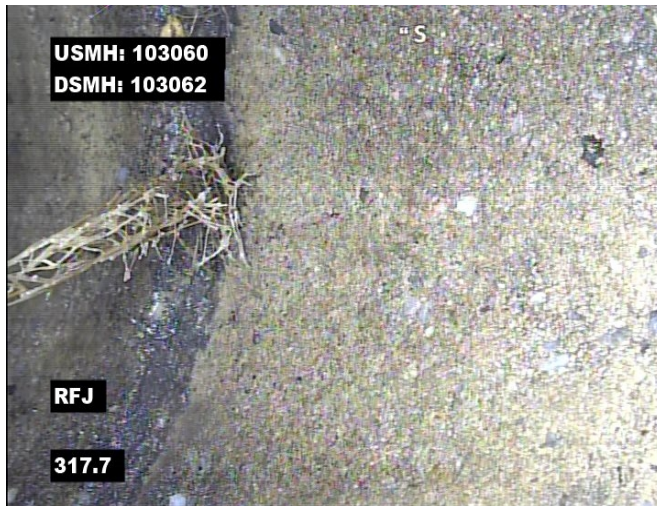
Distance: 317.7 ft. Grade: 1  
 Condition: RFJ-Roots Fine Joint  
 Remarks: N/A

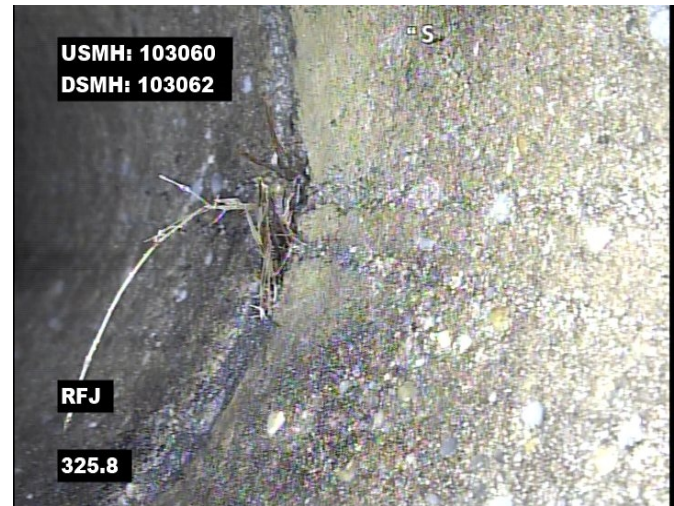
Distance: 325.8 ft. Grade: 1  
 Condition: RFJ-Roots Fine Joint  
 Remarks: N/A

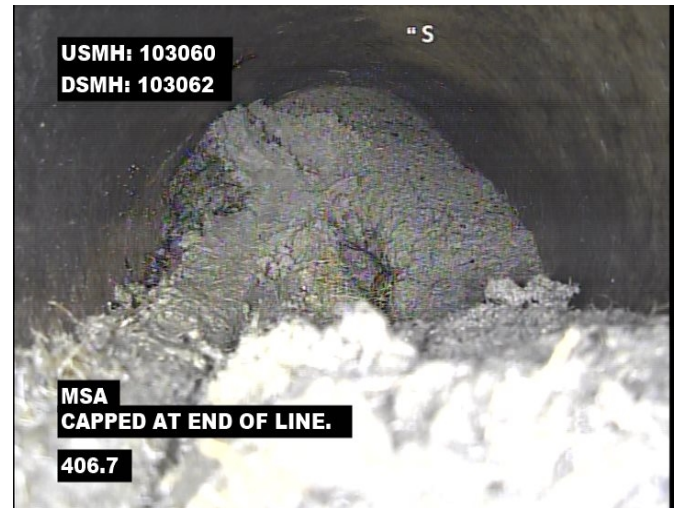
Distance: 406.7 ft. Grade: 0  
 Condition: MSA-Miscellaneous Survey Abandoned  
 Remarks: CAPPED AT END OF LINE.

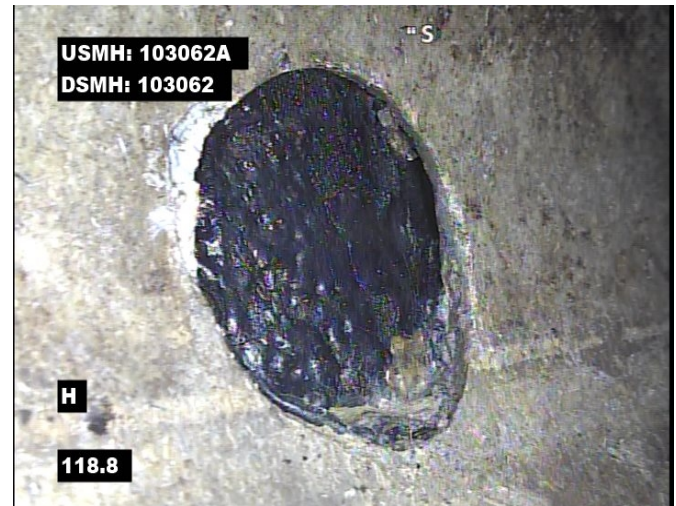
Distance: 118.8 ft. Grade: 4  
Condition: H-Hole  
Remarks: N/A

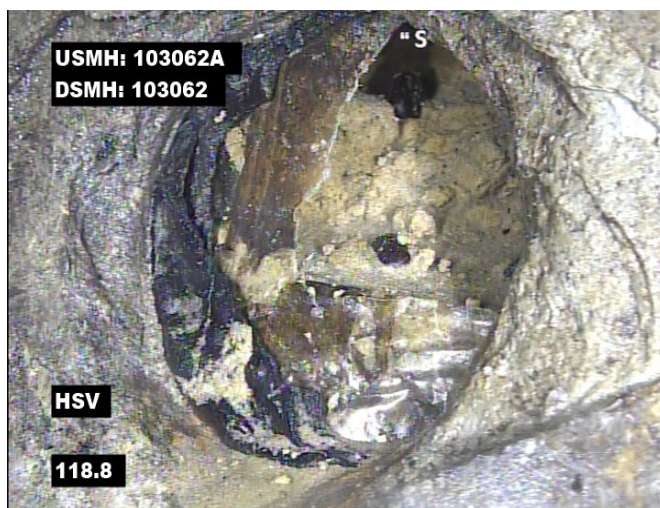
Distance: 118.8 ft. Grade: 5  
Condition: HSV-Hole Soil Visible  
Remarks: N/A

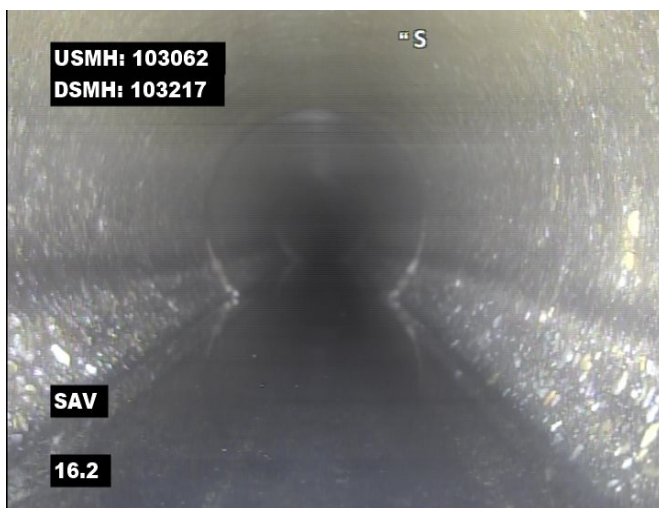
Distance: 16.2 ft. Grade: 2  
Condition: SAV-Surface Damage Aggregate Visible  
Remarks: N/A

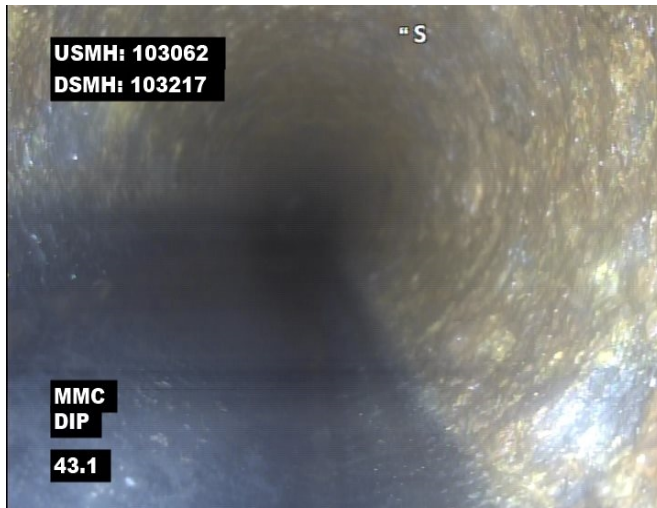
Distance: 43.1 ft. Grade: 0  
 Condition: MMC-Miscellaneous Material Change  
 Remarks: DIP

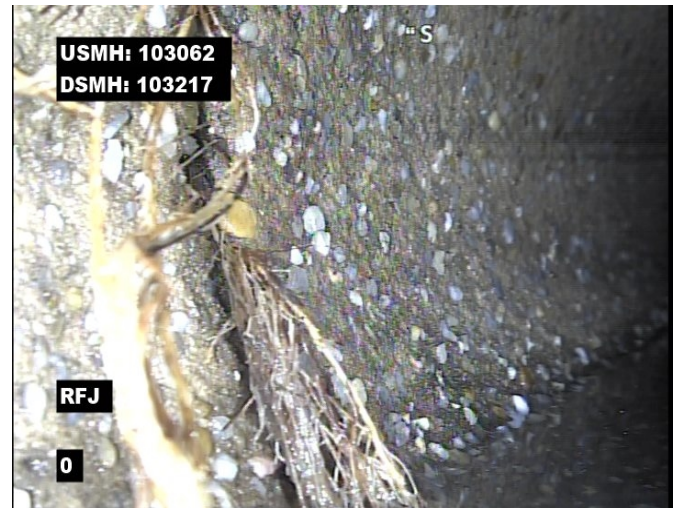
Distance: 0.0 ft. Grade: 1  
 Condition: RFJ-Roots Fine Joint  
 Remarks: N/A

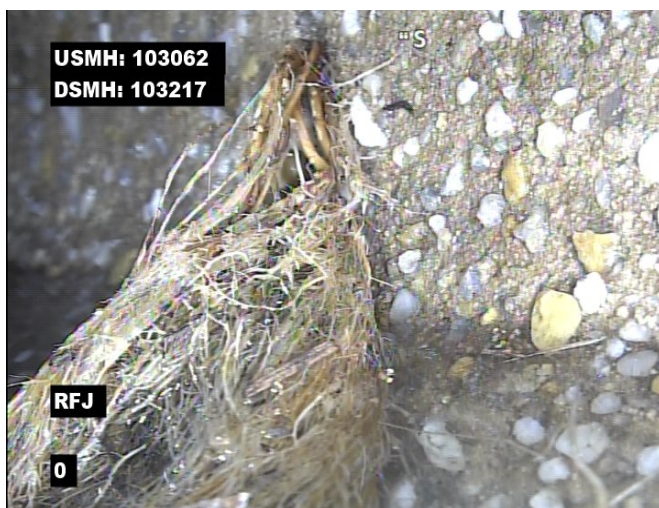
Distance: 0.0 ft. Grade: 1  
 Condition: RFJ-Roots Fine Joint  
 Remarks: N/A

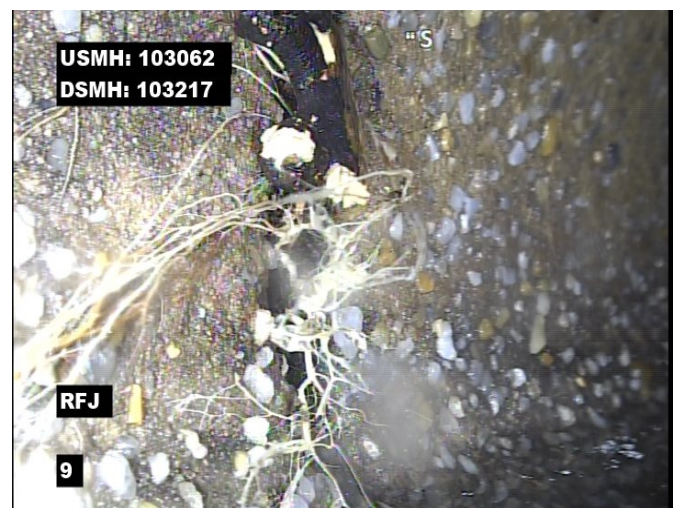
Distance: 9.0 ft. Grade: 1  
 Condition: RFJ-Roots Fine Joint  
 Remarks: N/A

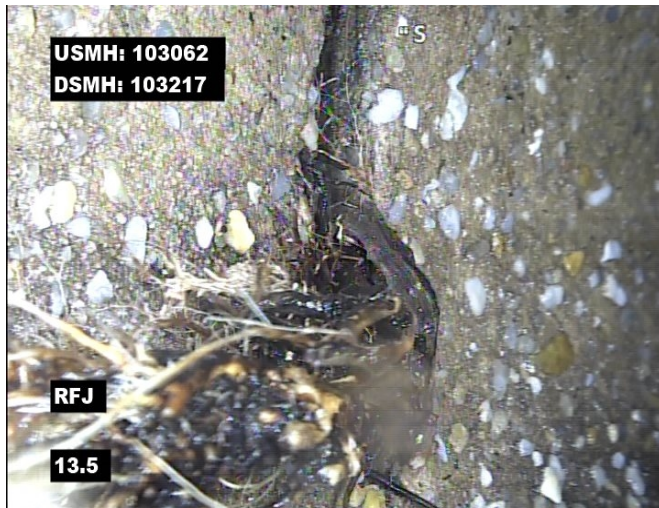
Distance: 13.5 ft. Grade: 1  
 Condition: RFJ-Roots Fine Joint  
 Remarks: N/A

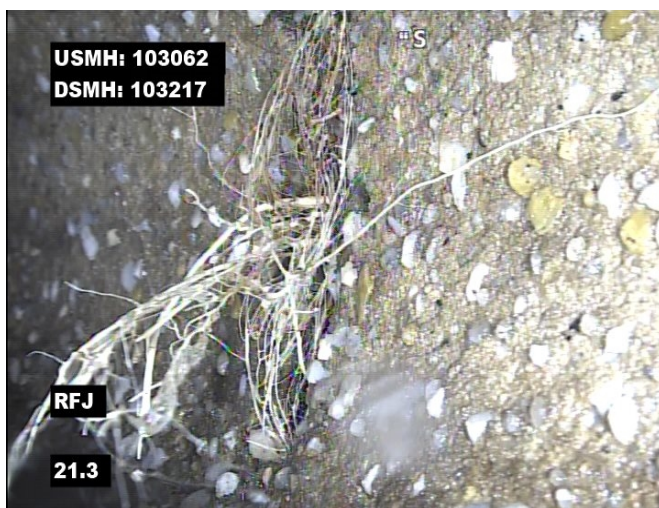
Distance: 21.3 ft. Grade: 1  
 Condition: RFJ-Roots Fine Joint  
 Remarks: N/A

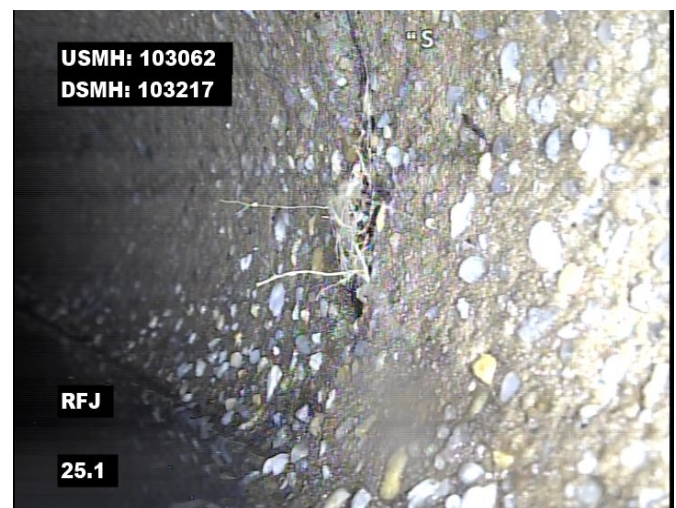
Distance: 25.1 ft. Grade: 1  
 Condition: RFJ-Roots Fine Joint  
 Remarks: N/A

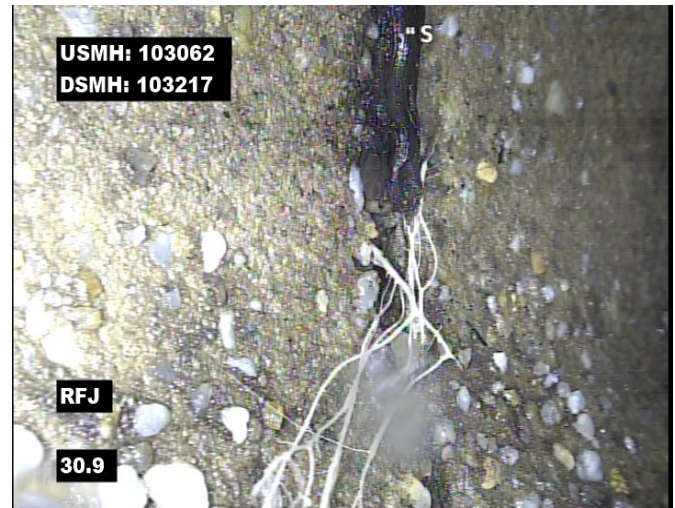
Distance: 30.9 ft. Grade: 1  
 Condition: RFJ-Roots Fine Joint  
 Remarks: N/A

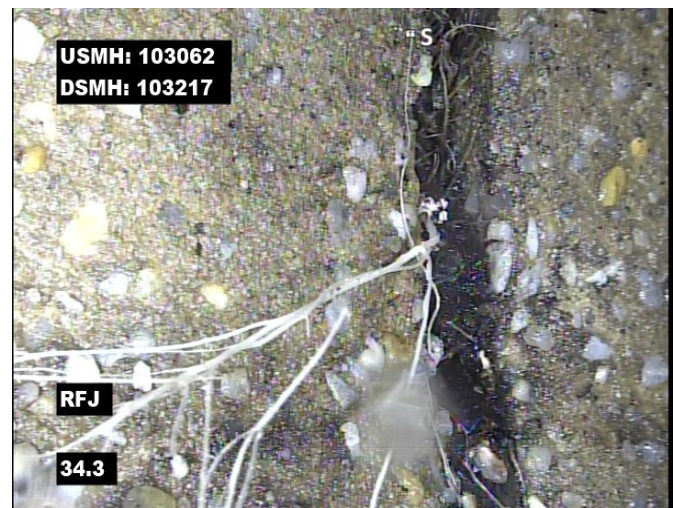
Distance: 34.3 ft. Grade: 1  
 Condition: RFJ-Roots Fine Joint  
 Remarks: N/A

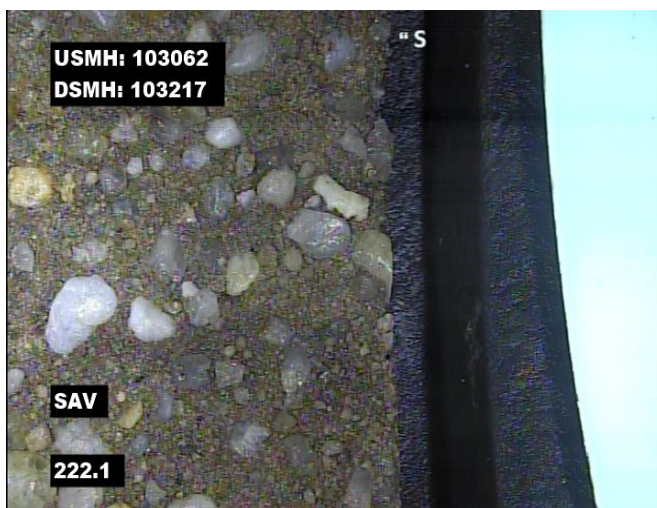
Distance: 222.1 ft. Grade: 2  
Condition: SAV-Surface Damage Aggregate Visible  
Remarks: N/A

222.1 ft. SAV-Surface Damage Aggregate Visible - F01

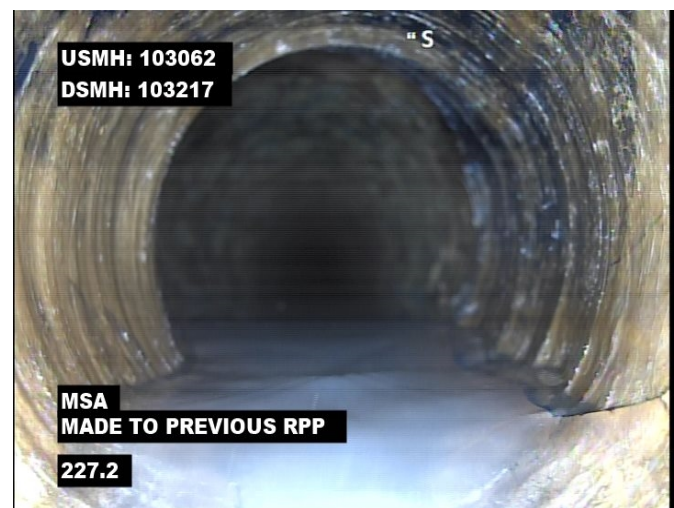
Distance: 227.2 ft. Grade: 0  
Condition: MSA-Miscellaneous Survey Abandoned  
Remarks: MADE TO PREVIOUS RPP

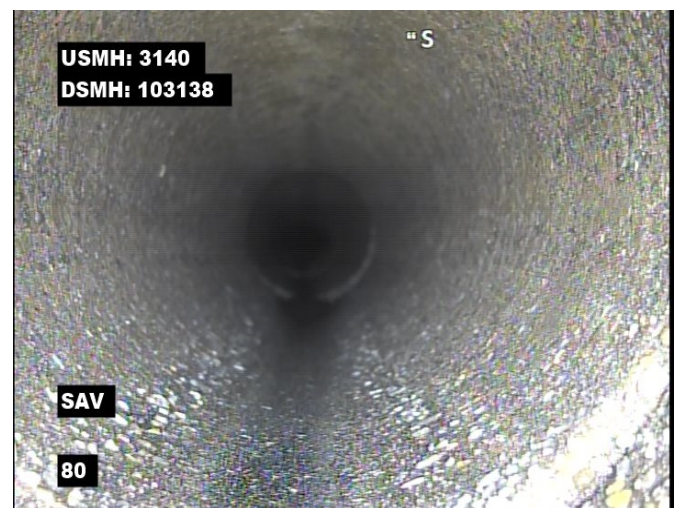
Distance: 80.0 ft. Grade: 2  
 Condition: SAV-Surface Damage Aggregate Visible  
 Remarks: N/A

RCP
80 ft.	SAV-Surface Damage Aggregate Visible - S01

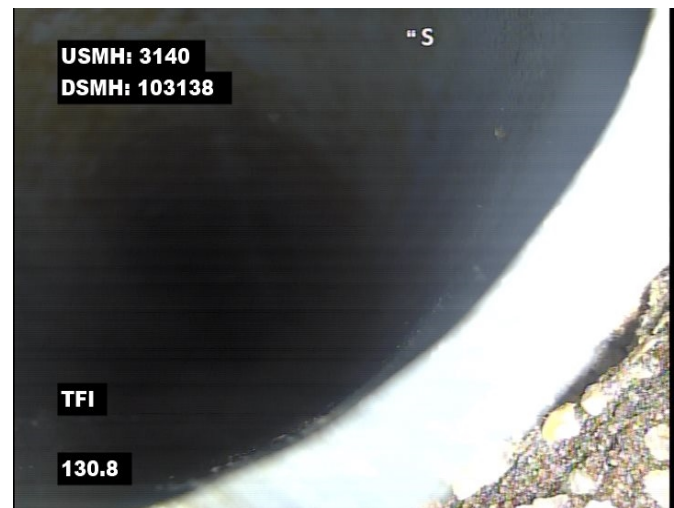
Distance: 130.8 ft. Grade: 5  
 Condition: TFI-Tap Factory Made Intruding  
 Remarks: N/A

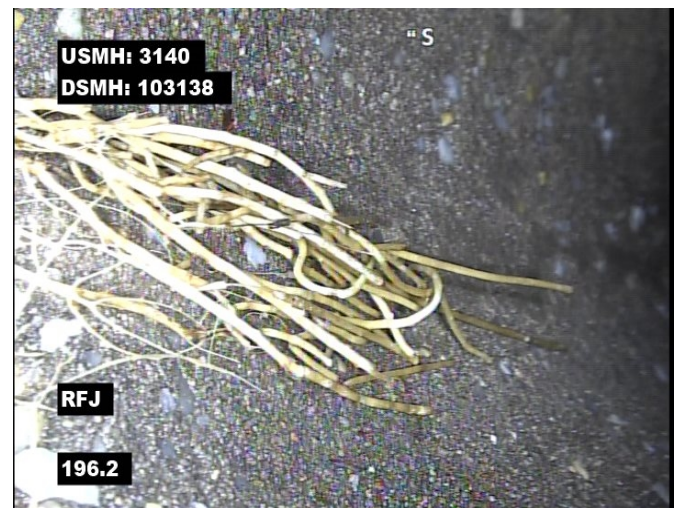
Distance: 196.2 ft. Grade: 1  
 Condition: RFJ-Roots Fine Joint  
 Remarks: N/A

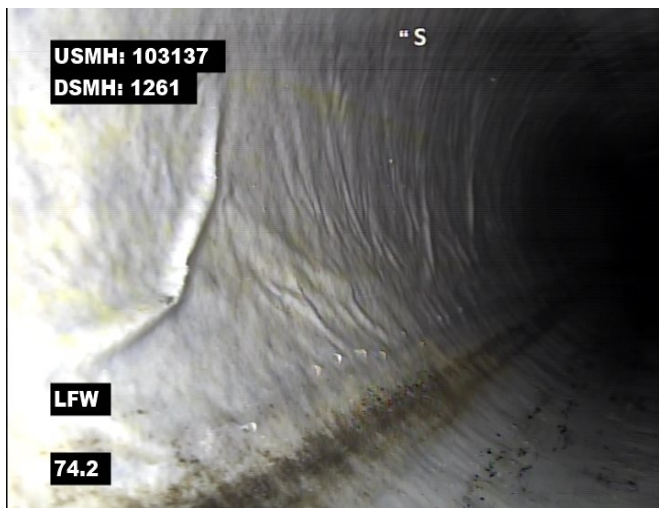
Distance: 74.2 ft. Grade: 3  
Condition: LFW-Lining Feature Wrinkled  
Remarks: N/A

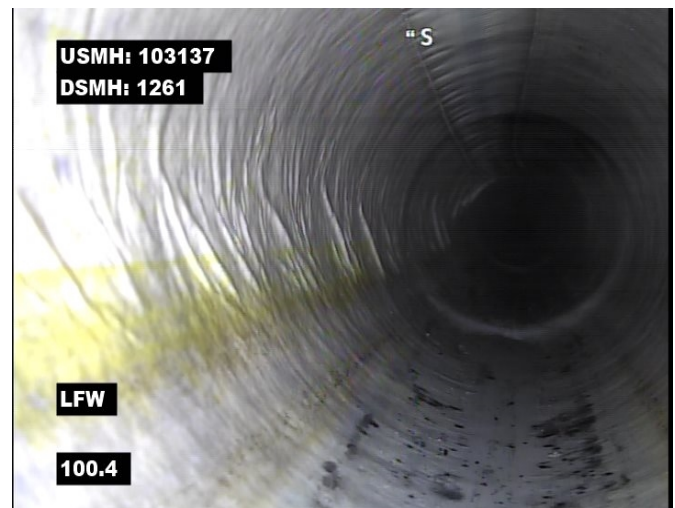
Distance: 100.4 ft. Grade: 3  
Condition: LFW-Lining Feature Wrinkled  
Remarks: N/A

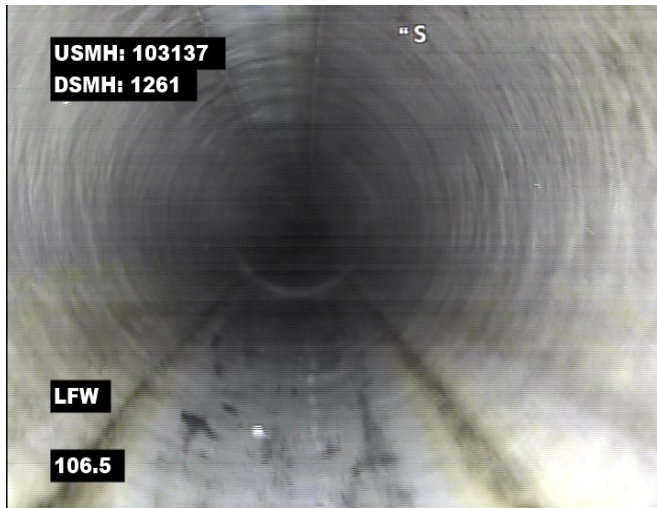
Distance: 106.1 ft. Grade: 3  
 Condition: LFW-Lining Feature Wrinkled  
 Remarks: N/A

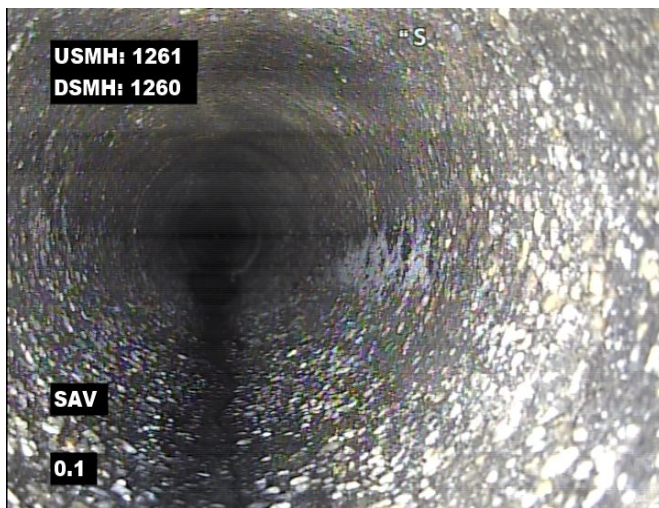
Distance: 0.1 ft. Grade: 2  
Condition: SAV-Surface Damage Aggregate Visible  
Remarks: N/A

SAV-Surface Damage  
Aggregate Visible - F01

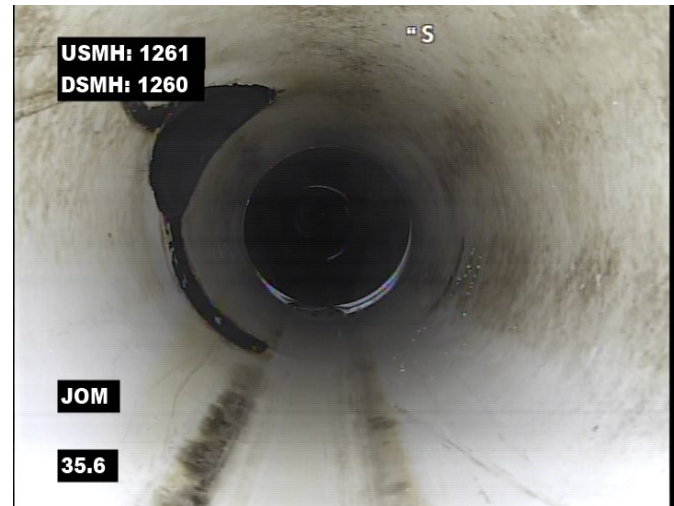
Distance: 35.6 ft. Grade: 3  
 Condition: JOM-Joint Offset Medium  
 Remarks: N/A

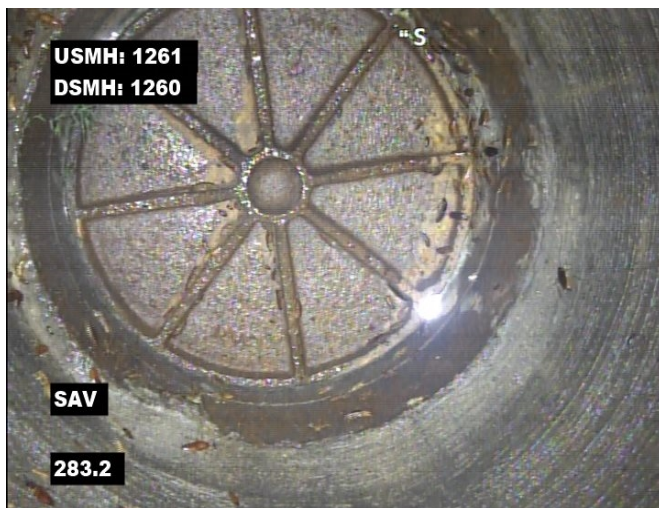
Distance: 283.2 ft. Grade: 2  
 Condition: SAV-Surface Damage Aggregate Visible  
 Remarks: N/A

283.2 ft. SAV-Surface Damage Aggregate Visible - F03

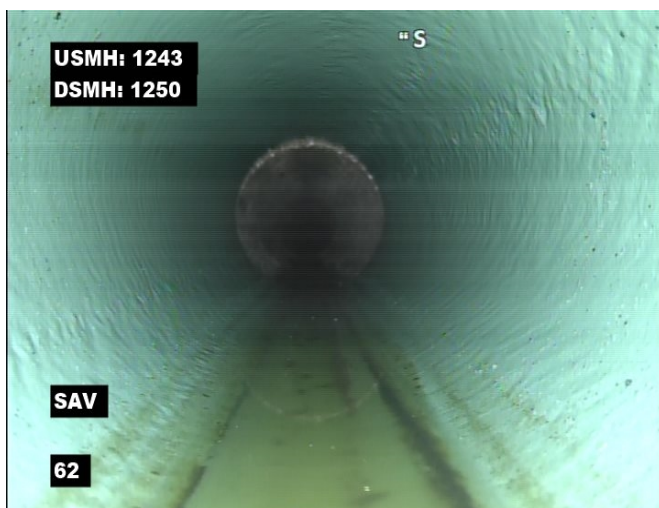
Distance: 62.0 ft. Grade: 2  
Condition: SAV-Surface Damage Aggregate Visible  
Remarks: N/A

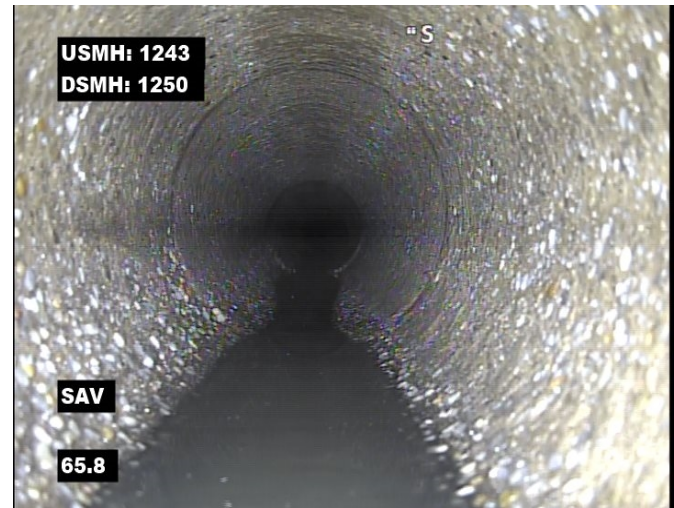
Distance: 65.8 ft. Grade: 2  
Condition: SAV-Surface Damage Aggregate Visible  
Remarks: N/A

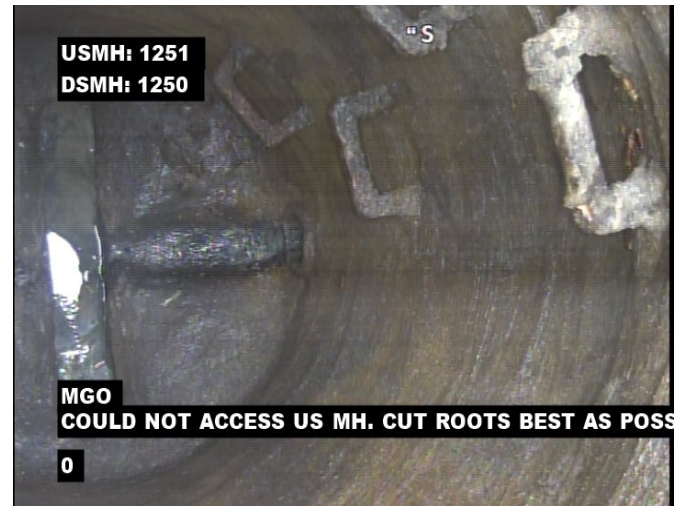
Distance: 0.0 ft. Grade: 0  
 Condition: MGO-Miscellaneous General Observation  
 Remarks: COULD NOT ACCESS US MH. CUT ROOTS BEST AS POSSIBLE WITH

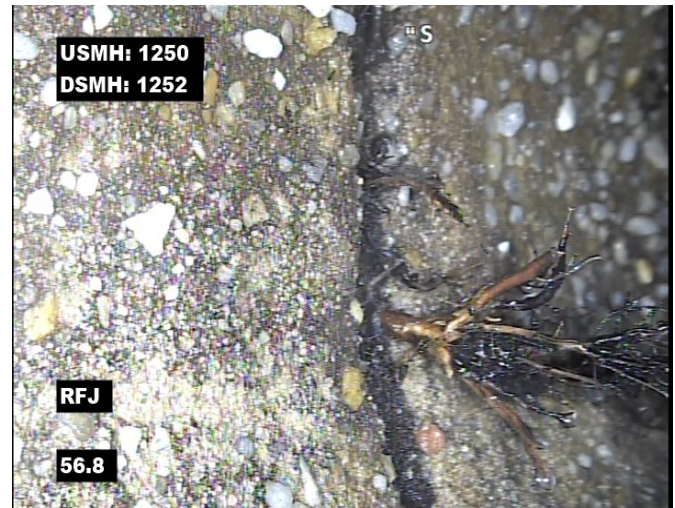
Distance: 56.8 ft. Grade: 1  
 Condition: RFJ-Roots Fine Joint  
 Remarks: N/A

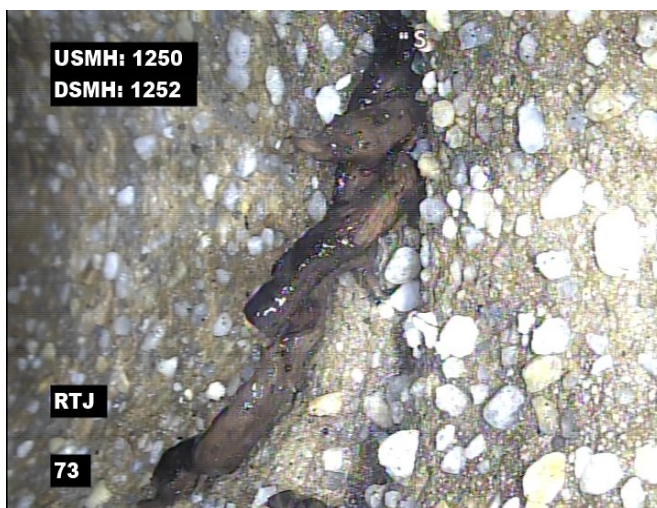
Distance: 73.0 ft. Grade: 2  
 Condition: RTJ-Roots Tap Joint  
 Remarks: N/A
