# TOWN OF CLARKTON - SEWER ASSET MANAGEMENT PLAN

October 2025

NC DEQ Project No. AIA-W-ARP-0065

WR Project No. 02200415.02

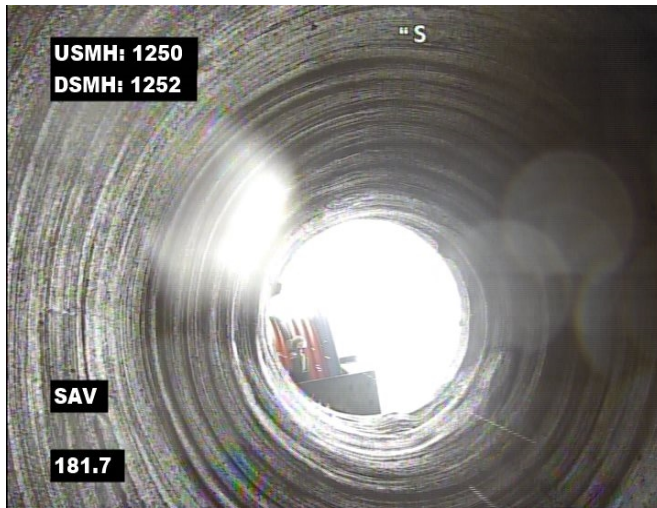
Distance: 181.7 ft. Grade: 2  
Condition: SAV-Surface Damage Aggregate Visible  
Remarks: N/A

181.7 ft. SAV-Surface Damage  
Aggregate Visible - F02

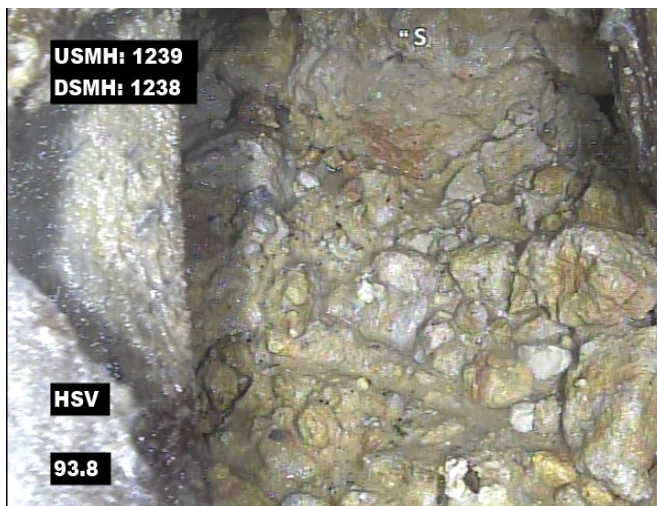
Distance: 93.8 ft. Grade: 5  
 Condition: HSV-Hole Soil Visible  
 Remarks: N/A

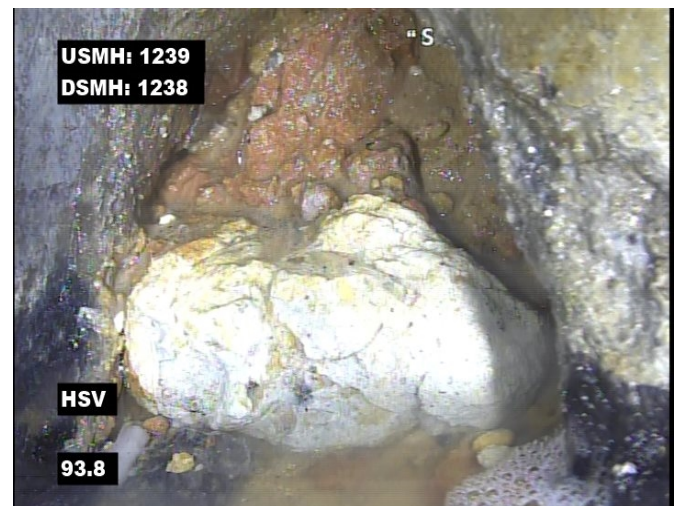
Distance: 93.8 ft. Grade: 5  
 Condition: HSV-Hole Soil Visible  
 Remarks: N/A

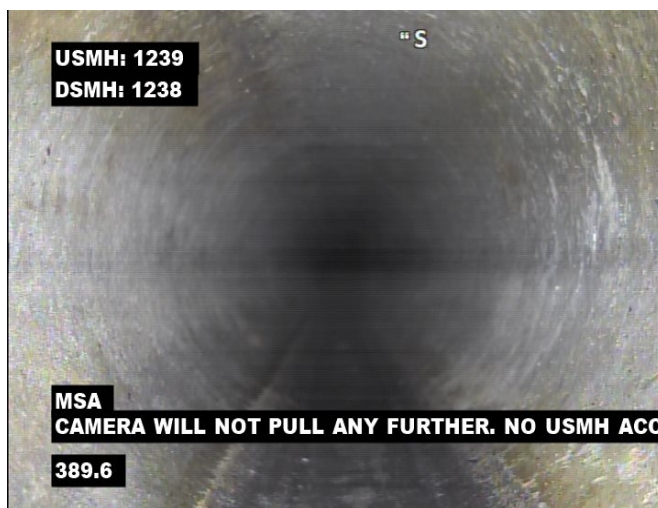
Distance: 389.6 ft. Grade: 0  
 Condition: MSA-Miscellaneous Survey Abandoned  
 Remarks: CAMERA WILL NOT PULL ANY FURTHER.  
 NO USMH ACCESS TO DO VIDEO FROM.

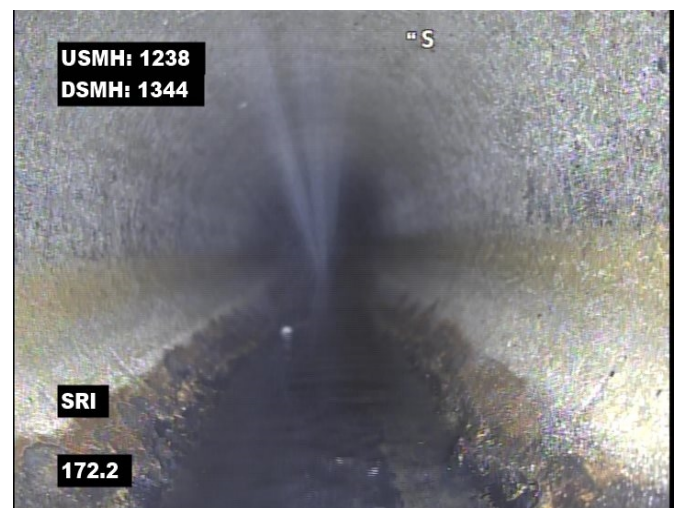
Distance: 172.2 ft. Grade: 1  
Condition: SRI-Surface Damage Roughness Increased  
Remarks: N/A

172.2 ft. SRI-Surface Damage  
Roughness Increased - S01

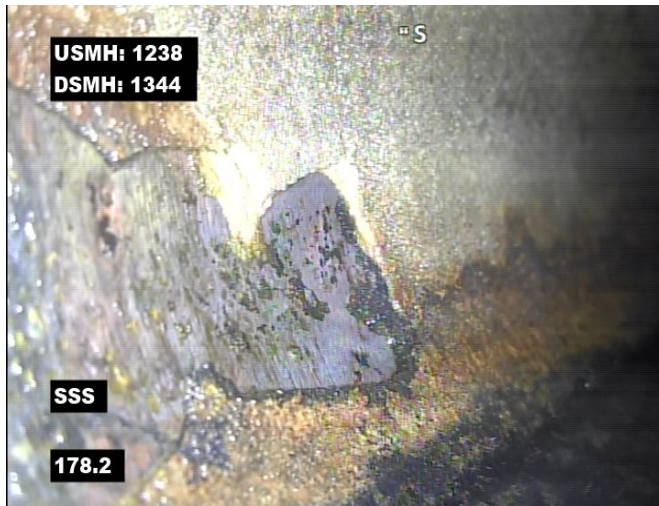
Distance: 178.2 ft. Grade: 2  
 Condition: SSS-Surface Damage Surface Spalling  
 Remarks: N/A

178.2 ft. SSS-Surface Damage Surface  
Spalling

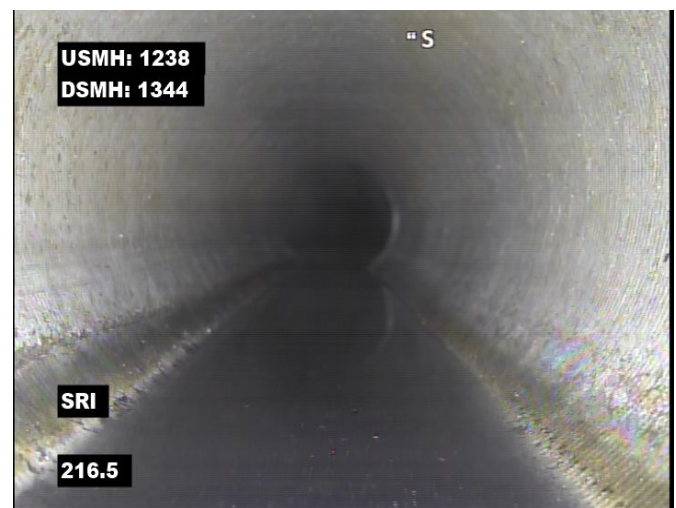
Distance: 216.5 ft. Grade: 1  
 Condition: SRI-Surface Damage Roughness Increased  
 Remarks: N/A

216.5 ft. SRI-Surface Damage  
Roughness Increased - F01

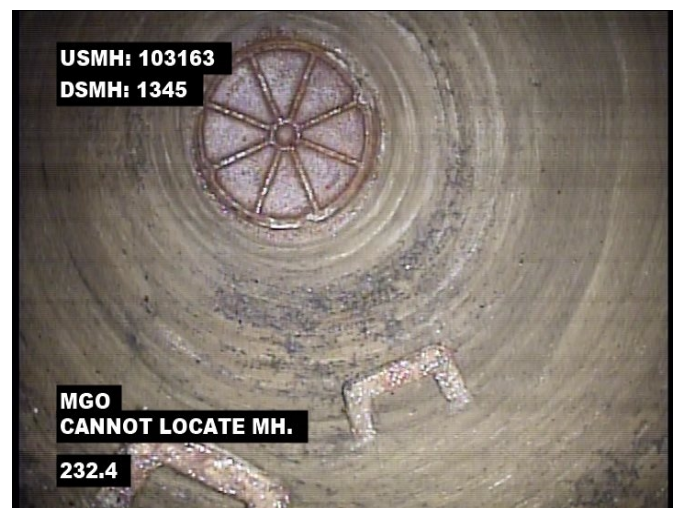
Distance: 232.4 ft. Grade: 0  
Condition: MGO-Miscellaneous General Observation  
Remarks: CANNOT LOCATE MH.

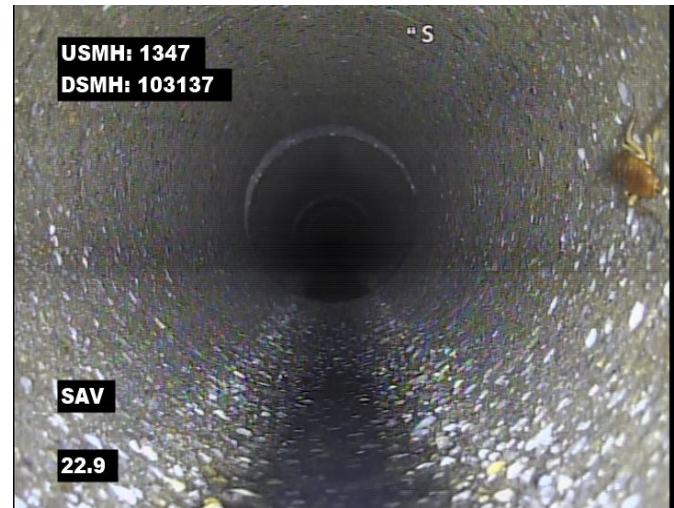
Distance: 22.9 ft. Grade: 2  
 Condition: SAV-Surface Damage Aggregate Visible  
 Remarks: N/A

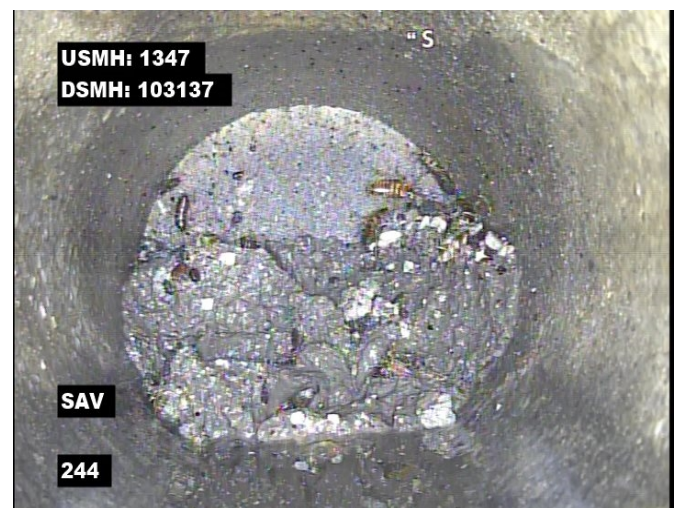
Distance: 244.0 ft. Grade: 2  
 Condition: SAV-Surface Damage Aggregate Visible  
 Remarks: N/A

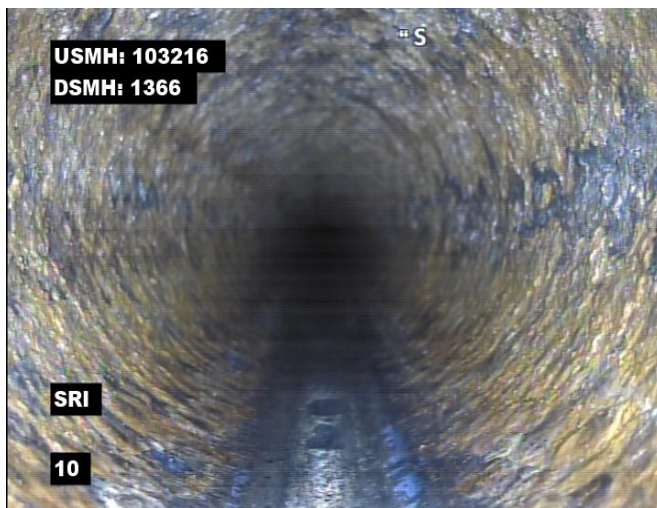
Distance: 10.0 ft. Grade: 1  
Condition: SRI-Surface Damage Roughness Increased  
Remarks: N/A

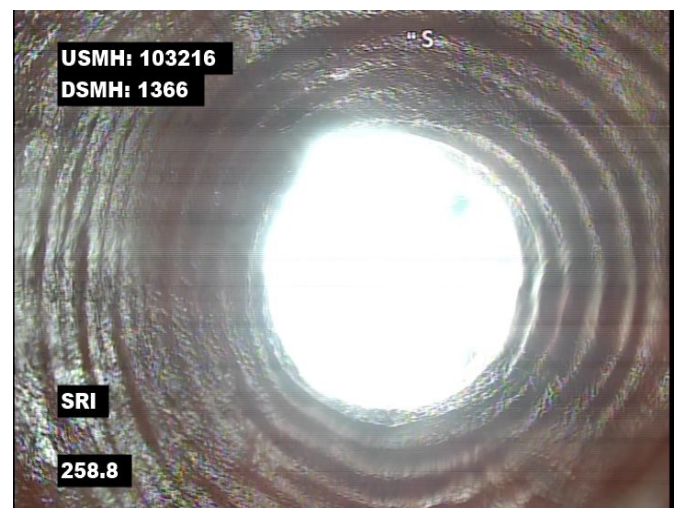
Distance: 258.8 ft. Grade: 1  
Condition: SRI-Surface Damage Roughness Increased  
Remarks: N/A

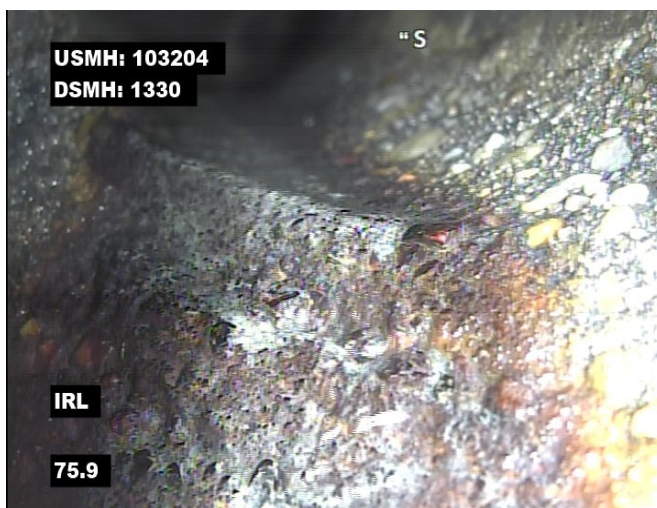
Distance: 75.9 ft. Grade: 4  
 Condition: IRL-Infiltration Runner Lateral  
 Remarks: N/A

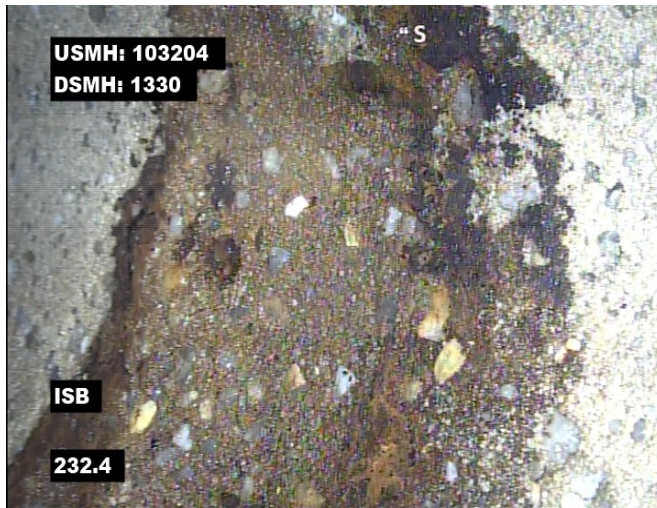
Distance: 232.4 ft. Grade: 1  
Condition: ISB-Infiltration Stain Barrel  
Remarks: N/A

232.4 ft. ISB-Infiltration Stain Barrel
