DIXON

Maintenance Inspection

150,000 Gallon Spheroid

Ontonagon, Michigan

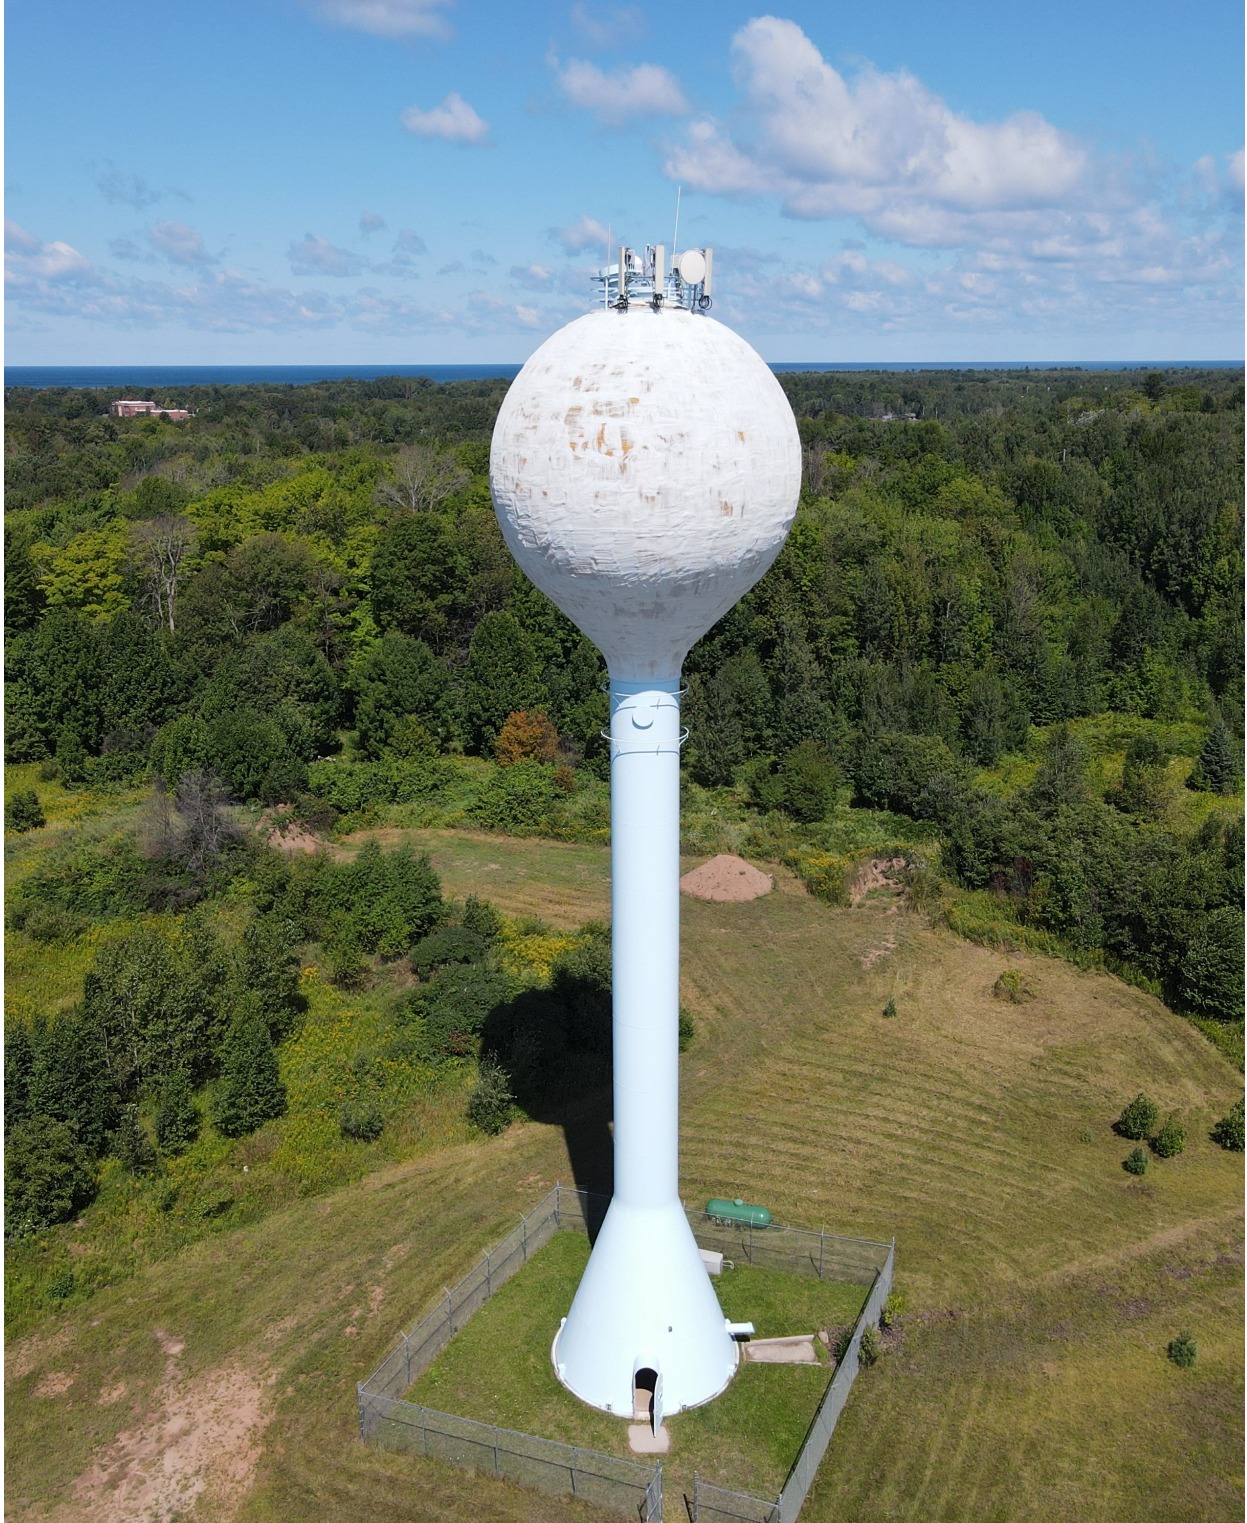
150,000 gallon spheroid elevated water storage tank located by the Village of Ontonagon, Michigan.

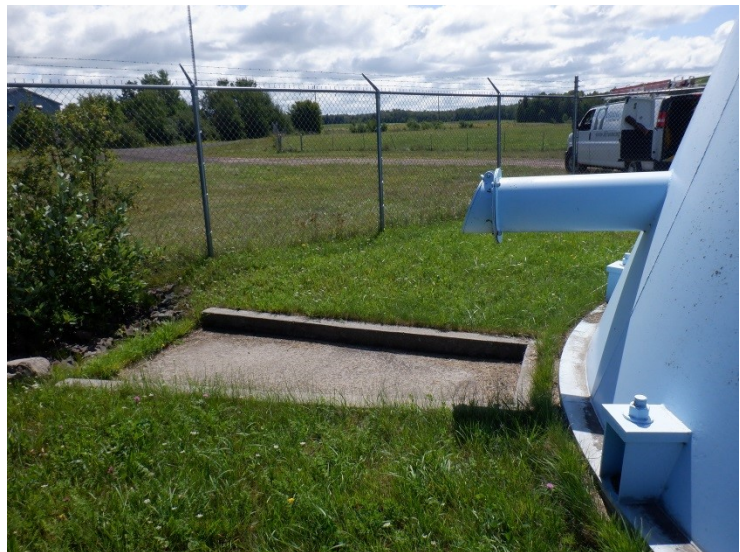
5) The overflow pipe discharges to a concrete splash pad and riprap.

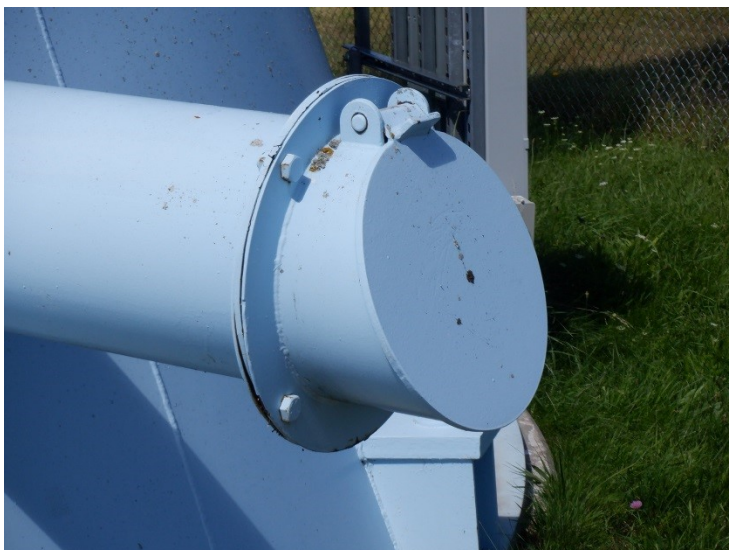
6) The solid flap gate at the overflow pipe discharge operated properly.

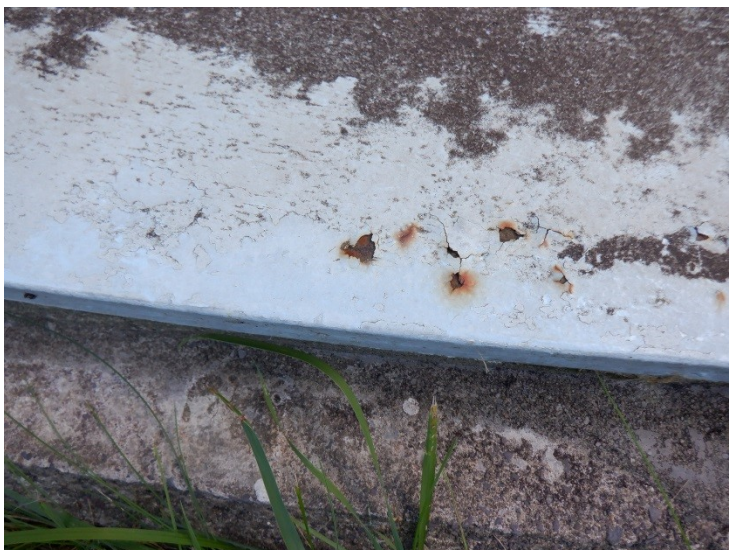
8) There are a few coating failures on the baseplate.

9) Same.

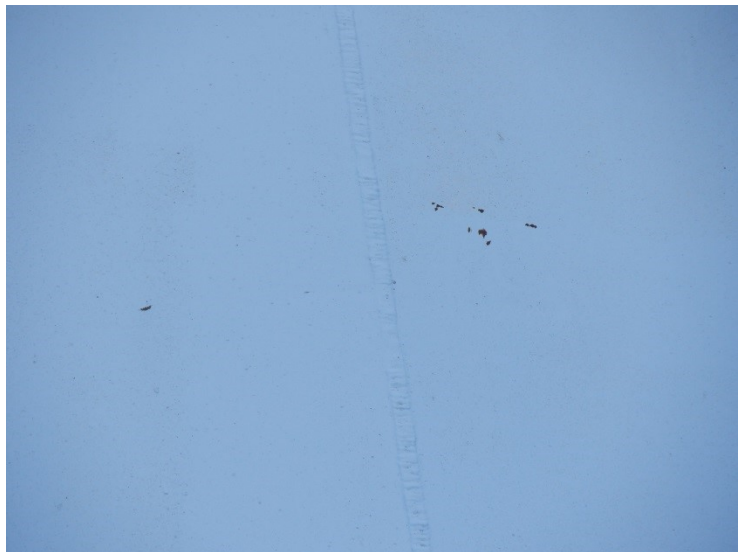
10) There are a few minor coating failures on the basebell.

11) Same.

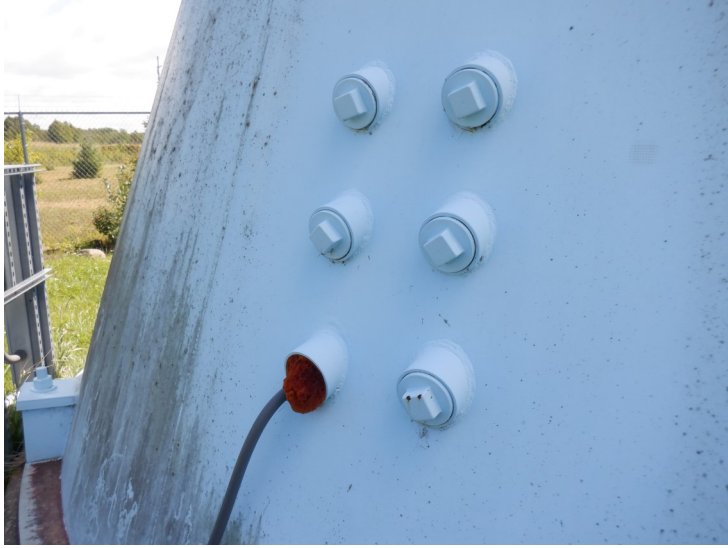
12) The basebell coating is in good condition overall.

13) Same.

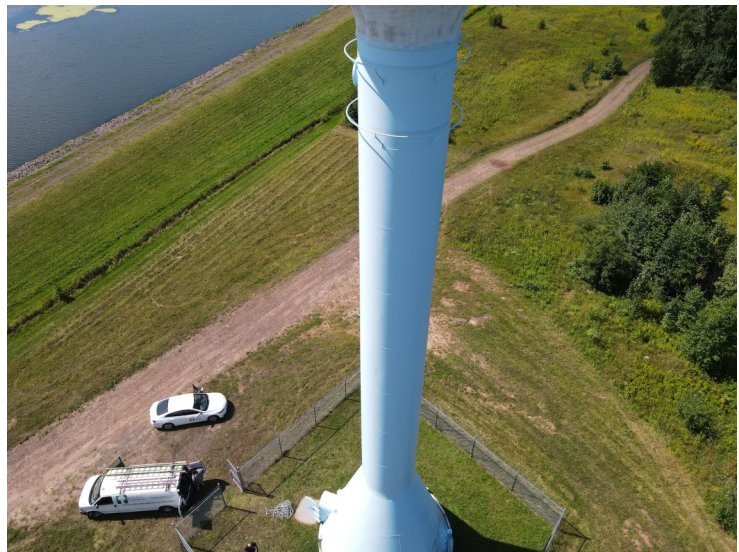
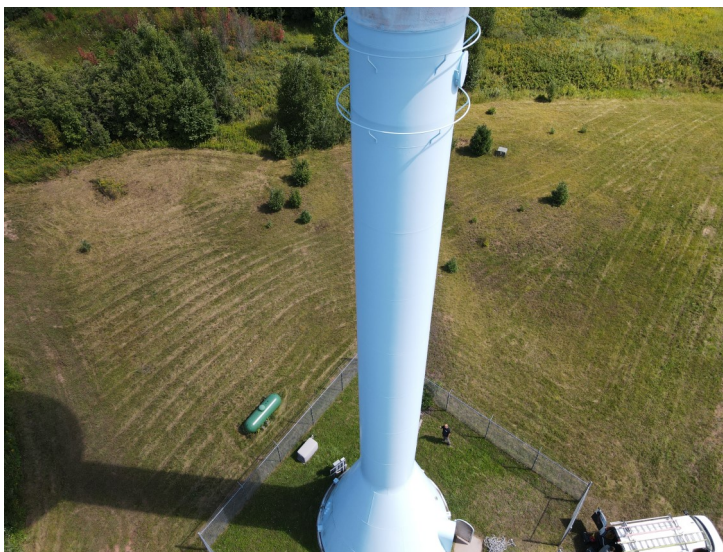
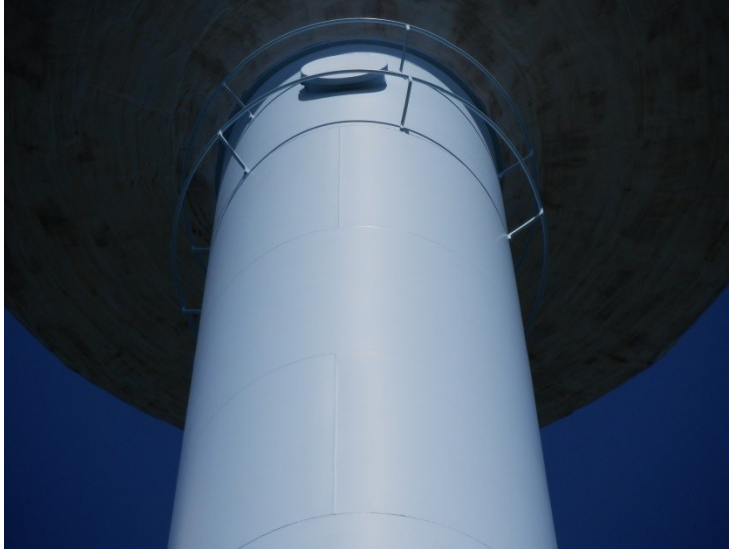
14) There are no coating failures on the riser.

15) Same.

16) Same.

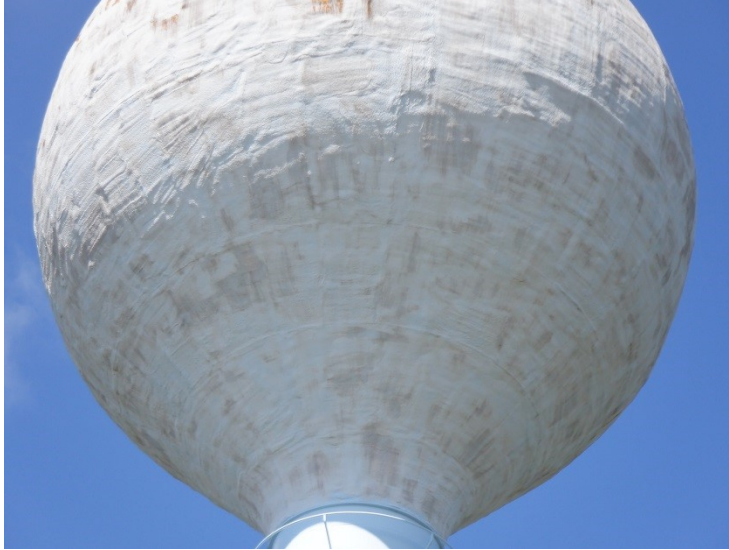
17) The bowl is covered with spray foam insulation. The coating on the insulation is in fair condition.

18) Same.

19) Same.

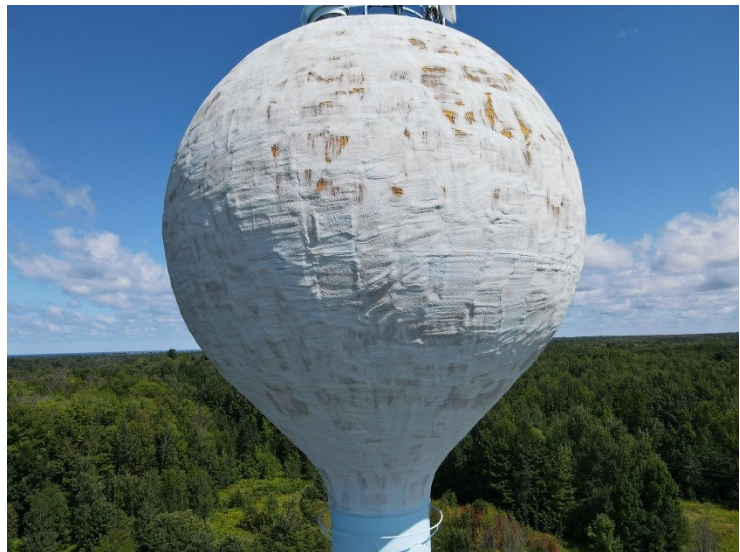
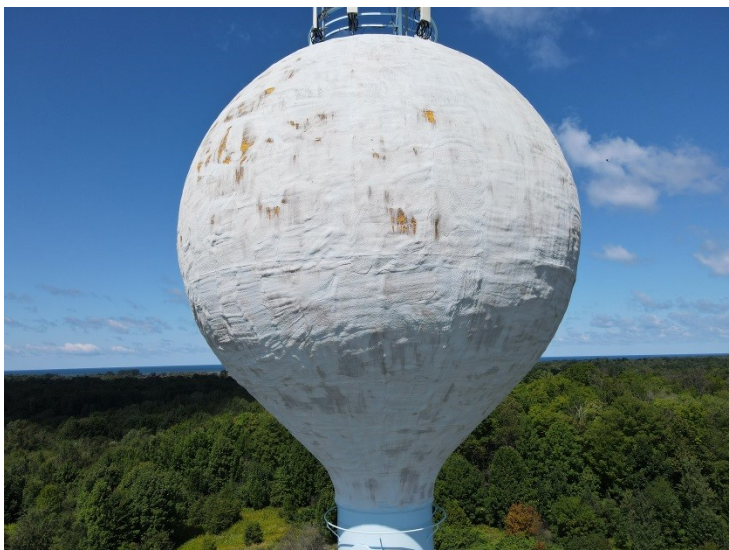
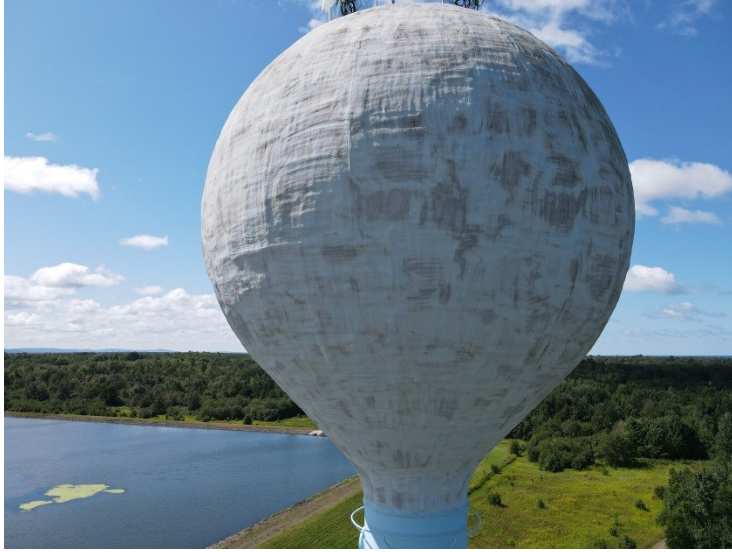
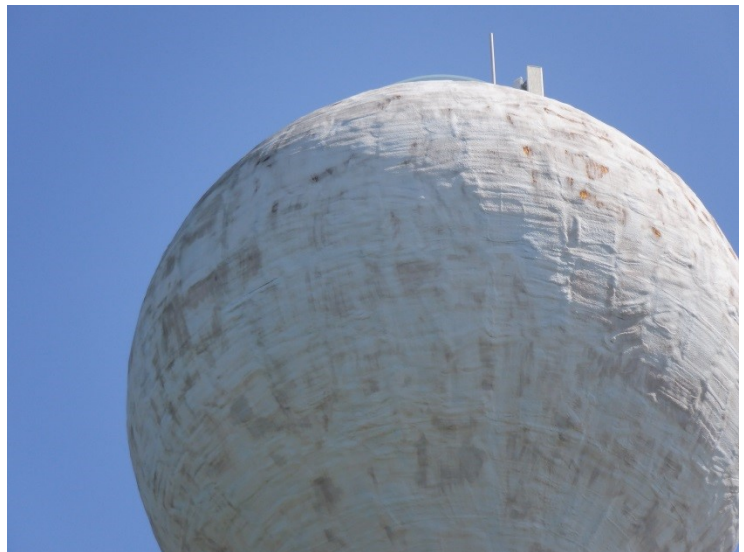
20) The sidewall is covered with spray foam insulation. The coating on the insulation is in fair condition.

21) Same.

22) Same.

23) Same.

24) Same.

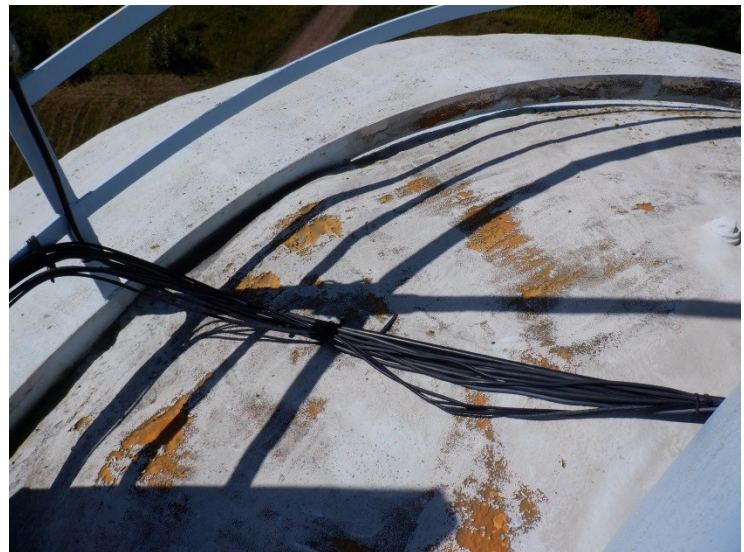
25) The insulation on the roof has deteriorated.

26) Same.

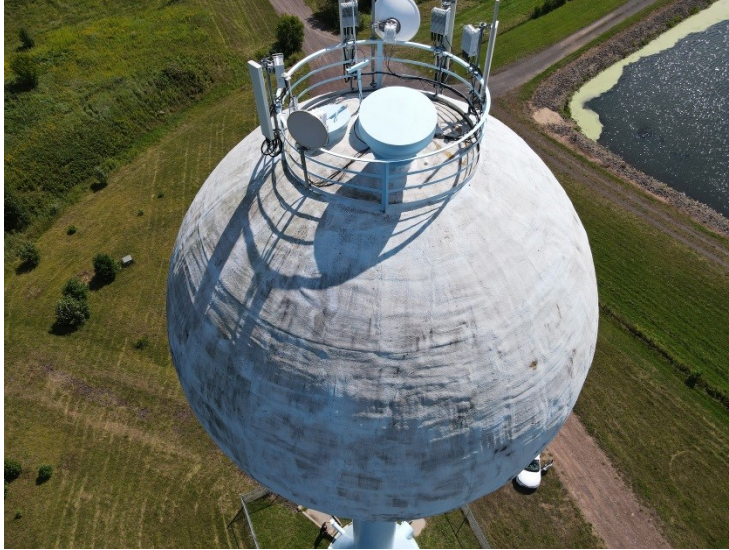
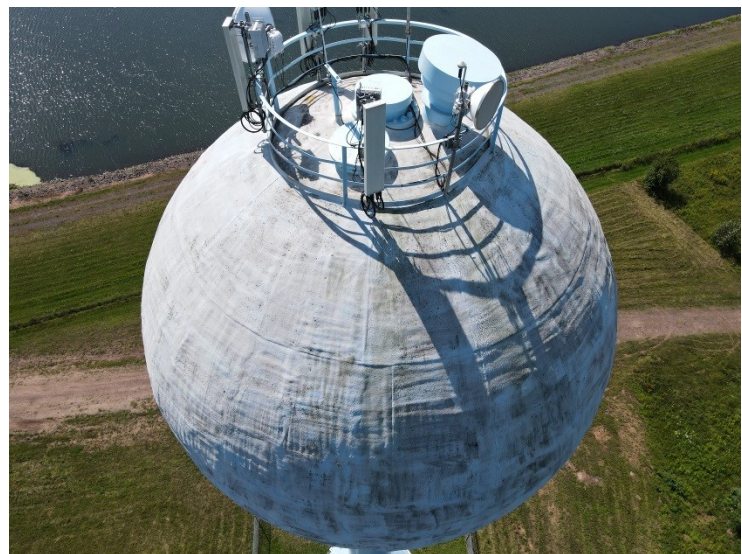
27) The coating on the roof insulation is in fair condition with areas of erosion.

28) Same.

29) Same.

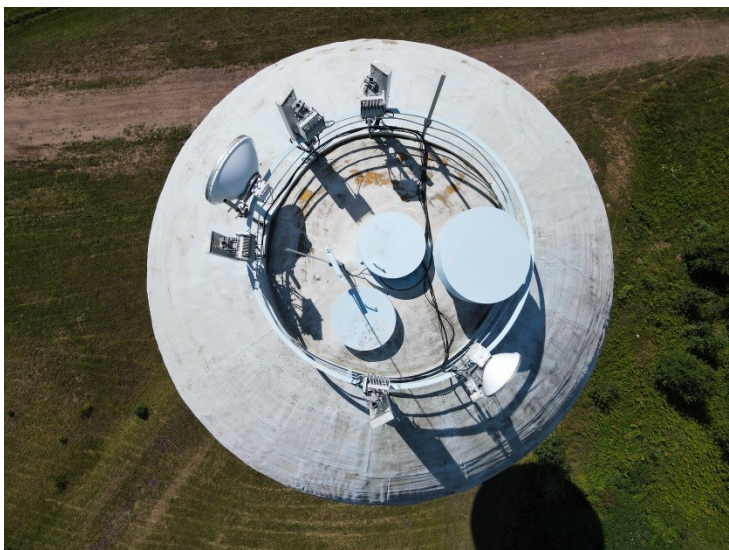
30) The roof handrail is being used for antenna mounting.

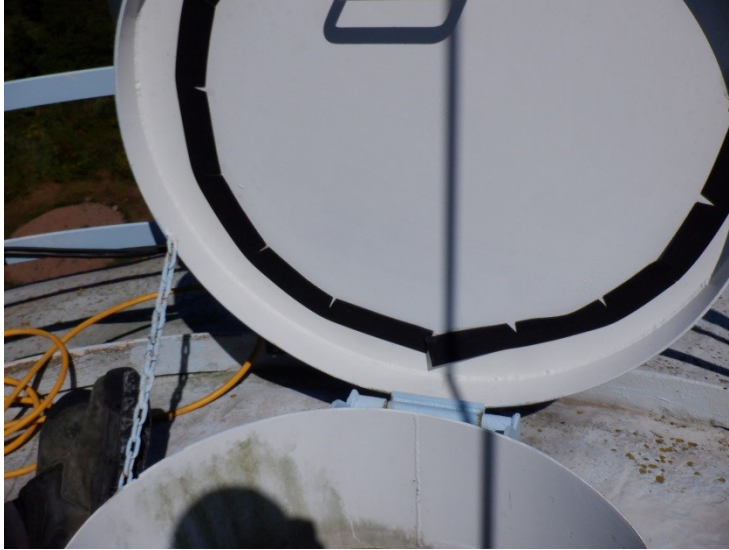
33) Antenna cables are routed through the screens on the access tube roof hatch neck. The screen are oversized.

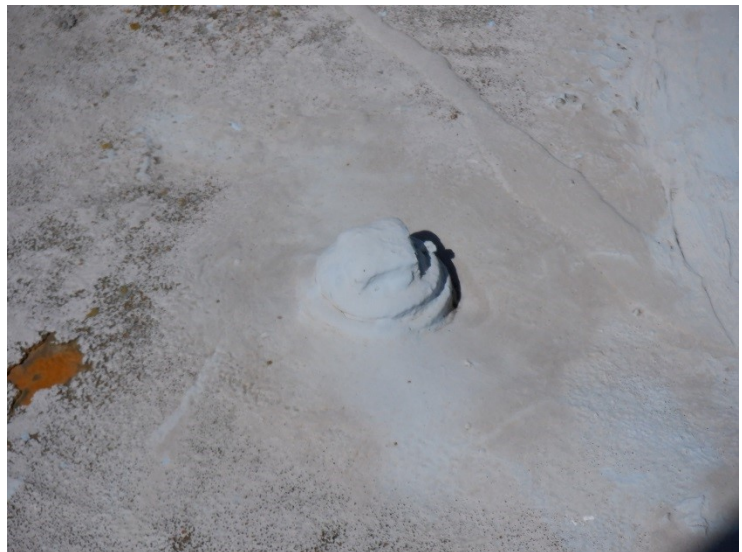
35) The roof rigging couplings are properly capped.

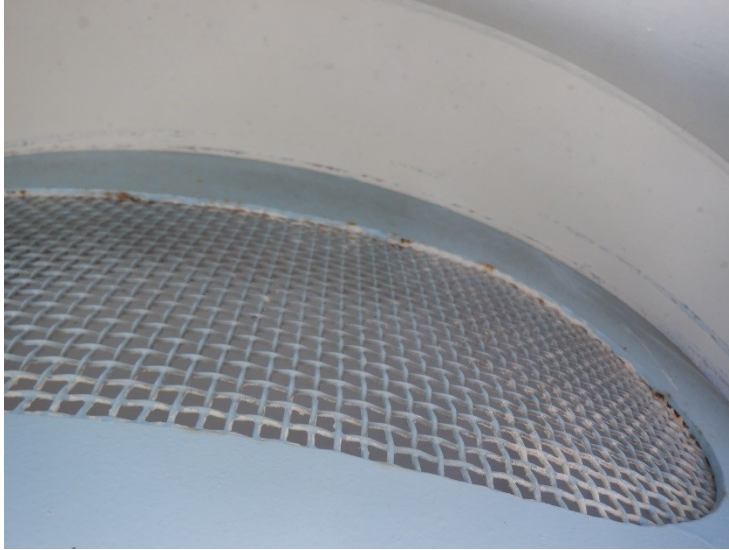
36) The pressure vacuum roof vent is in good condition.

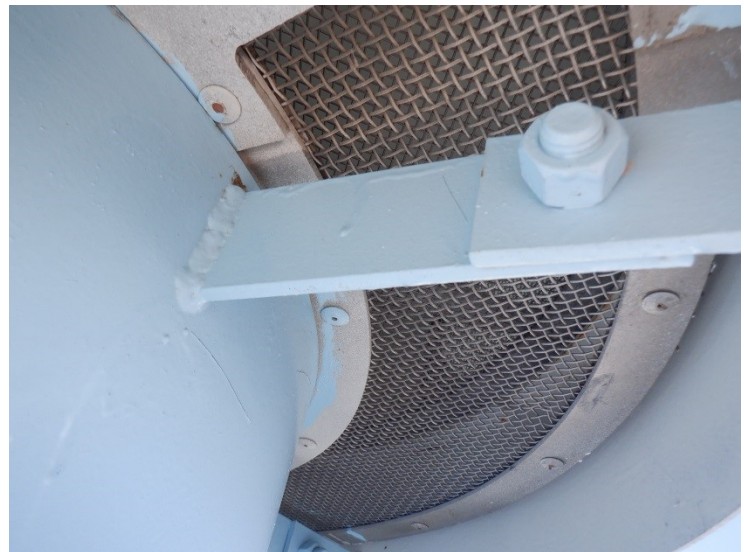
38) The screened roof vent pressure plate was found to be properly aligned.

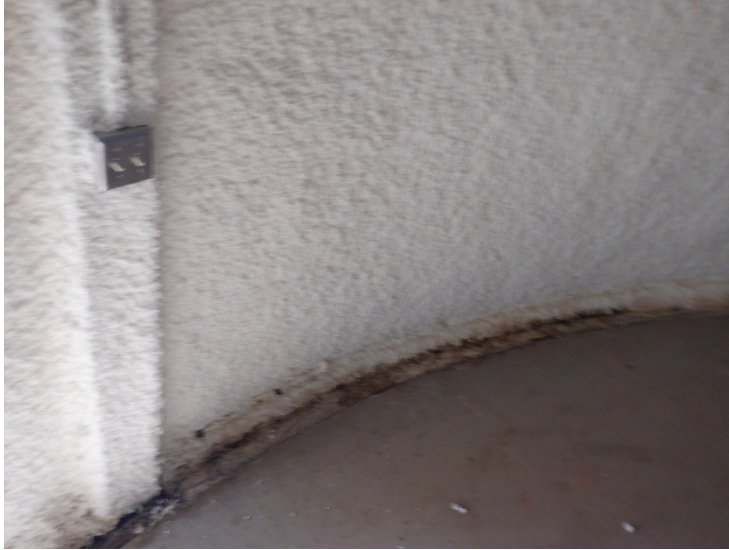
39) The interior roof vent screen is in good condition but oversized.

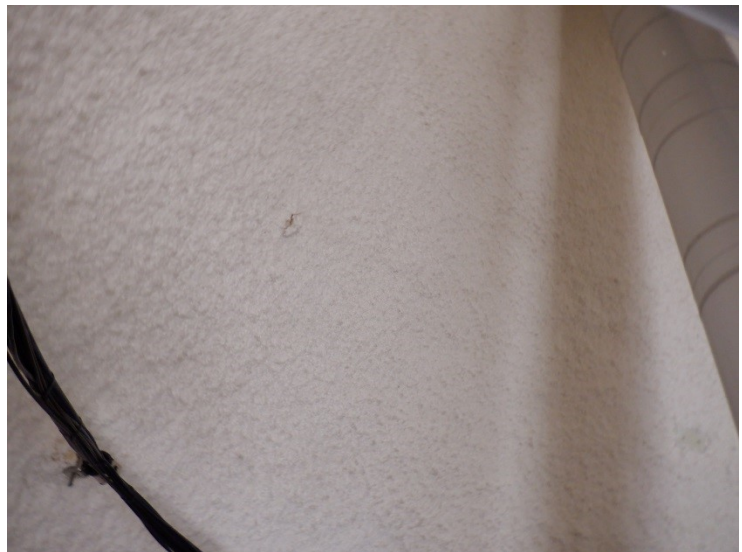
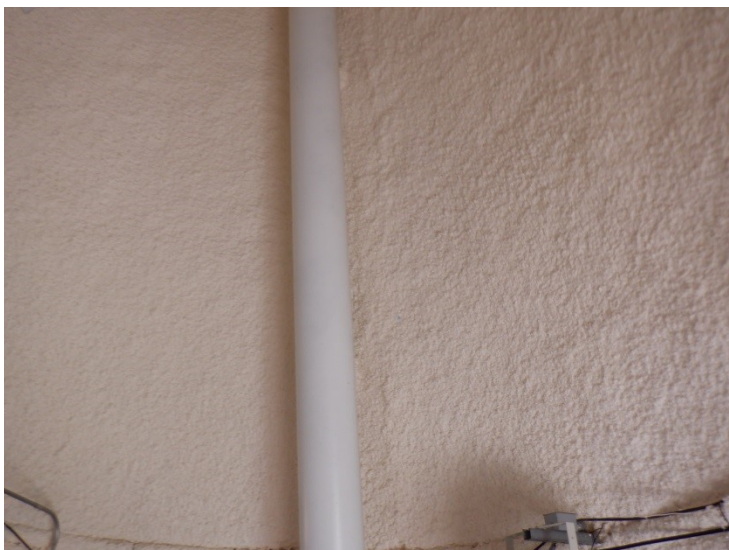
40) The dry interior baseball coating is covered with insulation and not visible for inspection. The insulation is in good condition.

41) Same.

42) Same.

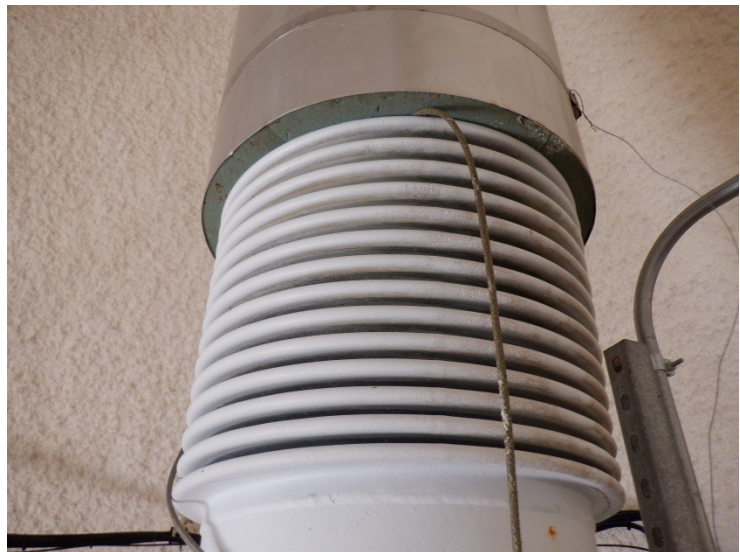
44) The bellows expansion joint on the fill/draw pipe in the basebell appears to be in good condition.

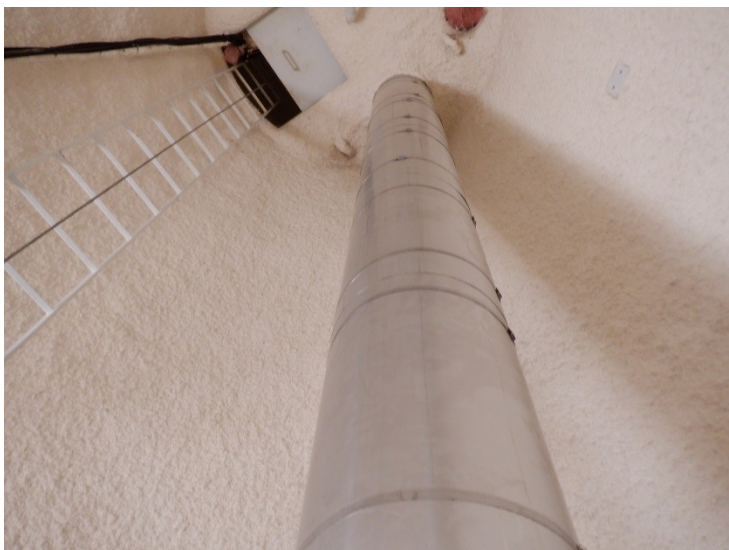
45) The fill/draw pipe insulation and aluminum cover are in good condition.

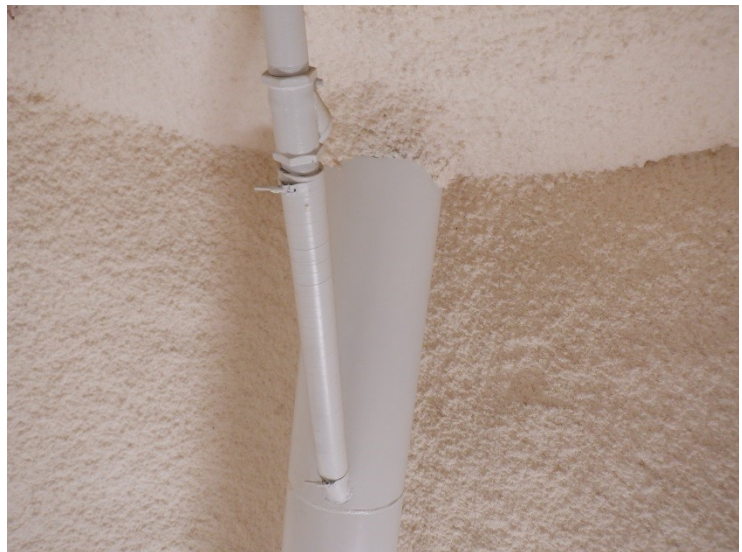
47) The condensate platform drain with a check valve is in good condition.

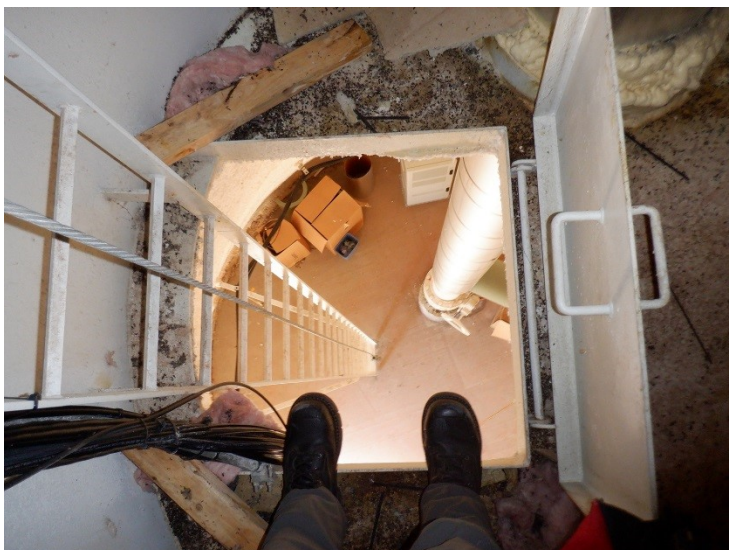
48) The ladder opening in the condensate platform is equipped with a hinged cover.

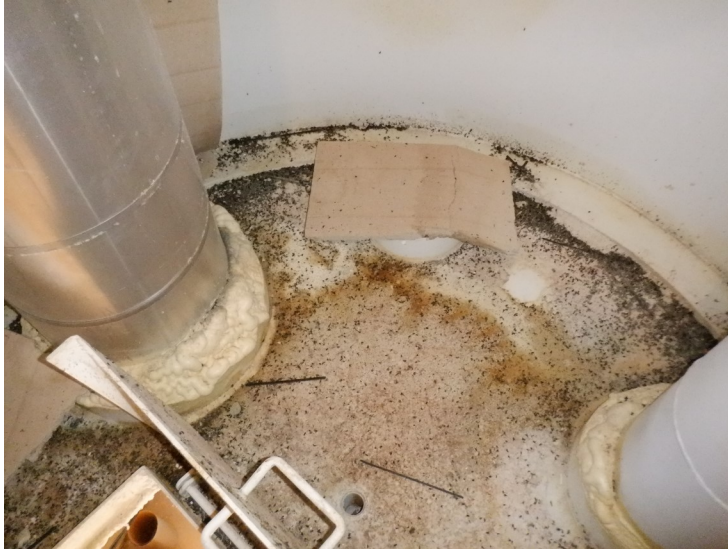
49) The condensate platform coating is in good condition.

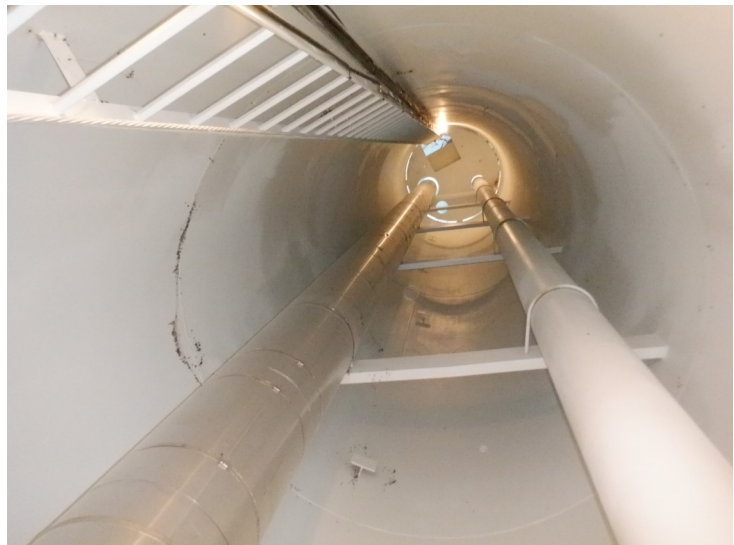
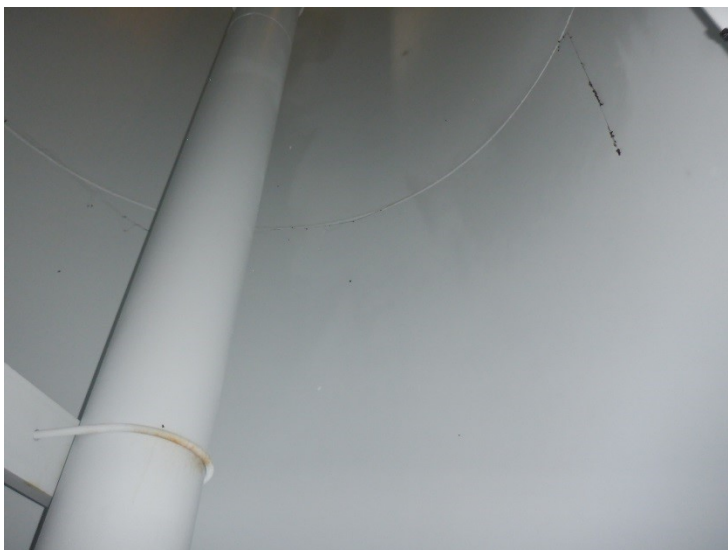
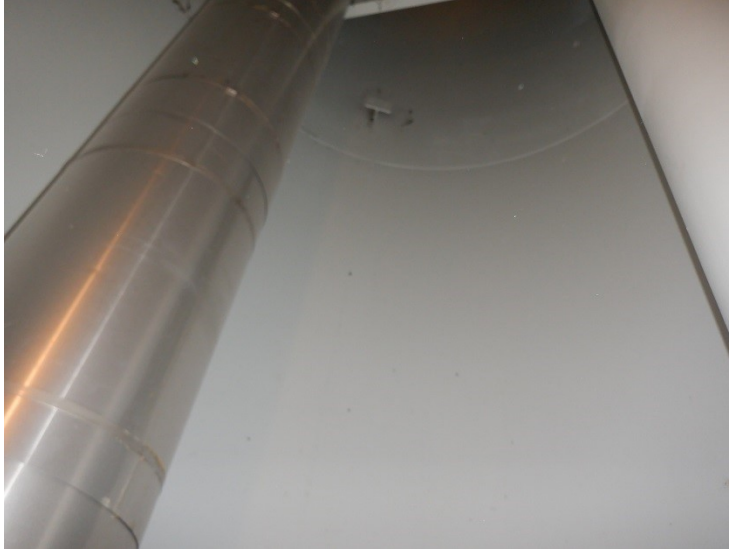
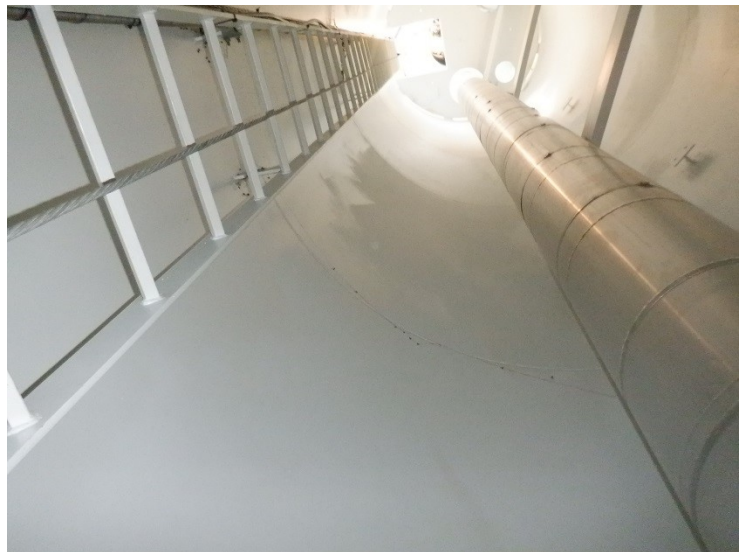
50) There are no coating failures in the dry riser.

51) Same.

52) Same.

53) Same.

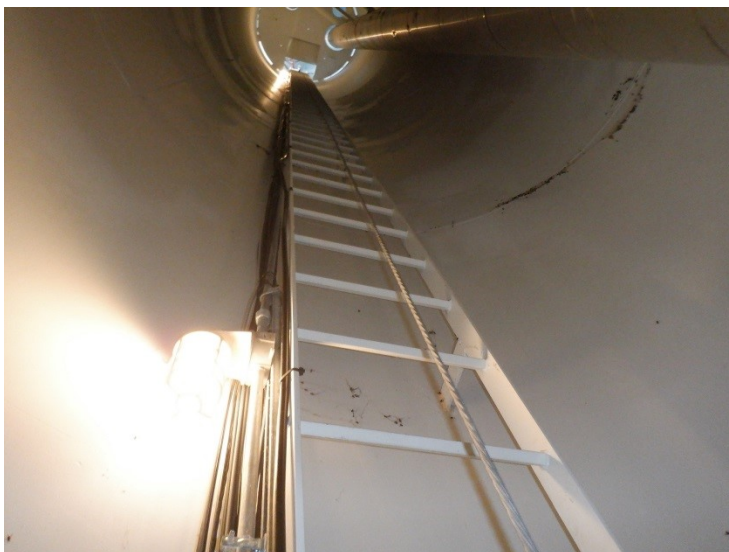
54) The dry interior lighting is in good condition.

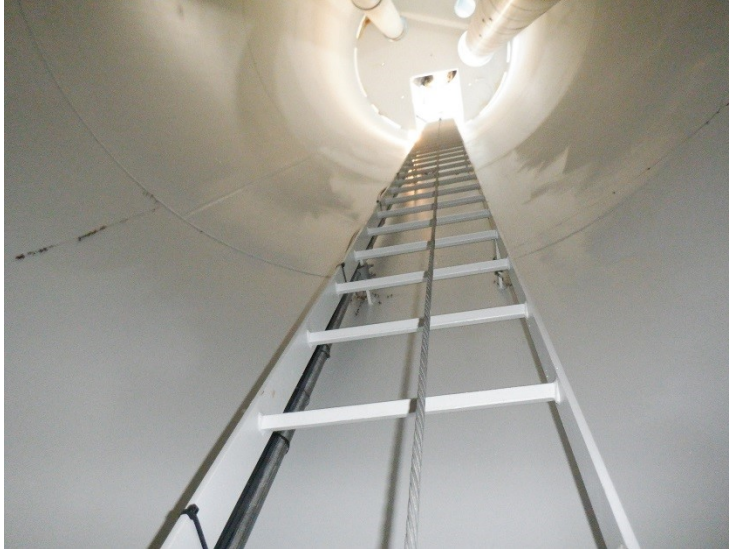
55) The riser ladder is in good condition. The ladder is equipped with a fall prevention device.

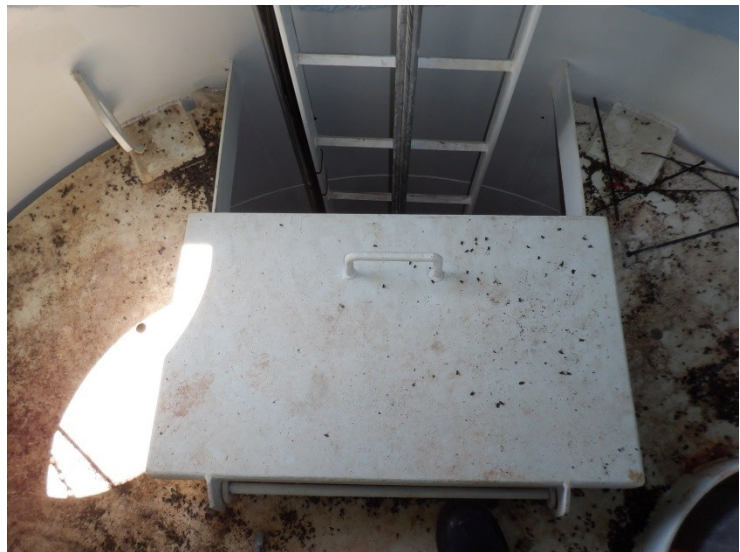
56) The ladder opening in the top platform is equipped with a hinged cover.

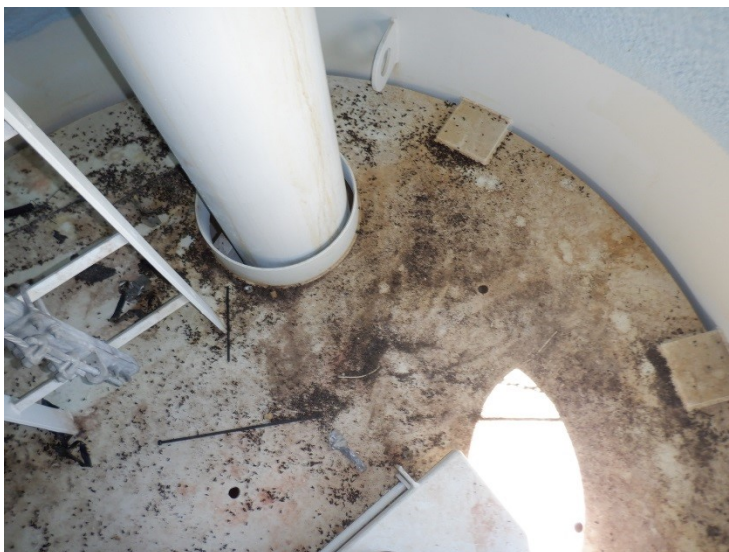
57) There are no significant coating failures on the top platform.

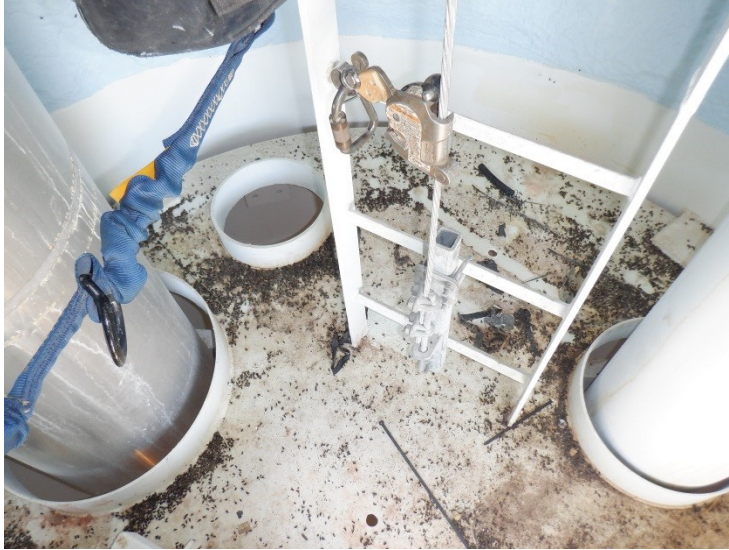
58) Same.

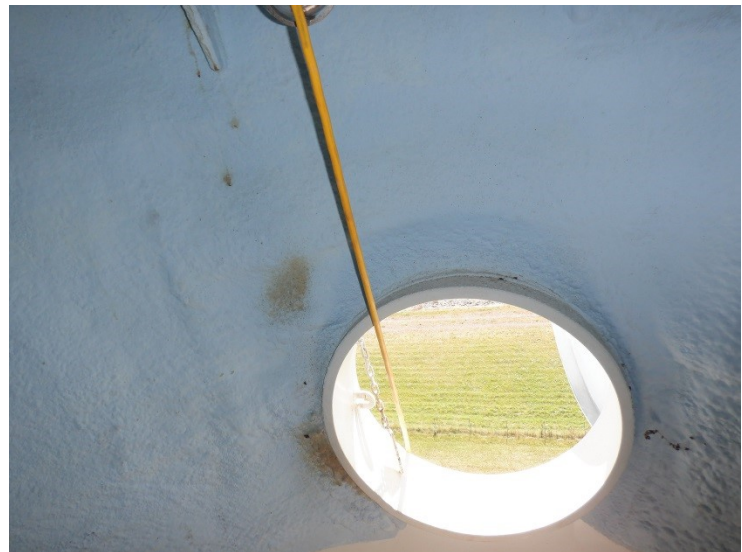
59) There is no handhold above the painter's hatch at the top of the riser.

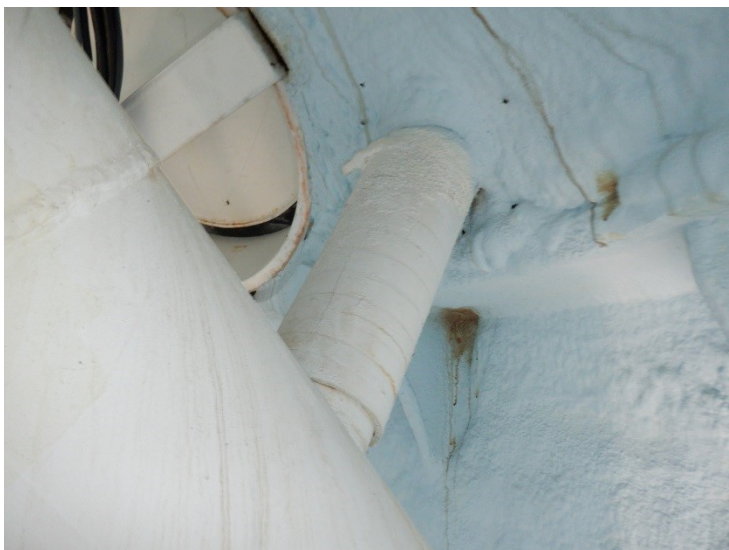
60) The drain plug can only be opened from the wet interior.

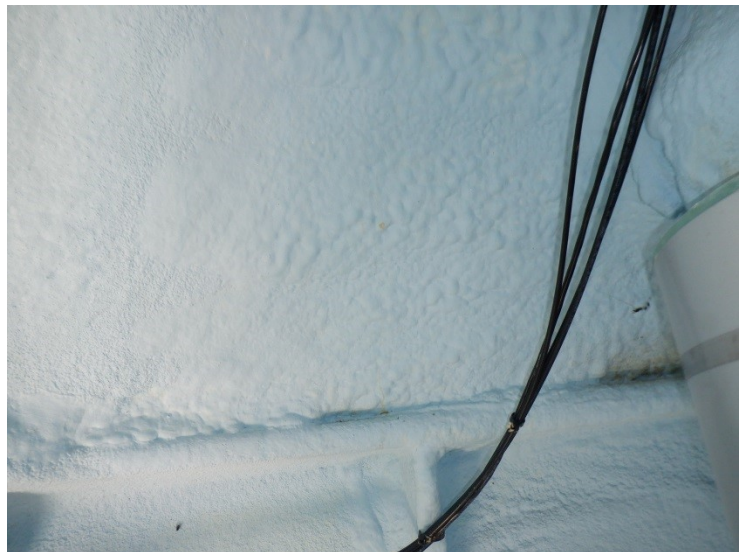
62) The transition cone coating is covered with spray foam insulation and not visible for inspection. The insulation is in good condition.

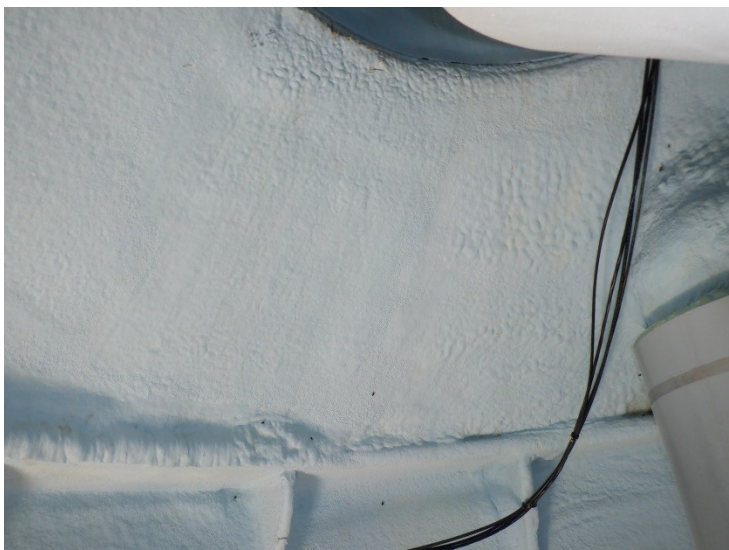
63) Same.

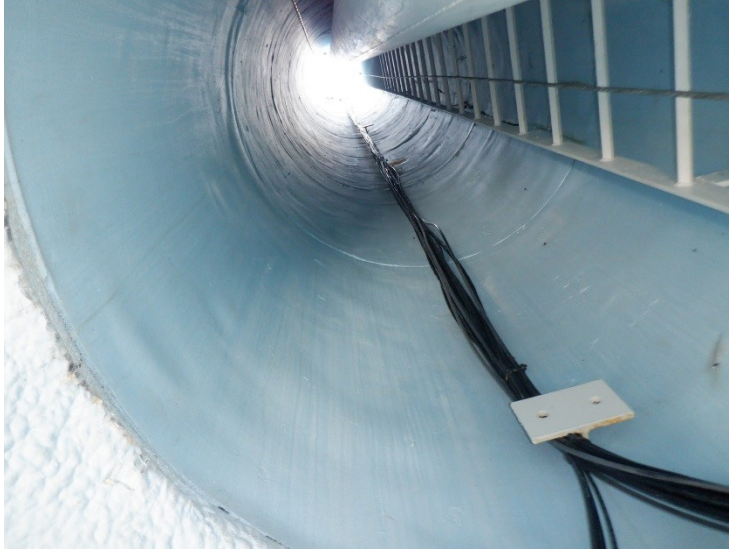
64) The access tube coating is in good condition with no failures.

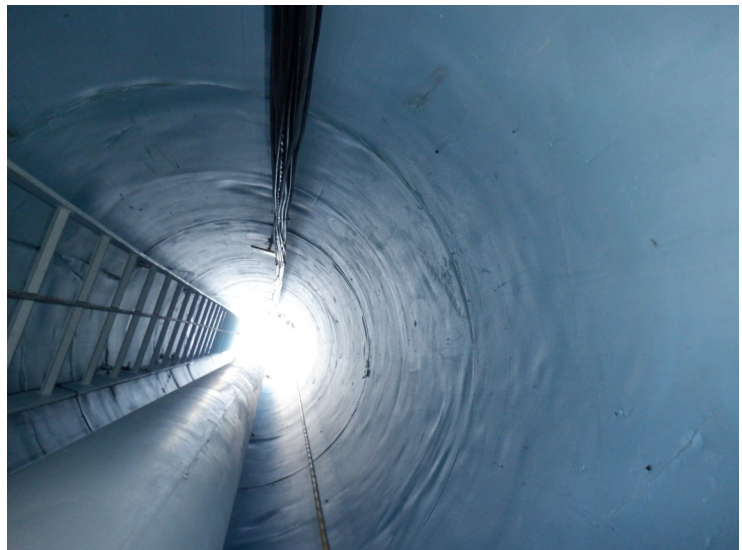
65) Same.

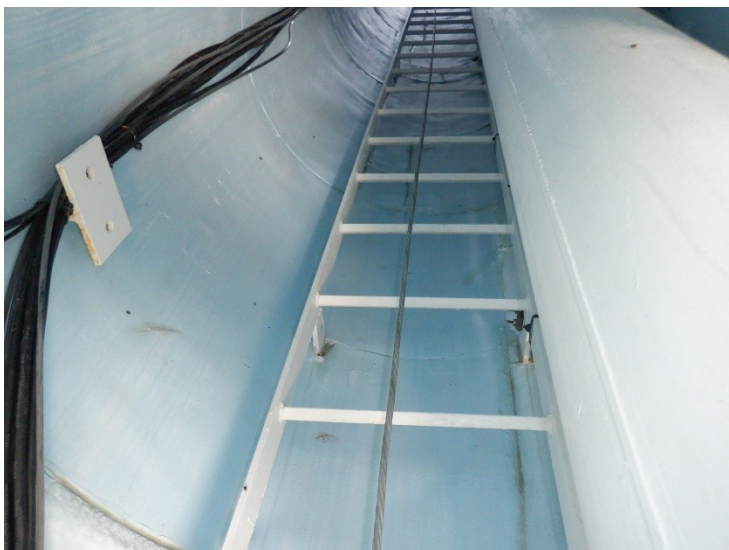
66) The access tube ladder is in good condition. The ladder is equipped with a fall prevention device.

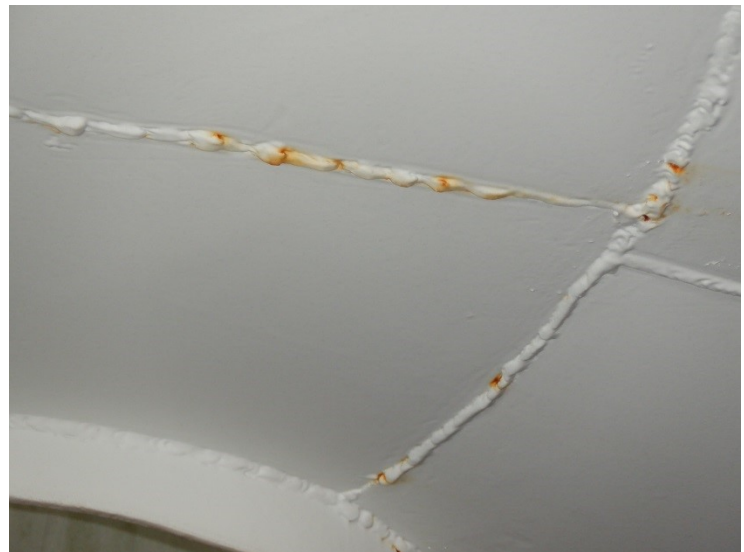
67) There are a few coating failures at the welded lap seams on the wet interior roof.

68) Same.

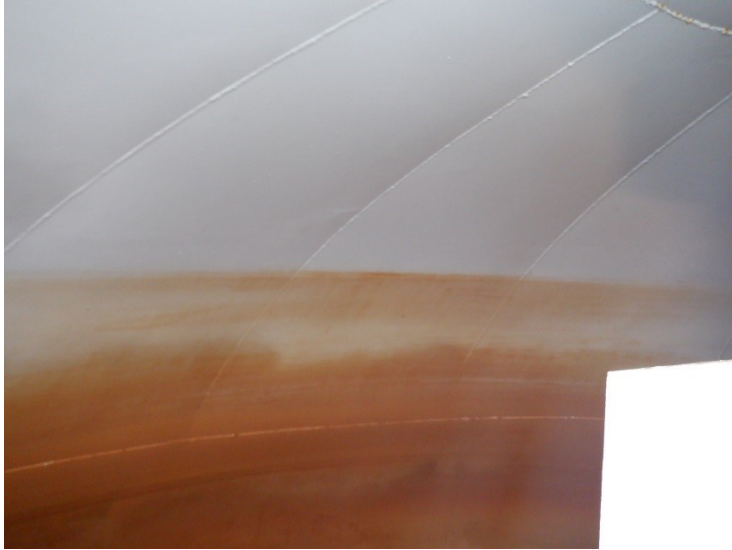
69) The wet interior roof coating is in good condition overall.

70) Same.

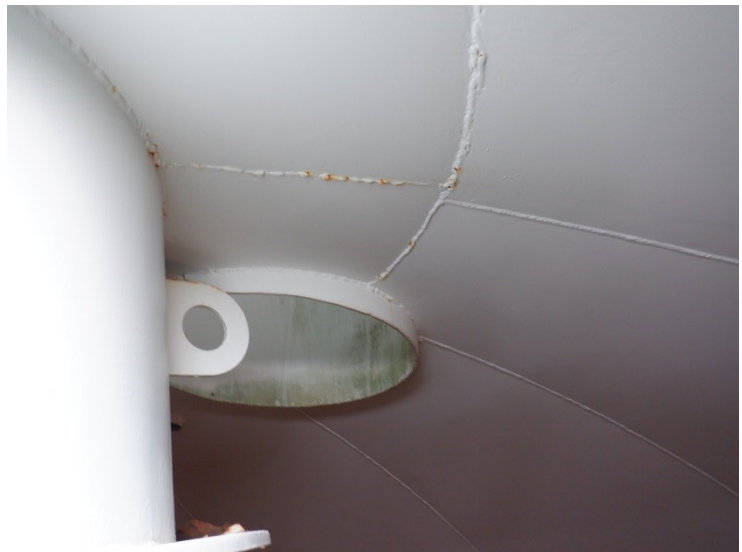
71) Same.

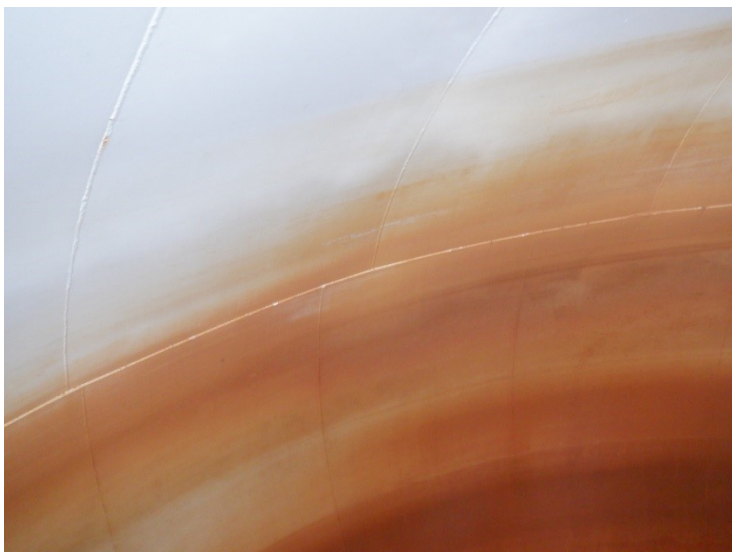
72) Same.

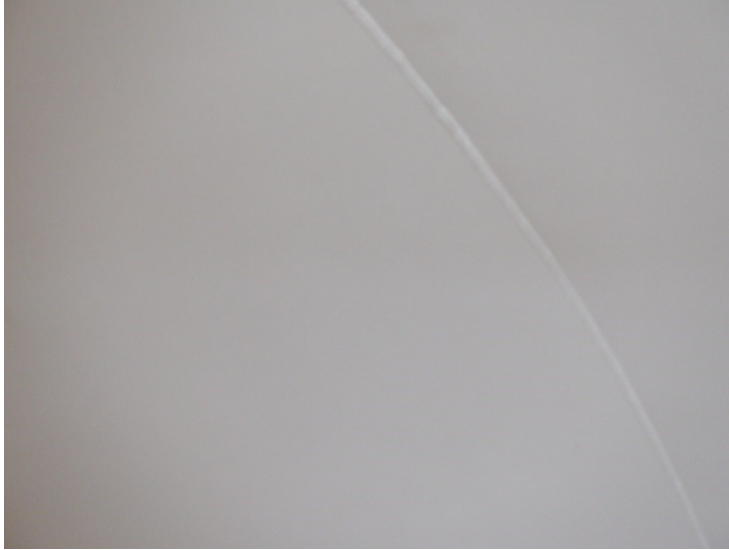
73) Same.
