DIXON

Maintenance Inspection

150,000 Gallon Spheroid

Ontonagon, Michigan

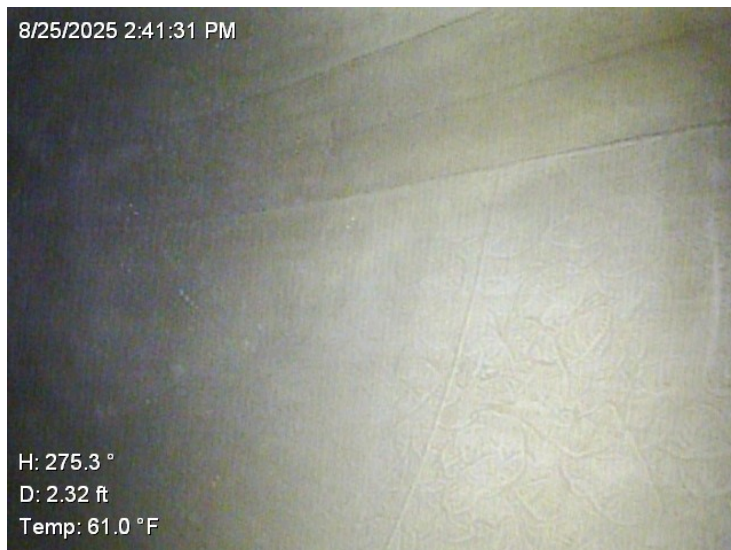
75) The wet interior sidewall coating is in good condition overall.

76) Same.

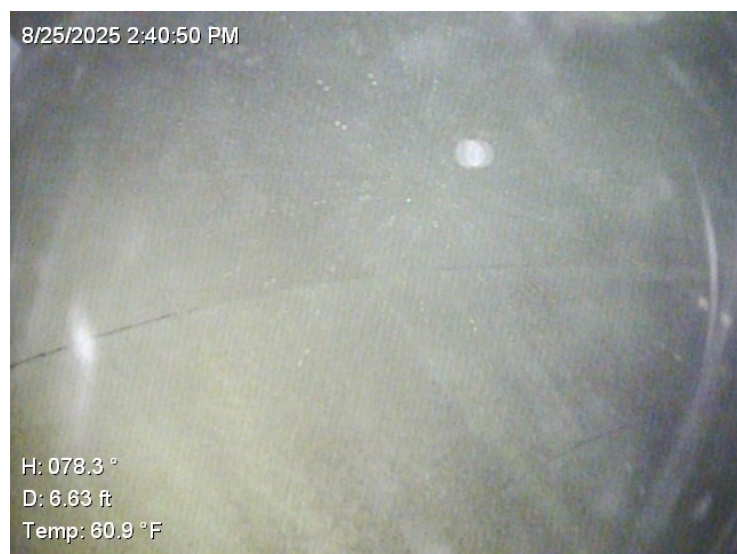
77) Same.

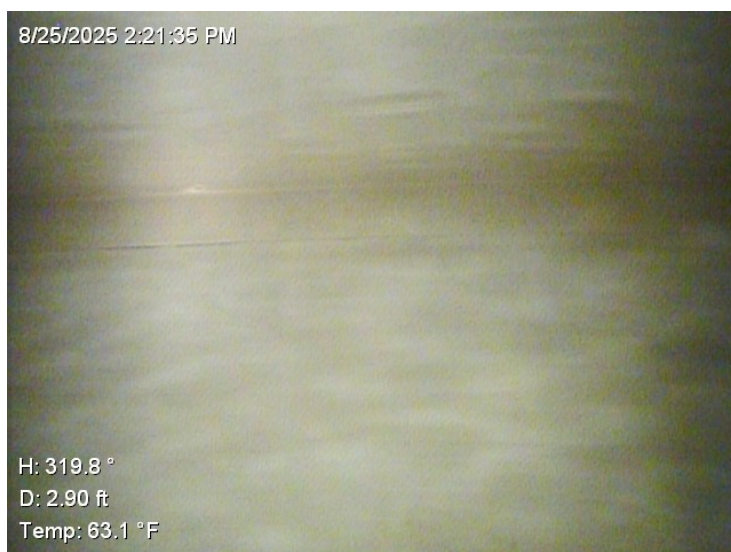
78) Same.

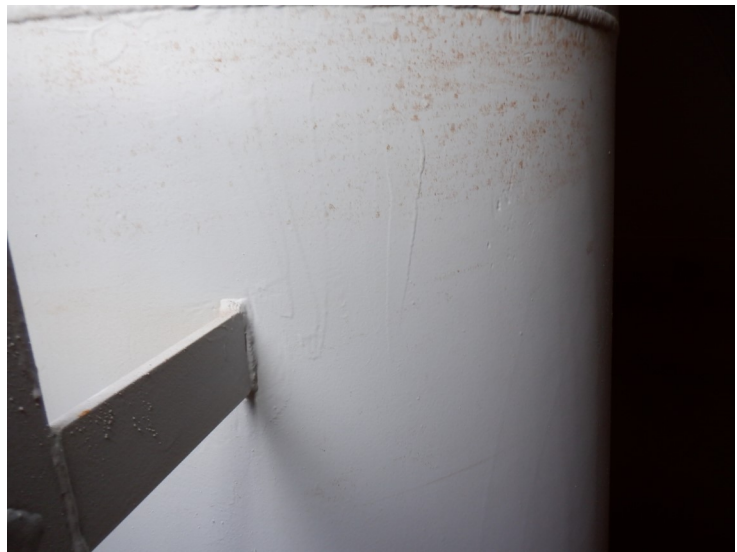
80) The access tube coating is in good condition overall.

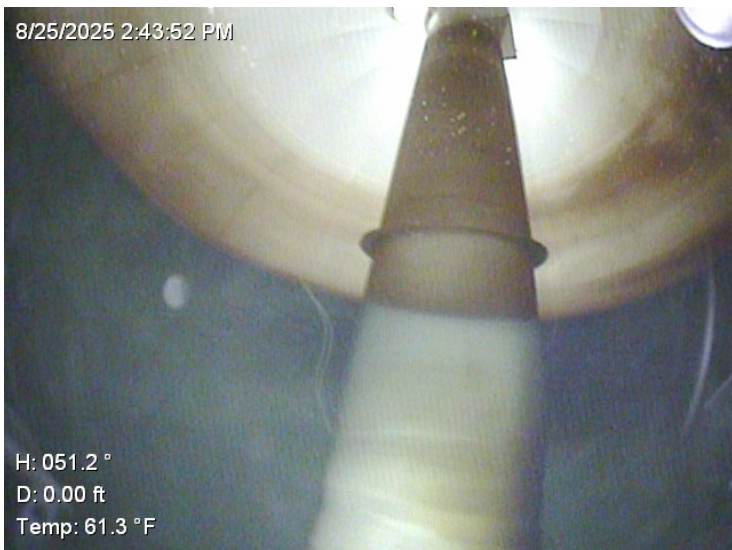
81) Same.

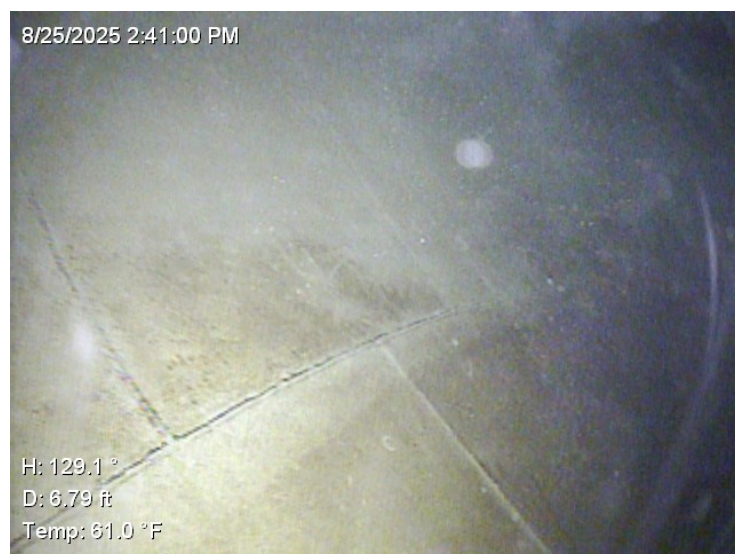
83) There are no visible coating failures on the bowl.

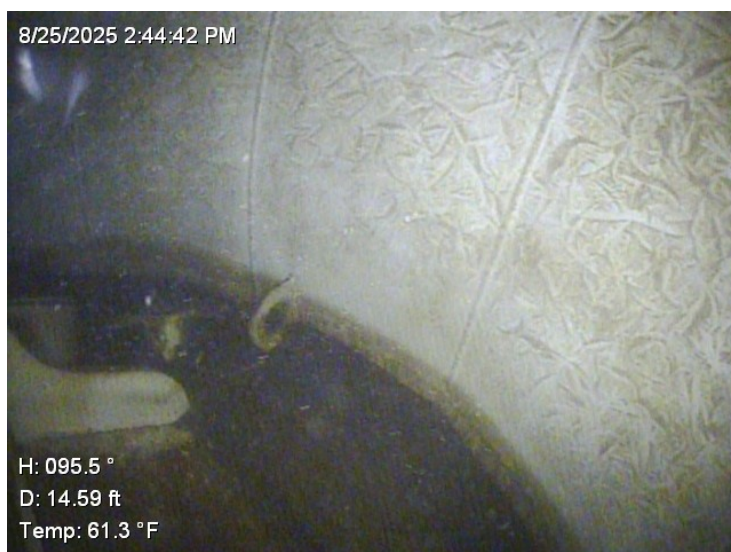
84) Same.

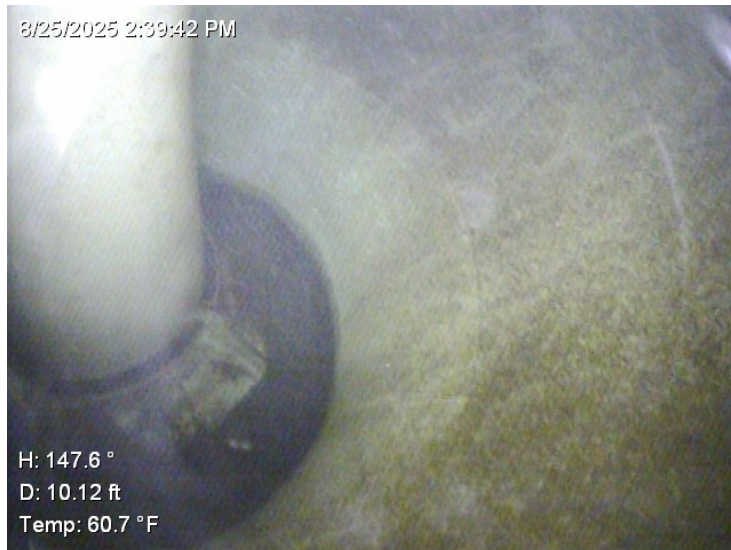
85) The transition cone is covered with sediment that limited the amount of surface visible with the ROV.

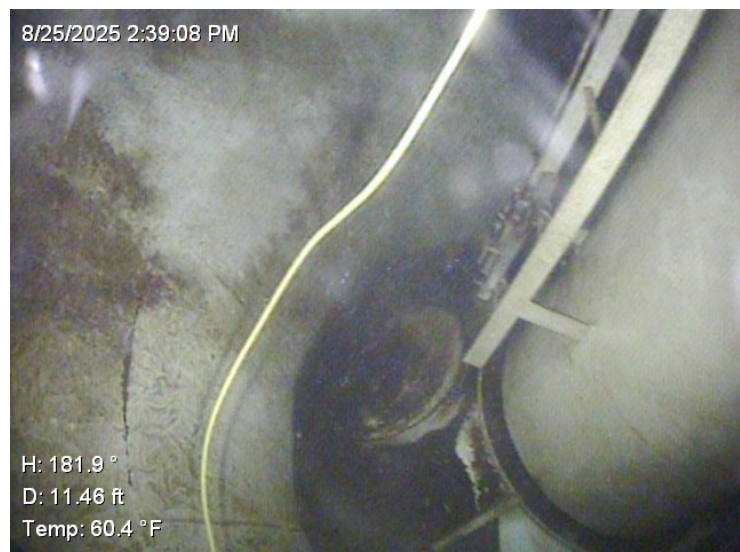
86) Same.

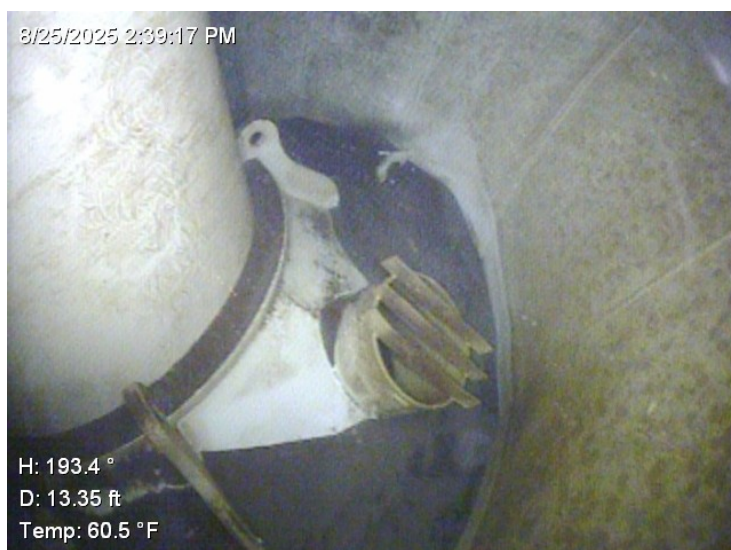
87) There are deflector bars over the fill/draw pipe in the wet interior.
