Maintenance Inspection

250,000 Gallon Double Ellipse

Ontonagon, Michigan

Inspection Performed: September 25, 2025
Reviewed by: Joseph T. Hoban, P.E.: November 15, 2025

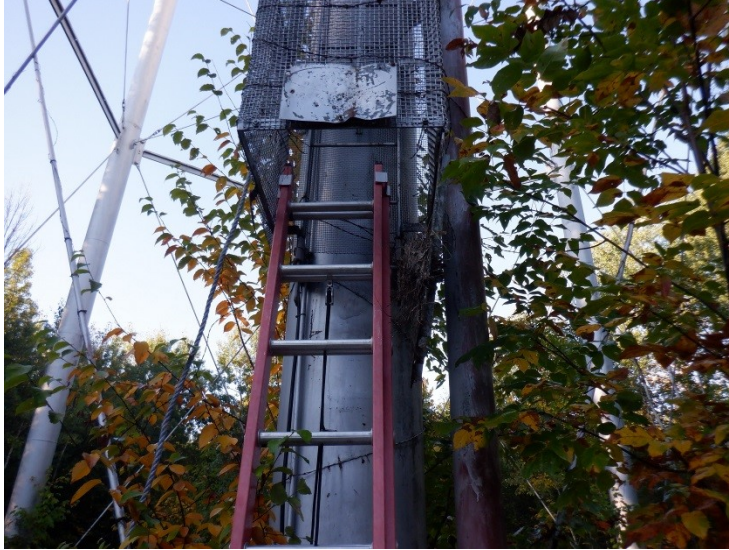
1) Tree branches and vegetation are rubbing and encroaching on the tank.

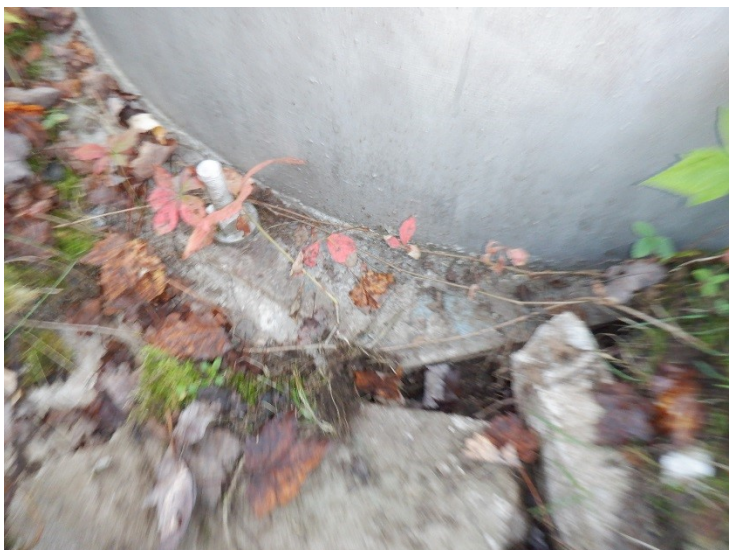
3) The concrete riser foundation is in good condition with no significant deterioration.

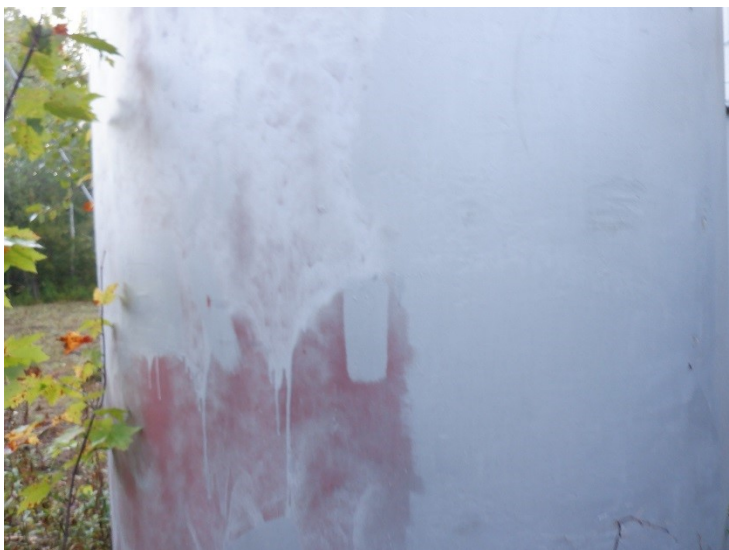
6) There are a few coating failures on the riser.

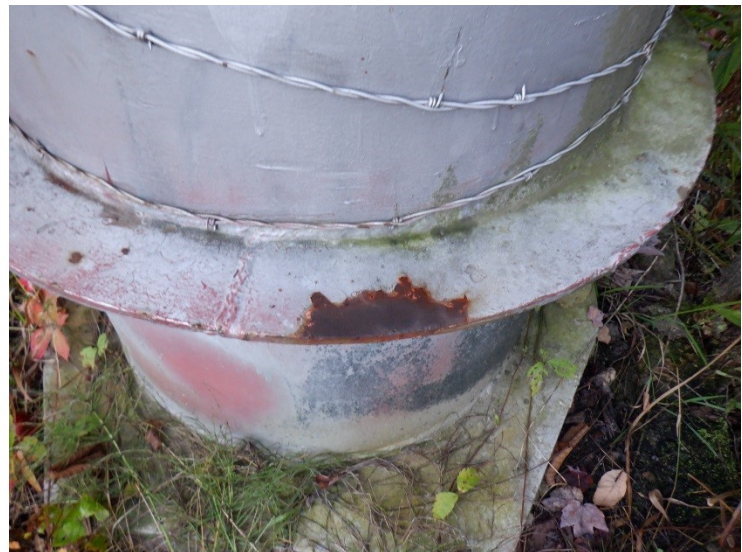
14) There are a few coating failures on the legs.

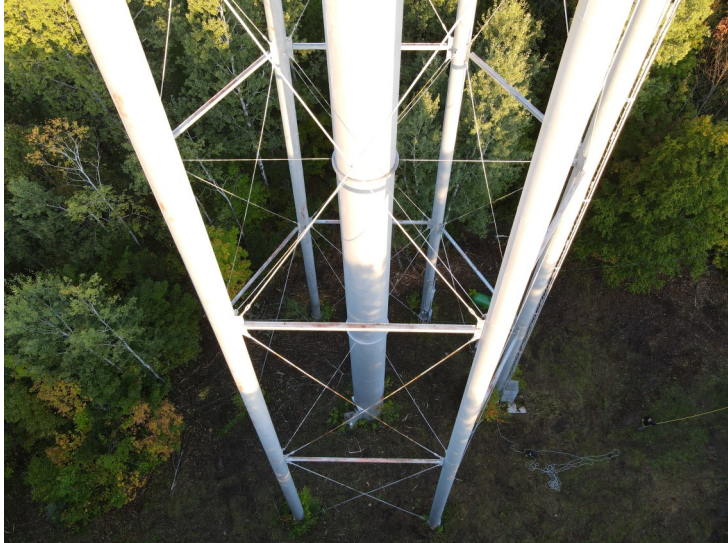
19) The leg coating is in fair condition overall.

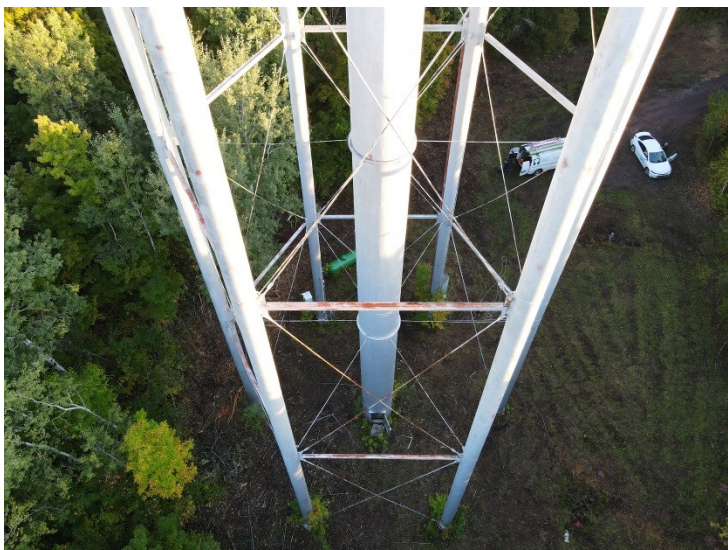
21) There are coating failures on the struts.

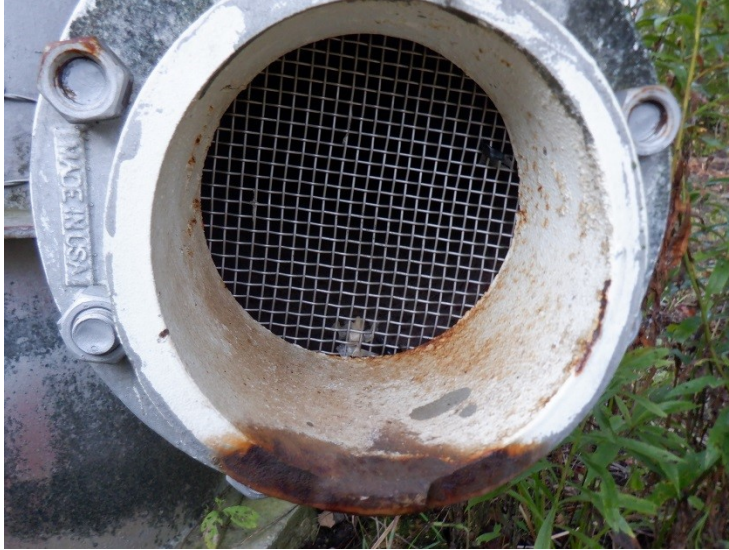
25) The screen at the overflow pipe discharge is intact but oversized.

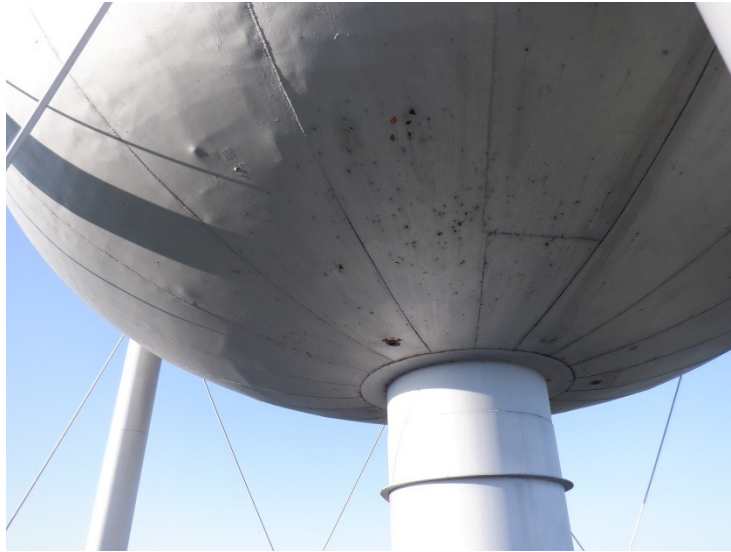
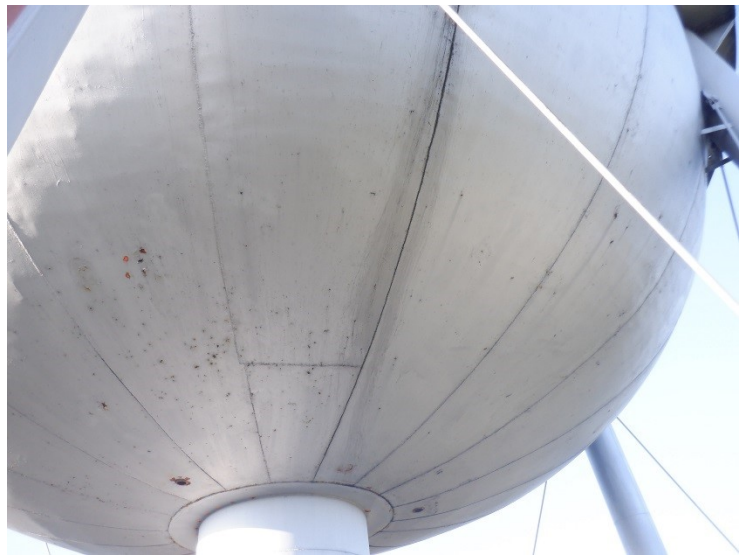
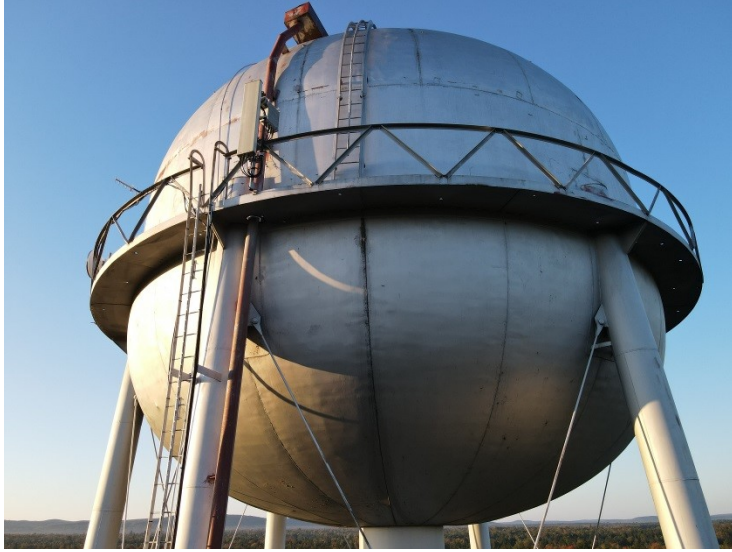
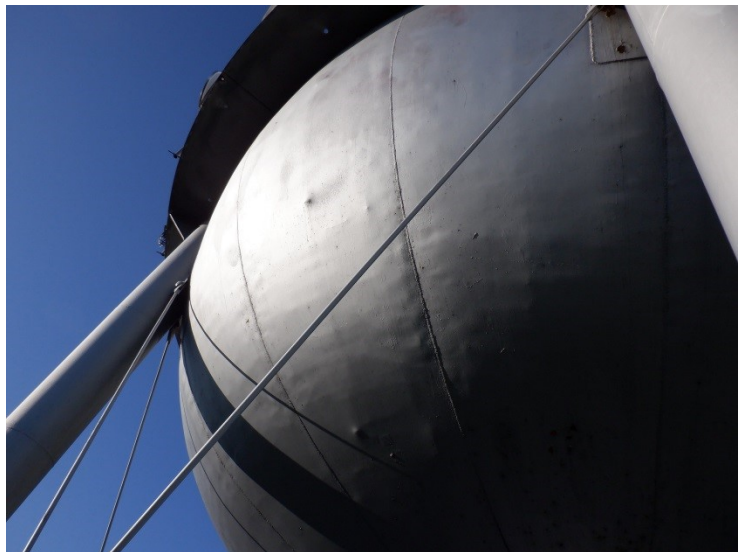
28) The bowl coating is in fair condition with a few failures.

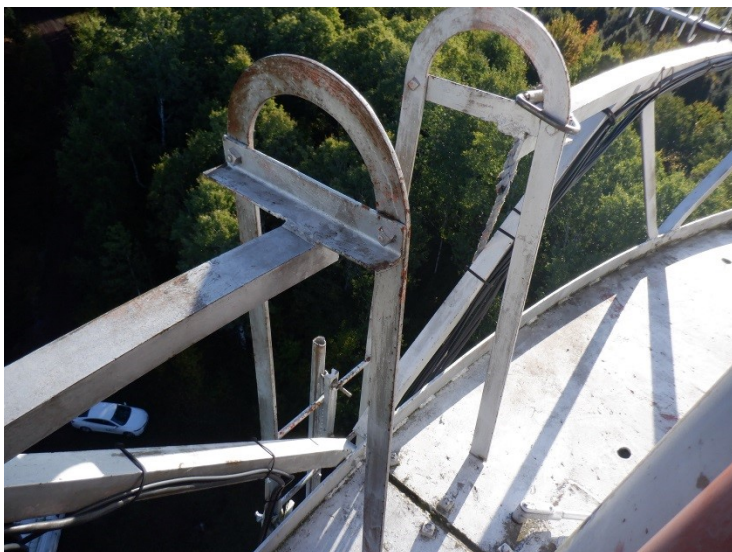
33) There is not a swing gate across the leg ladder opening in the balcony railing.

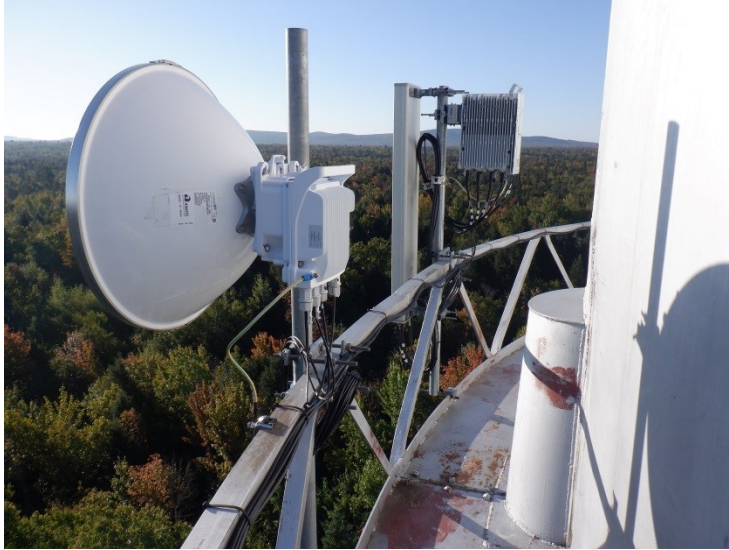
34) There is evidence of water ponding on the balcony.

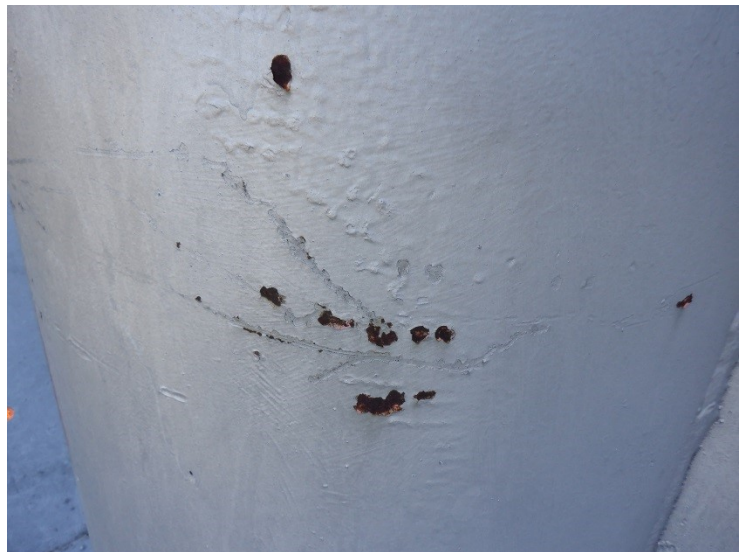
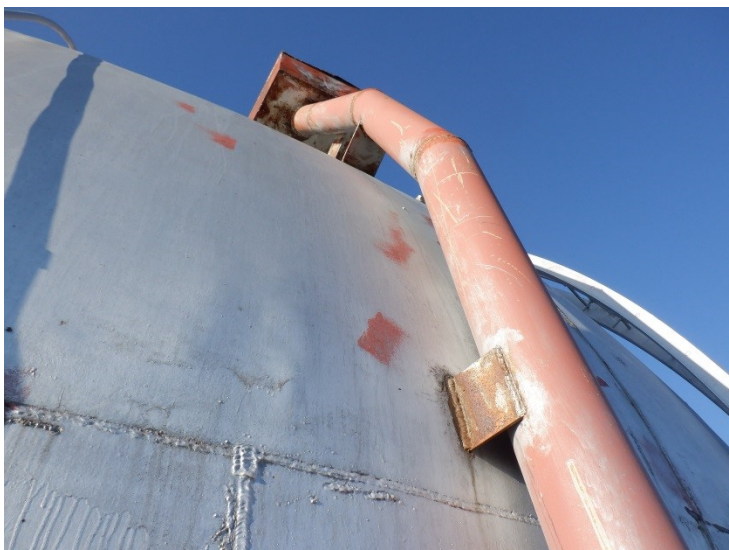
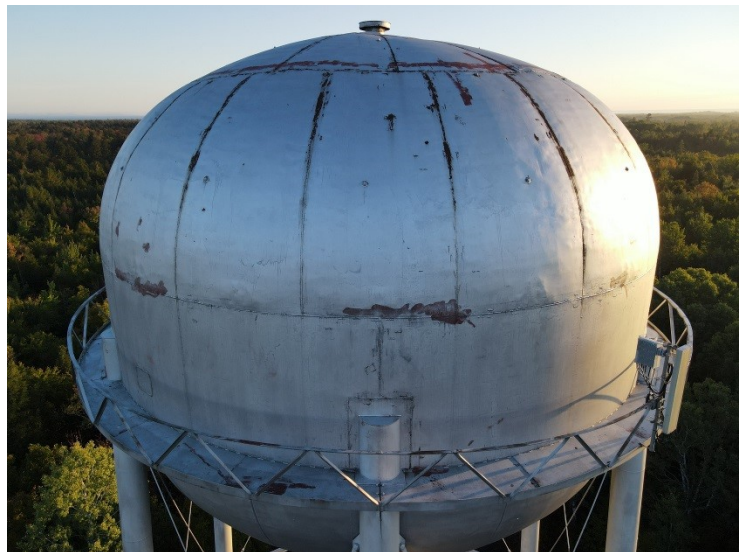
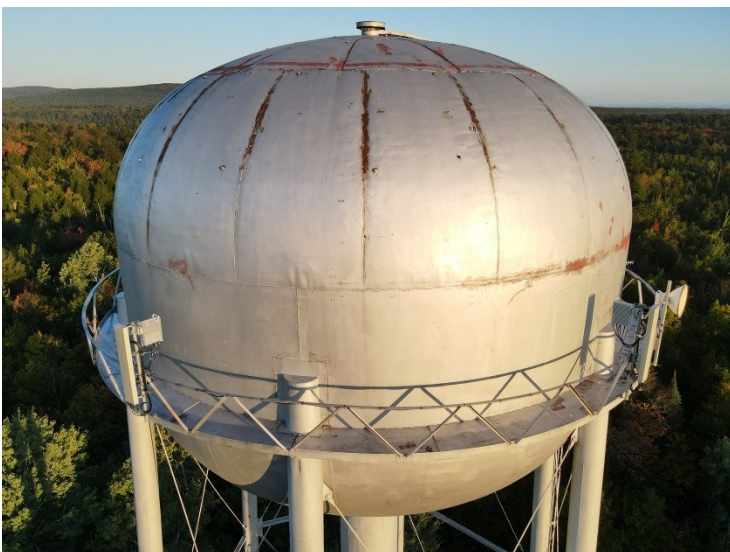
Sidewall comments: **There are extensive coating failures**

36) The sidewall coating is in poor condition with numerous failures.

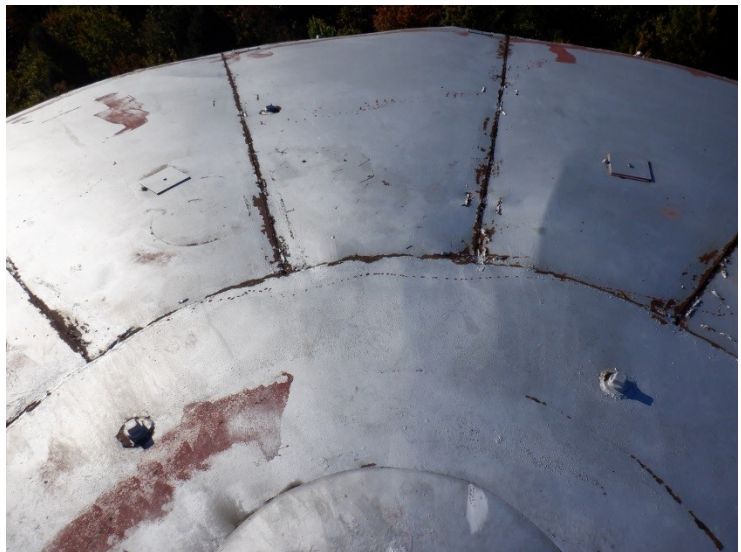
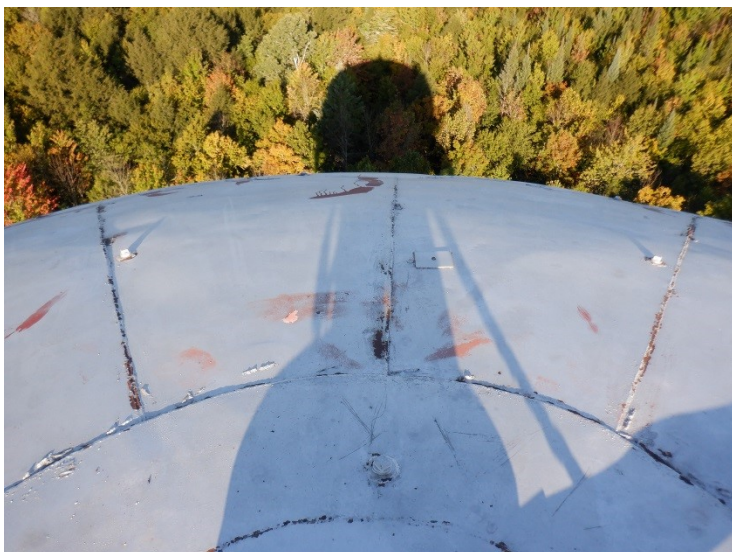
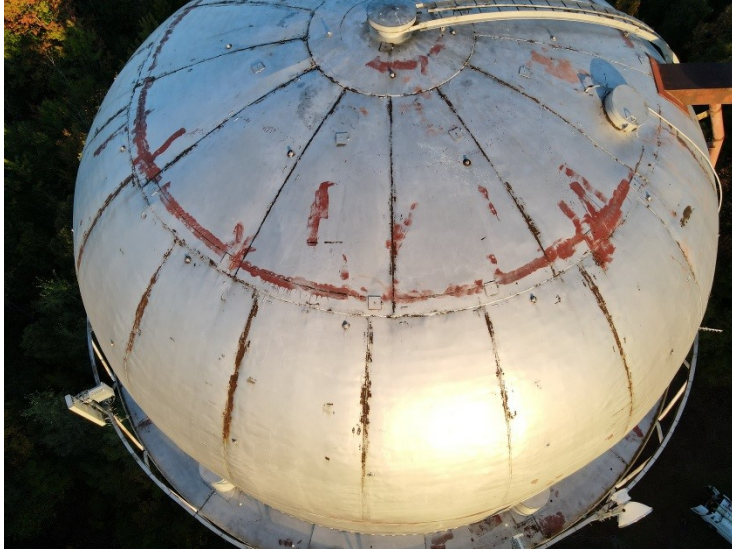
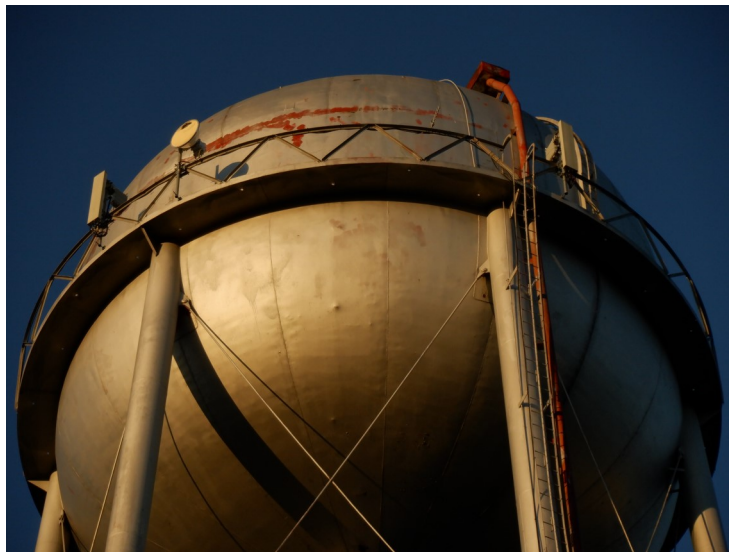
Roof comments: **There are extensive coating failures**

48) The roof coating is in poor condition with numerous failures.

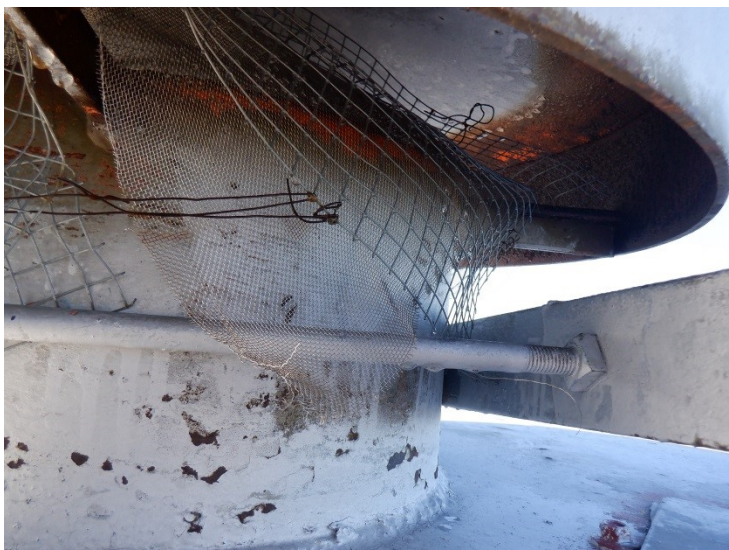
57) The roof vent screen is damaged.

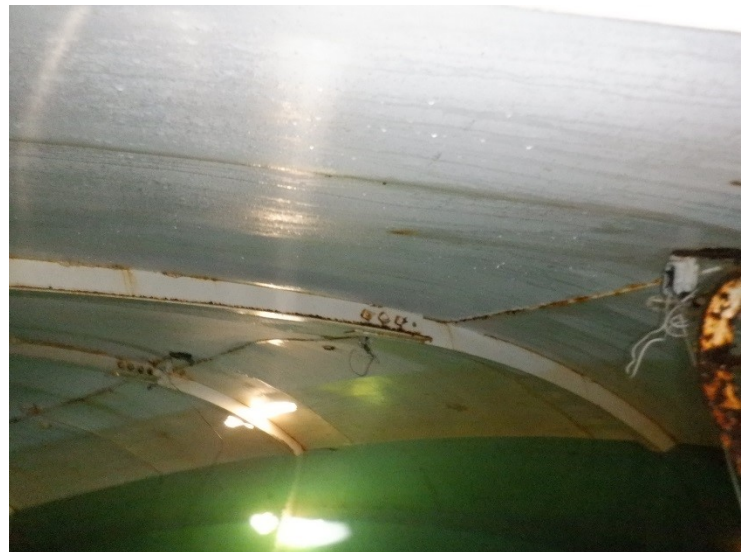
62) The wet interior roof coating is in poor condition with numerous failures.

64) Same.

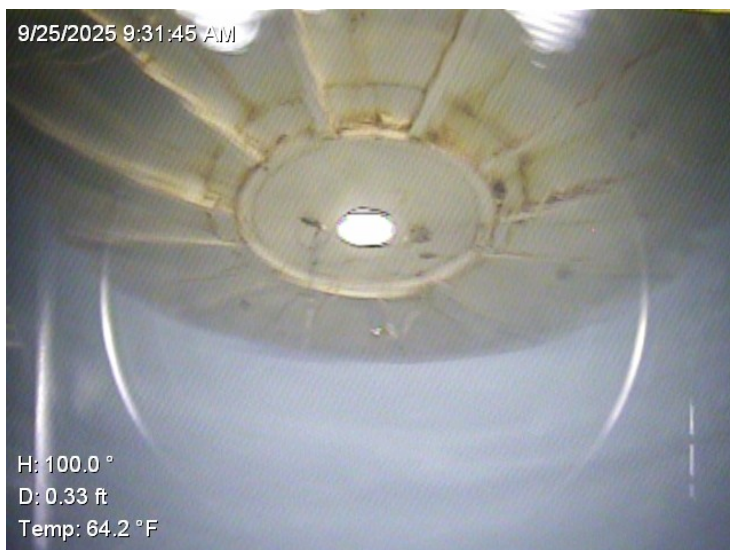
65) Same.

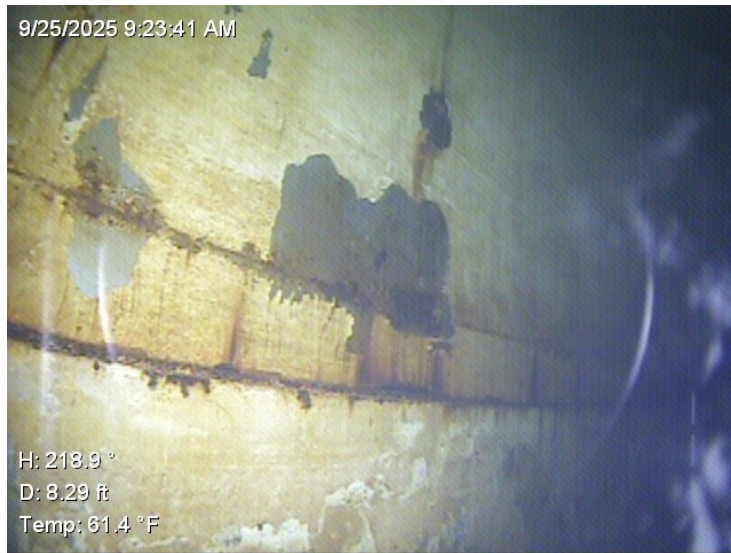
66) Same.

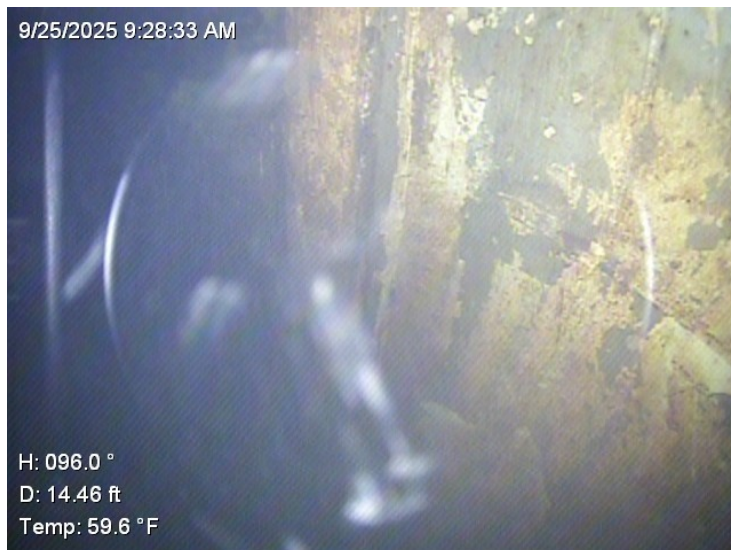
67) The wet interior sidewall coating is in poor condition with extensive failures.

69) Same.

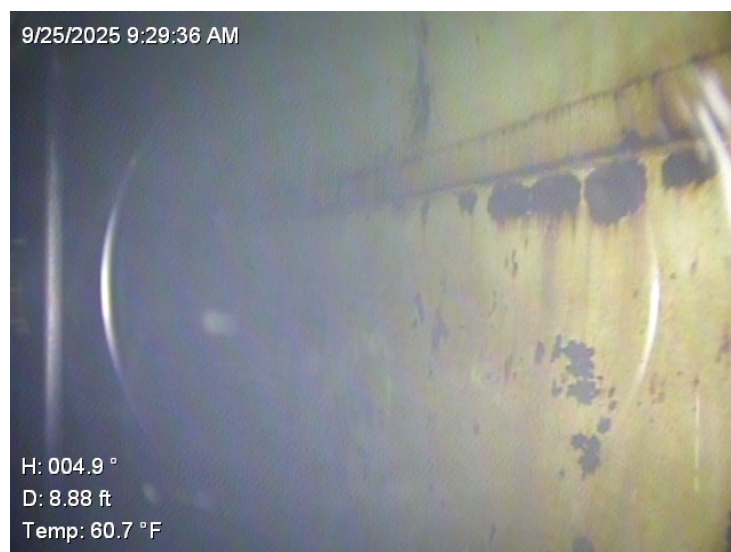
70) Same.
