FACILITY CONDITION ASSESSMENT

Lakeside Middle School
11000 Kenney Street
Norwalk, California 90650

159753.22R000-005.017

October 14, 2022

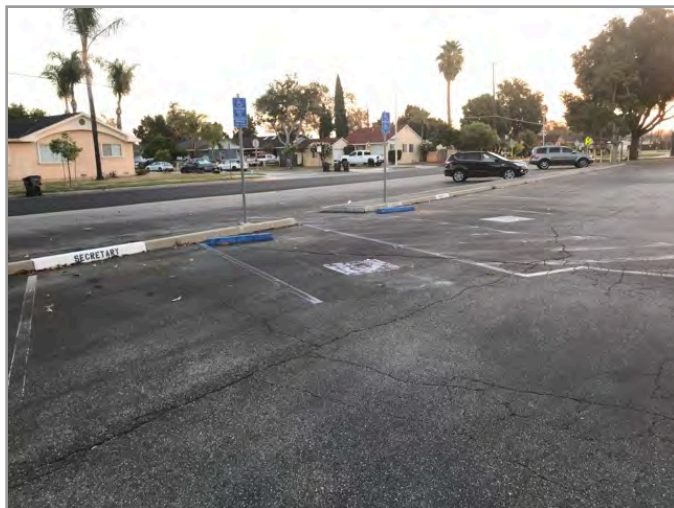
OVERVIEW OF ACCESSIBLE PARKING AREA

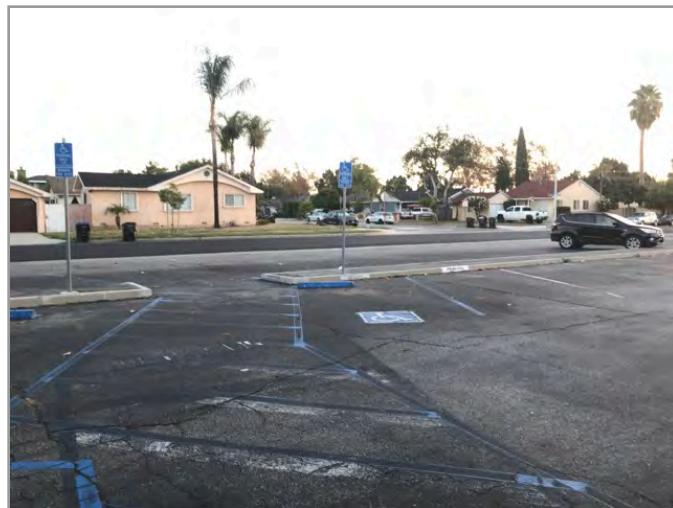
CLOSE-UP OF STALL

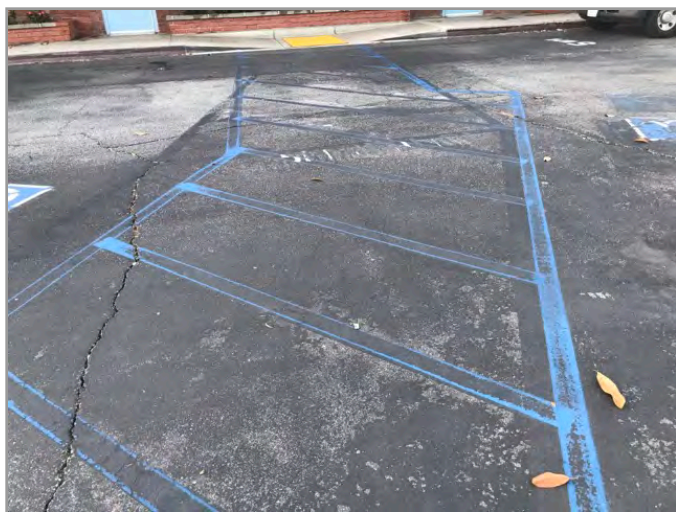
ACCESSIBLE PATH

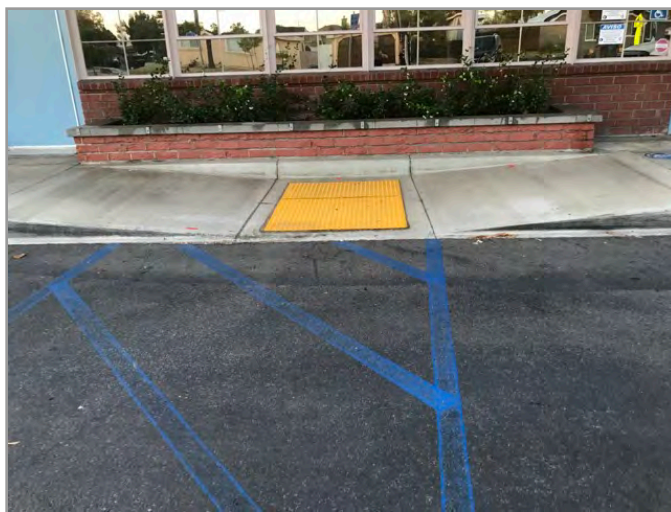
CURB CUT

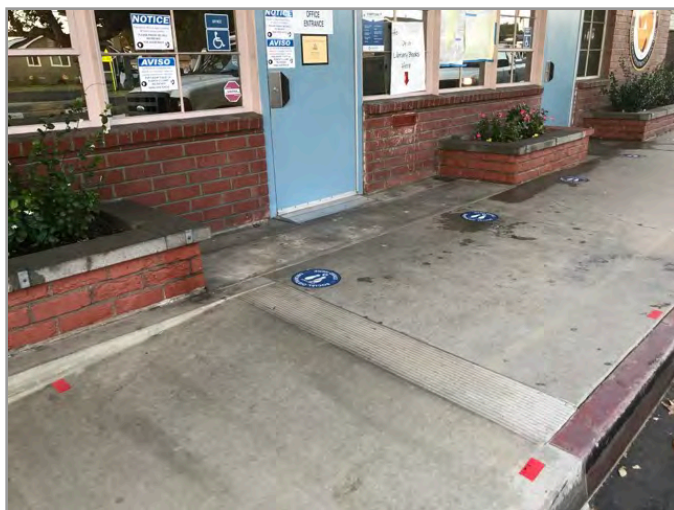
MAIN ENTRANCE

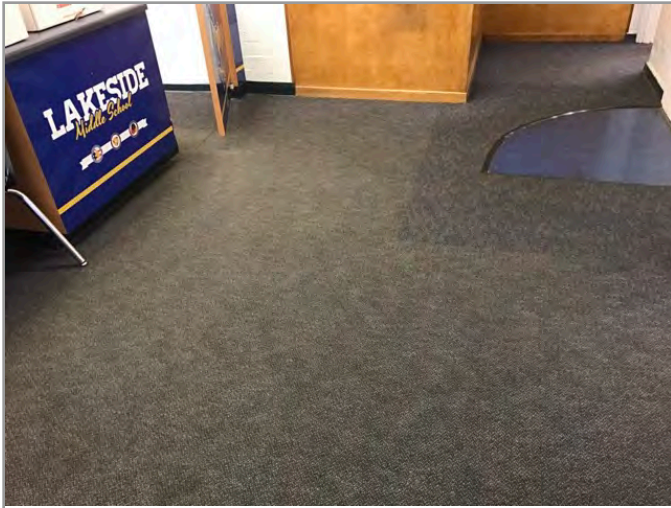
ACCESSIBLE INTERIOR PATH

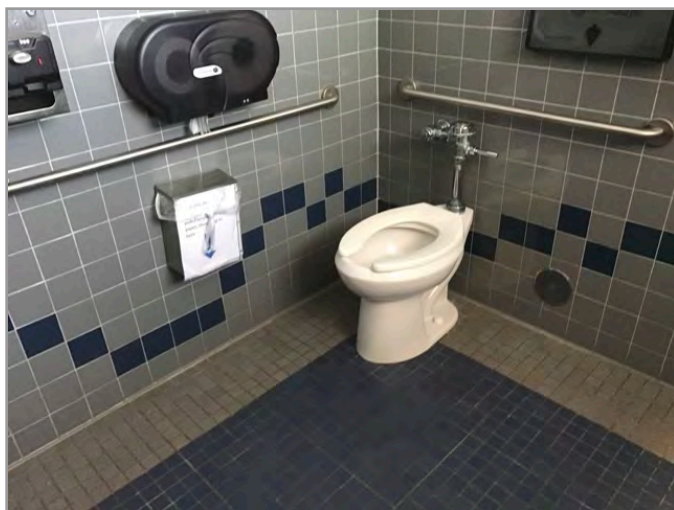
TOILET STALL OVERVIEW

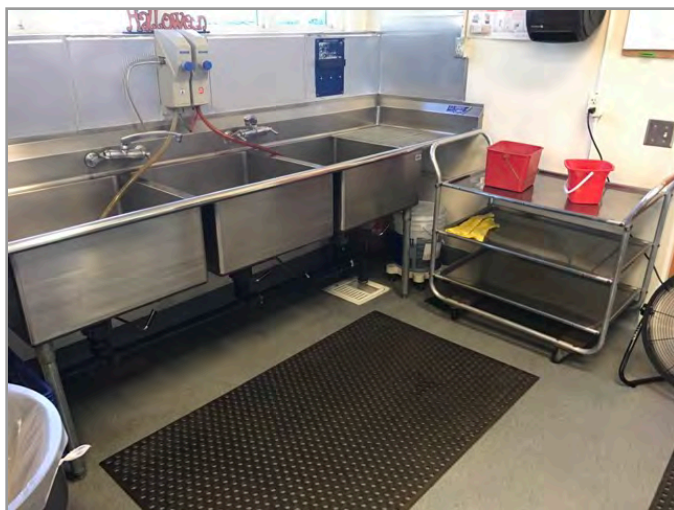
SINK CLEARANCE

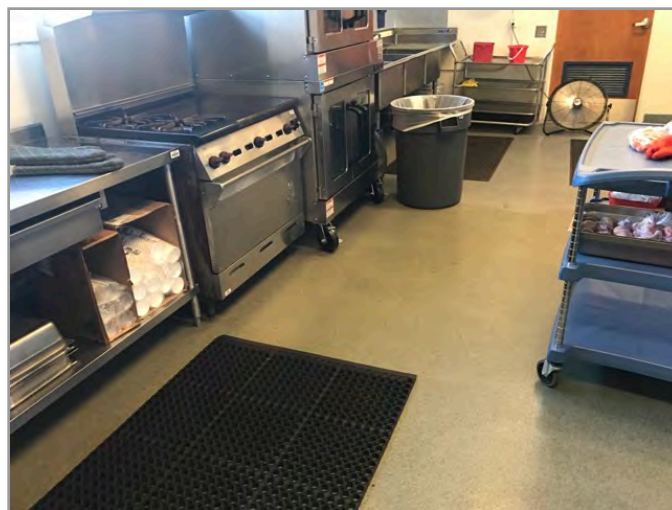
KITCHEN OVERVIEW

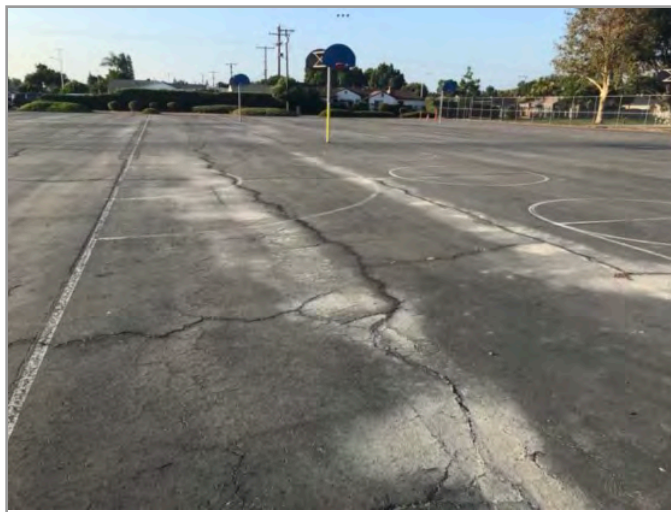
OVERVIEW OF PLAYGROUND
