FACILITY CONDITION ASSESSMENT

Manhattan Beach USD
325 South Peck Avenue
Manhattan Beach, CA 90266

Grand View Elementary School
455 24th Street
Manhattan Beach, CA 90266

June 14, 2024

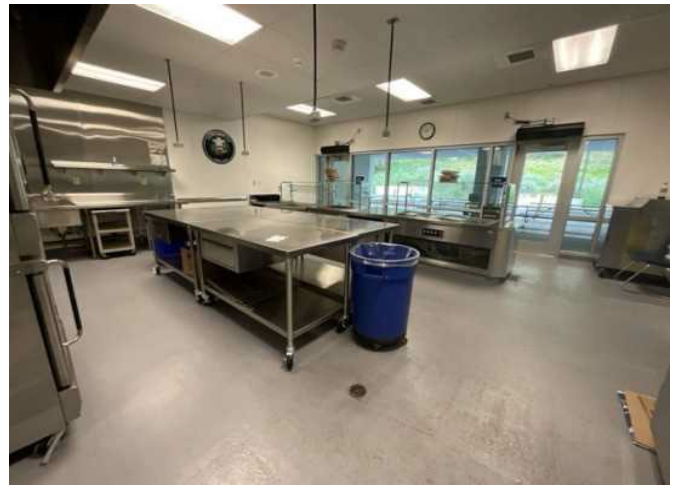
10 – KITCHEN

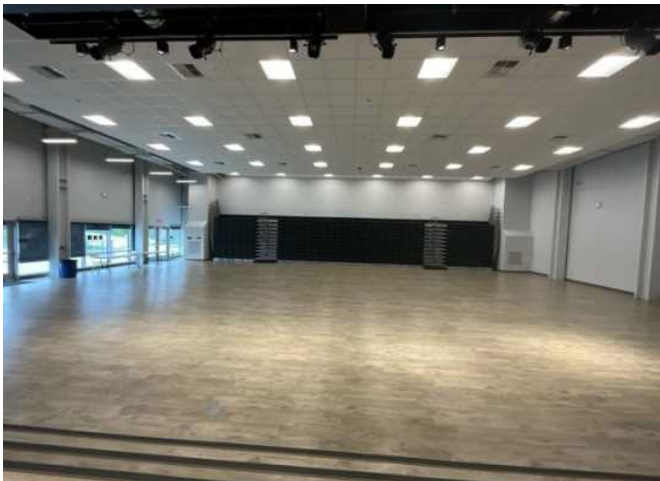
11 – FLOORING

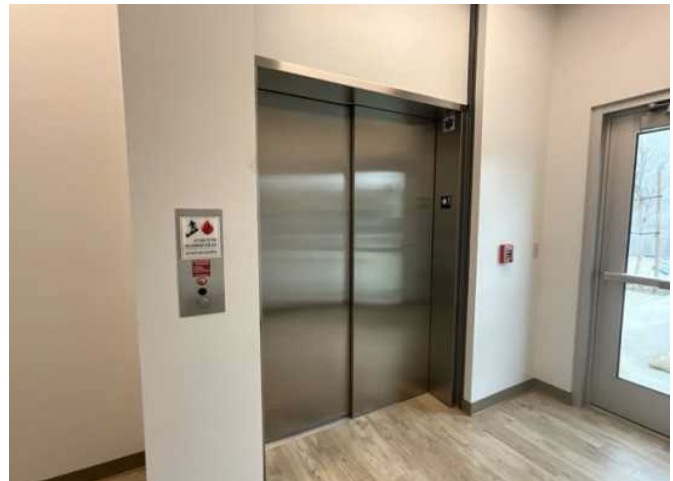
12 – ELEVATOR PHOTO

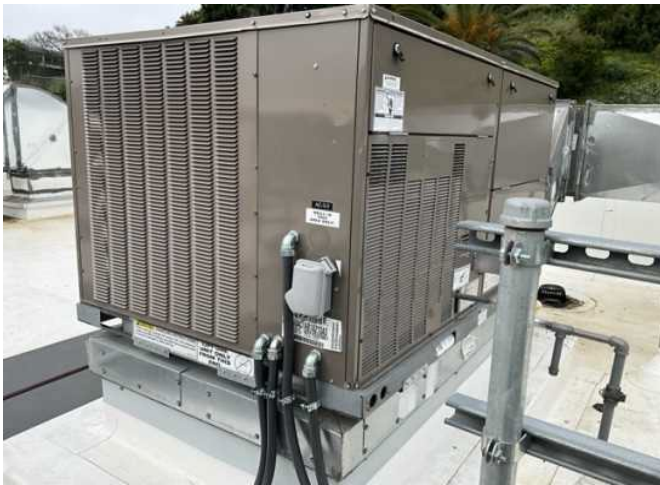
13 – ROOF TOP UNIT

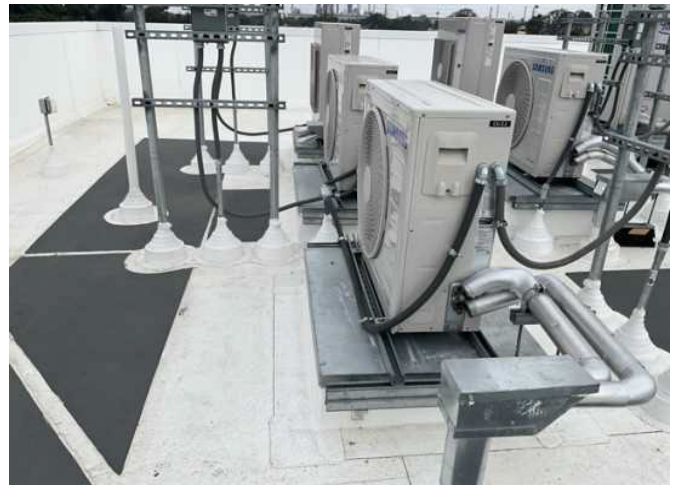
14 – HVAC SYSTEMS

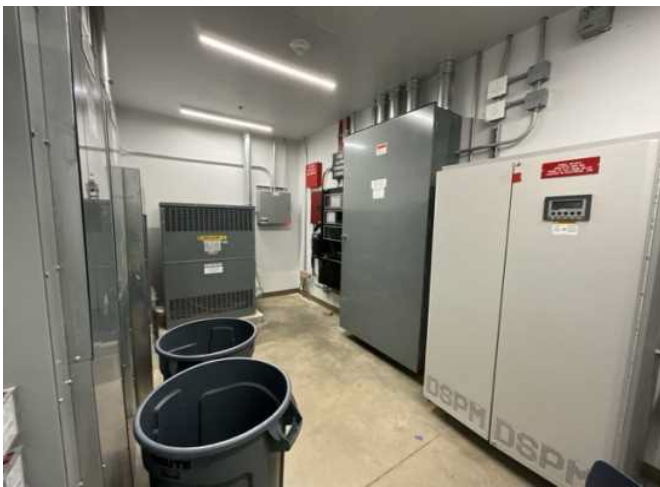
15 – ELECTRICAL ROOM

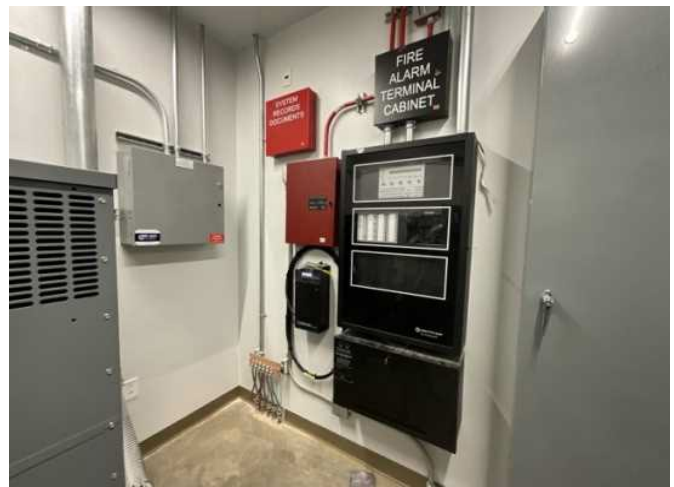
16 – FIRE ALARM / SECURITY

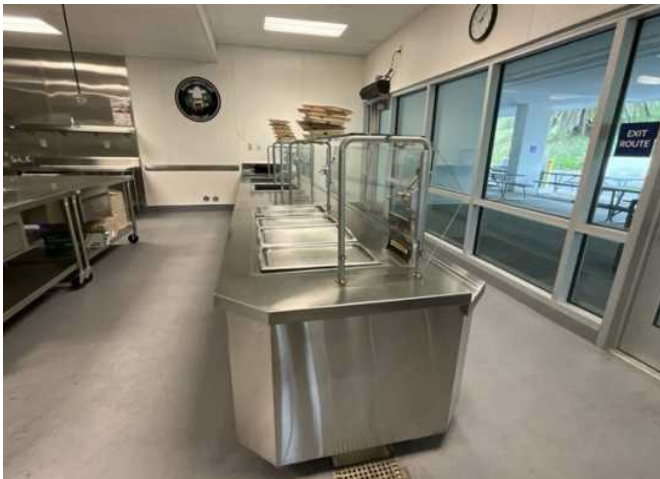
17 – COMMERCIAL KITCHEN

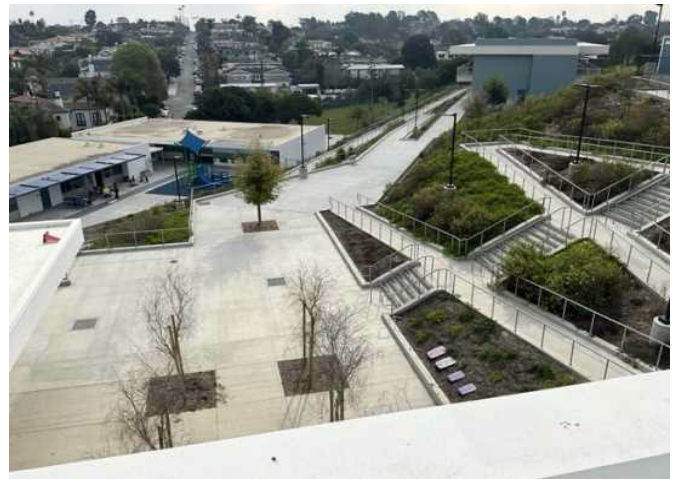
18 – SITE PHOTO

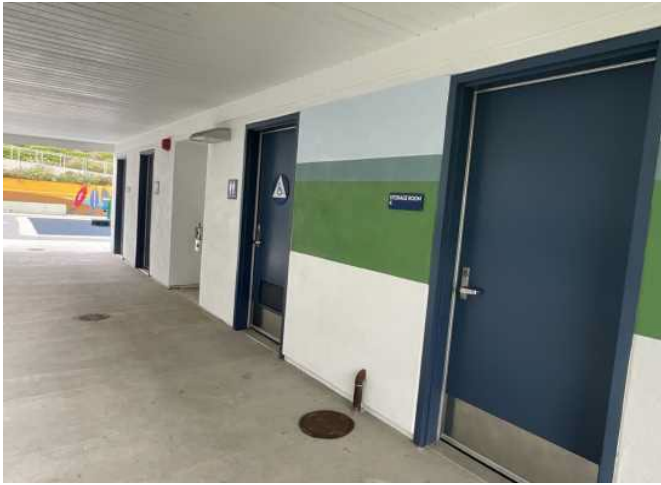
1 – LEFT ELEVATION

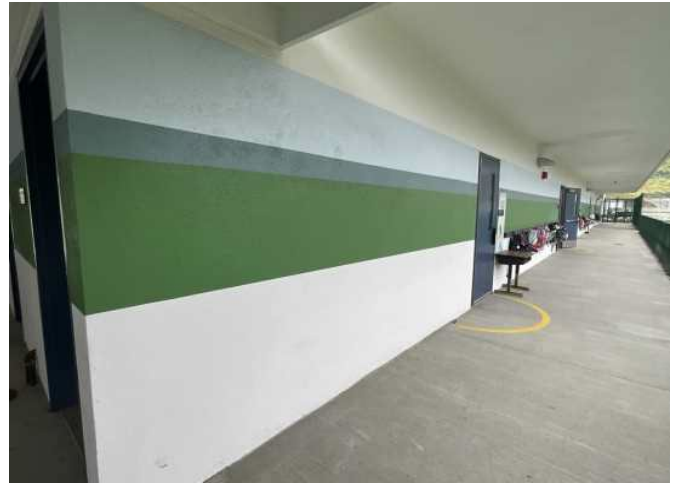
2 – REAR ELEVATION

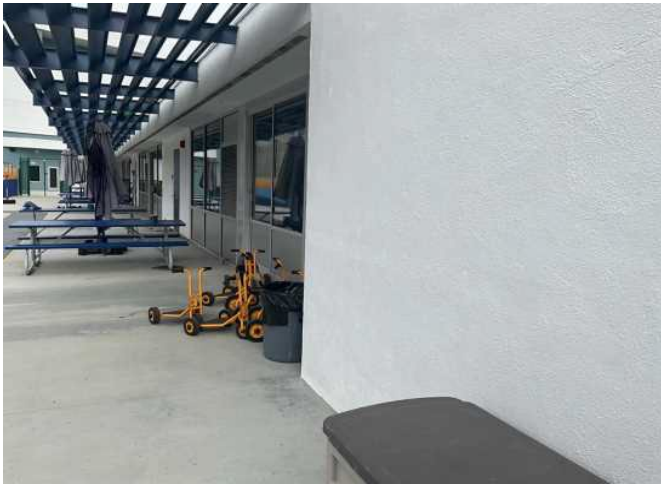
3 – RIGHT ELEVATION

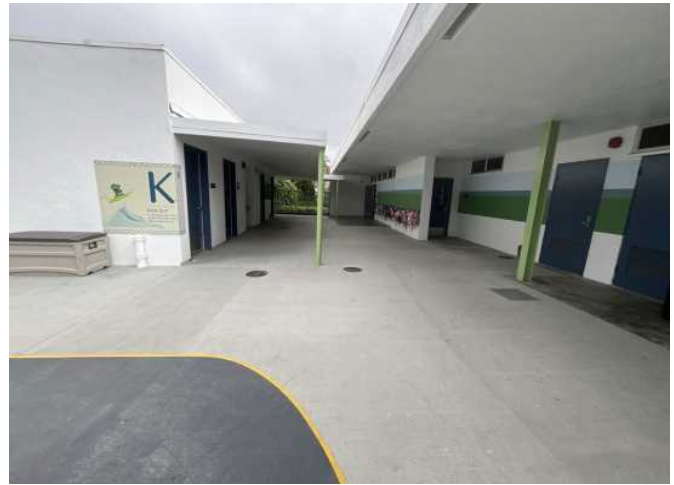
4 – EXTERIOR WALLS

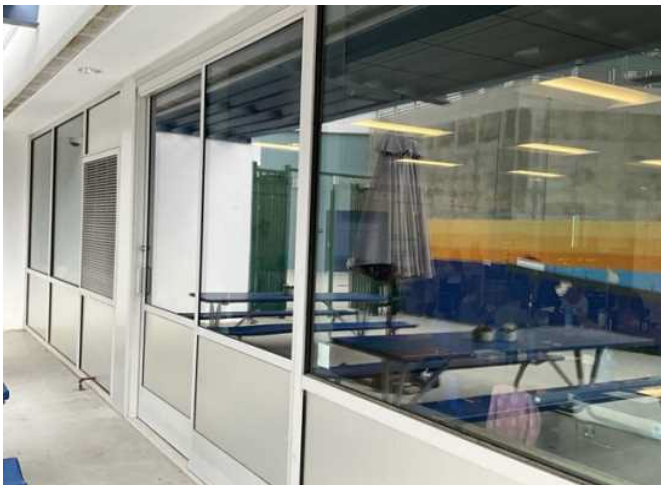
5 – STOREFRONT

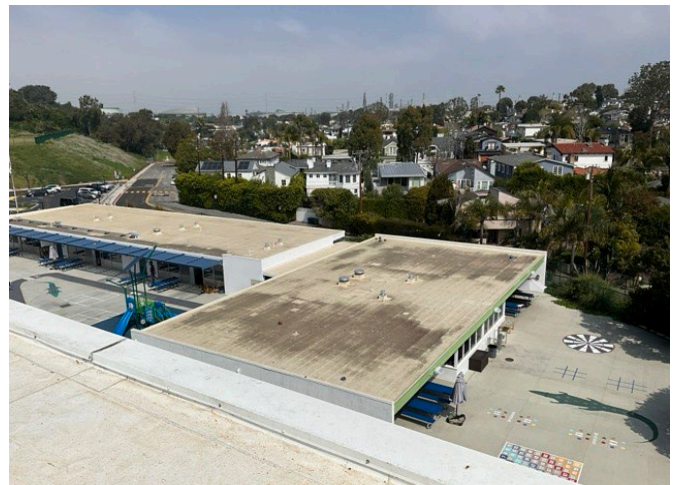
6 – ROOFING

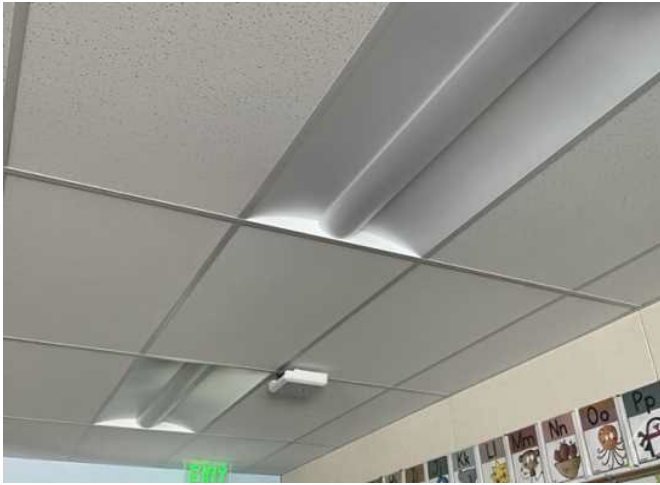
7 – SUSPENDED CEILINGS

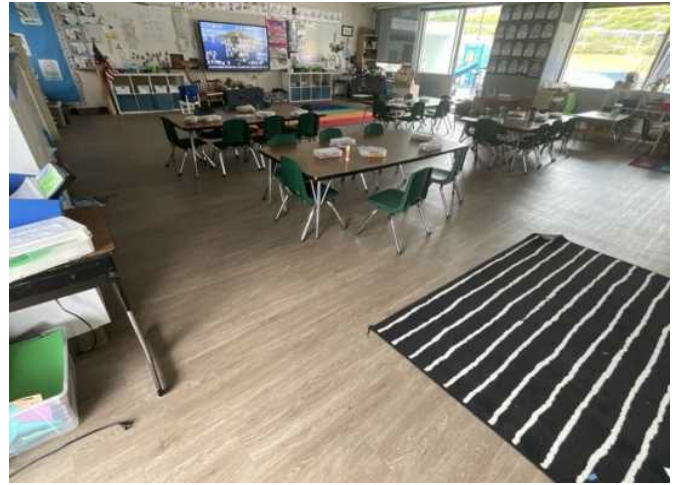
8 – FLOORING

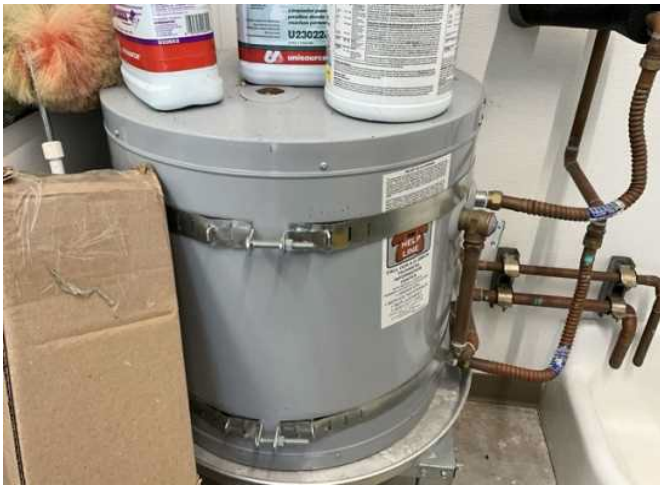
9 – WATER HEATER

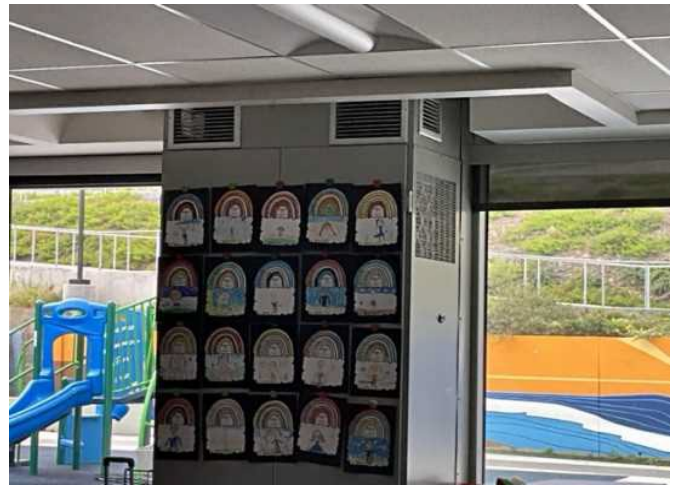
10 – HEAT PUMP

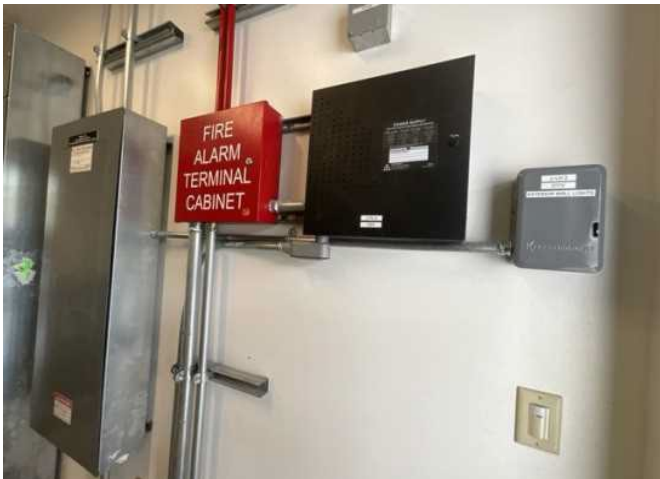
11 – FIRE ALARM SYSTEM

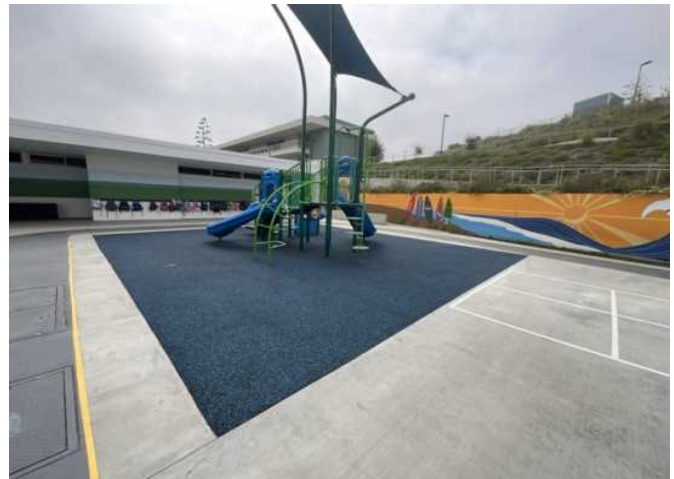
12 – SITE PHOTO

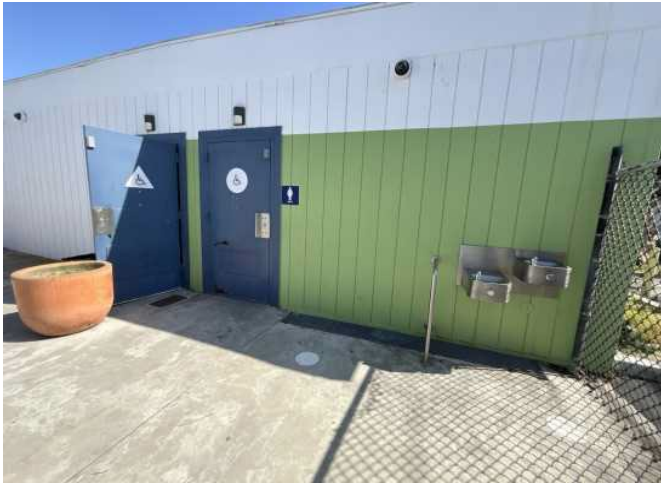
1 – LEFT ELEVATION

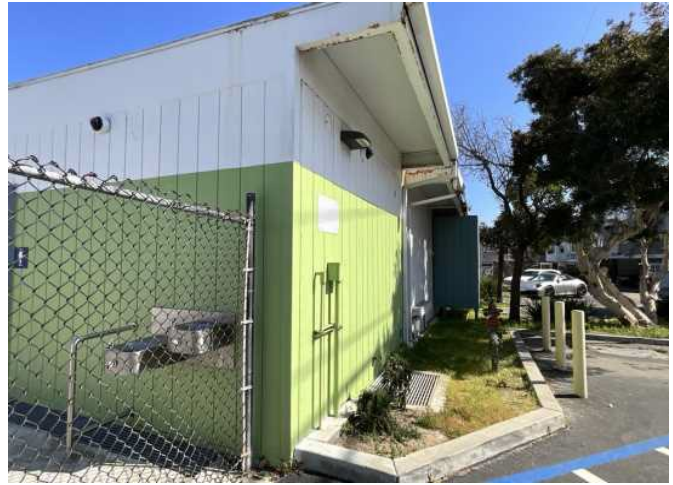
2 – REAR ELEVATION

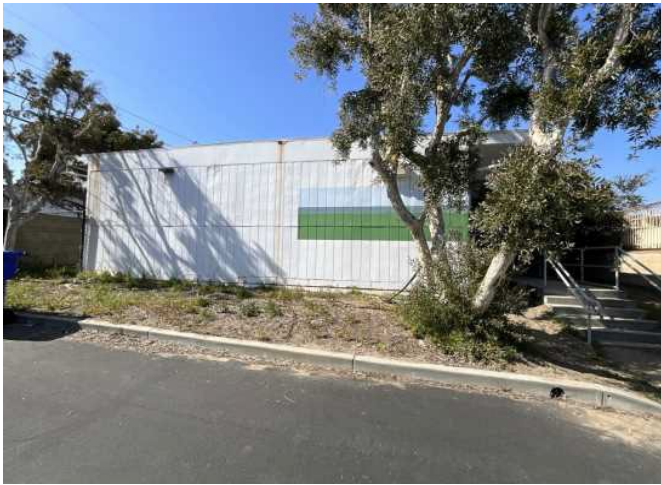
3 – RIGHT ELEVATION

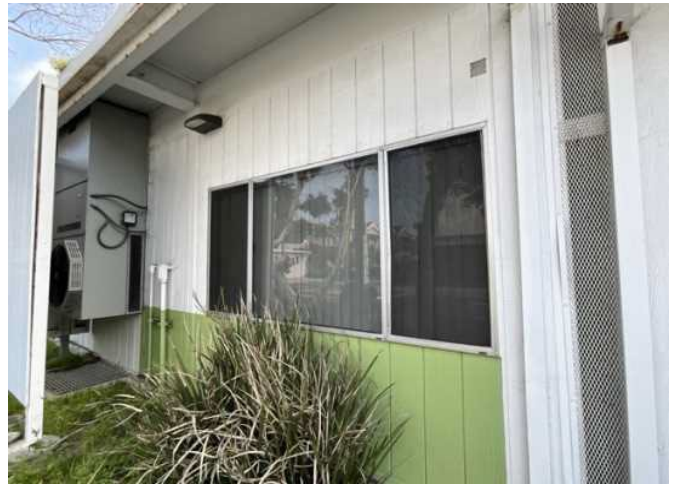
4 – EXTERIOR WINDOWS

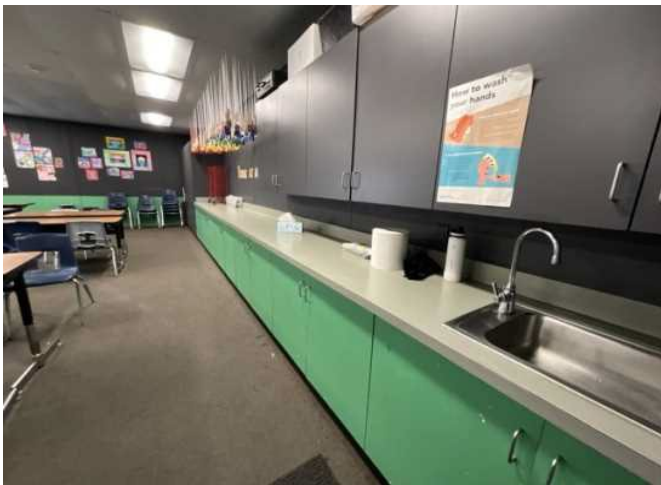
5 – CASEWORK

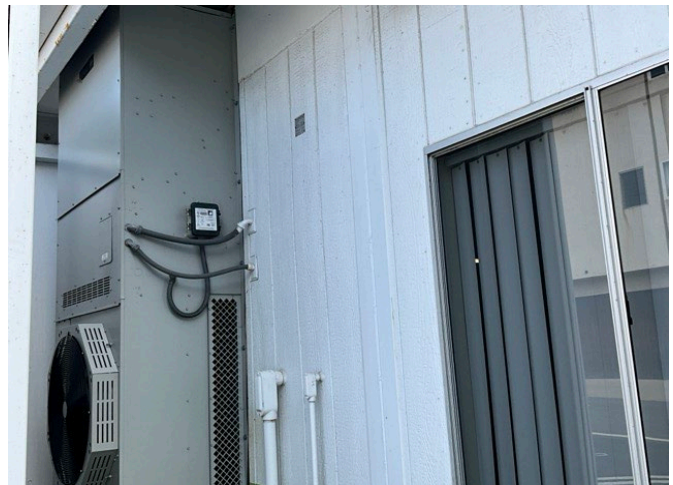
6 – HEAT PUMP

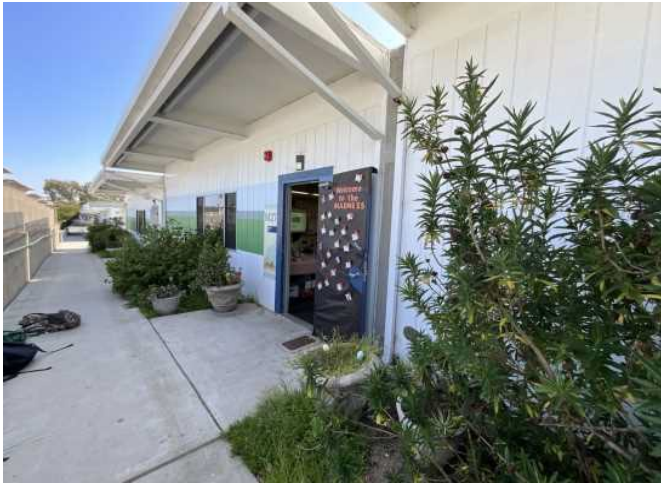
1 – FRONT ELEVATION

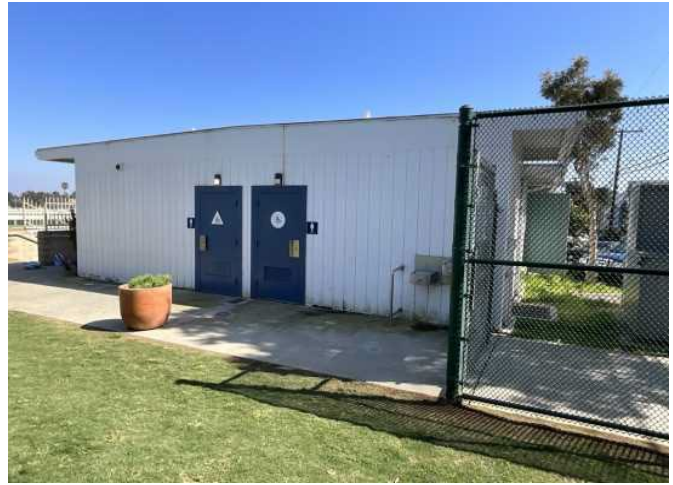
2 – LEFT ELEVATION

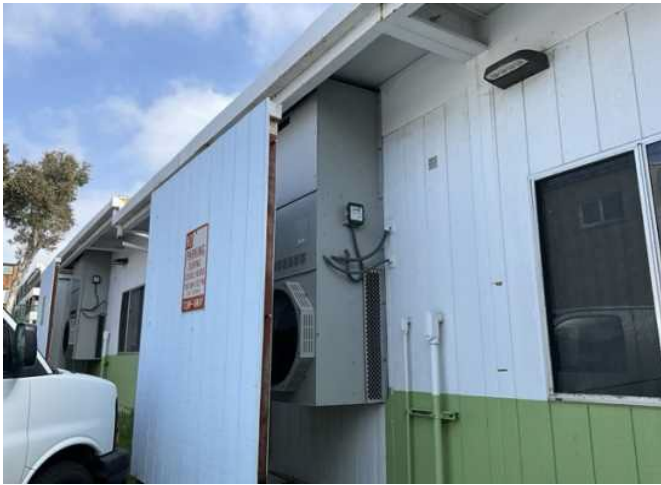
3 – WALL MOUNTED HEAT PUMP

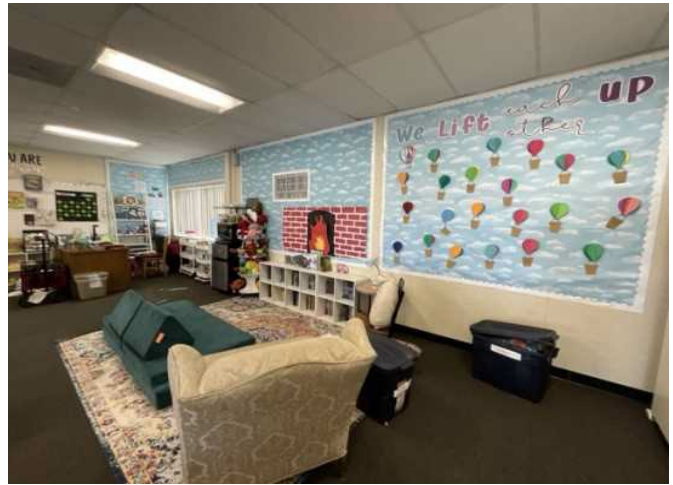
4 – WALL FINISHES

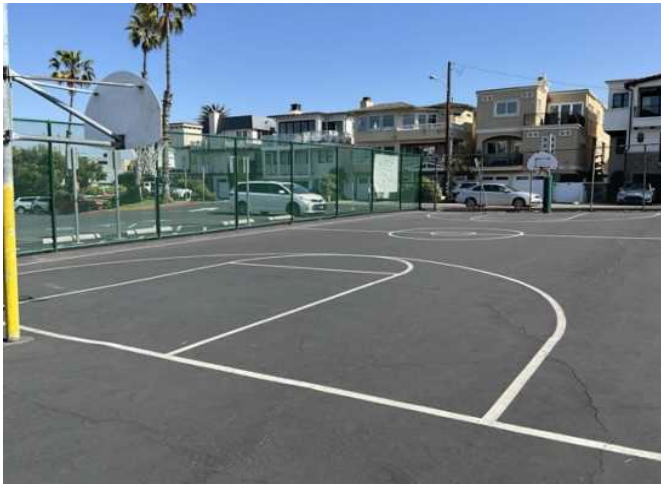
Athletic Surfaces & Courts in Poor condition.

Some areas on the asphalt pavement between buildings C, B, and A pose a potential hazard due to significant signs of deterioration, including alligator cracking, transverse cracking, extensive raveling, and localized depressions. - AssetCALC ID: 7472497

3 – BASKETBALL COURT

Uniformat Code: G2050
Recommendation: **Seal & Stripe in 2024**

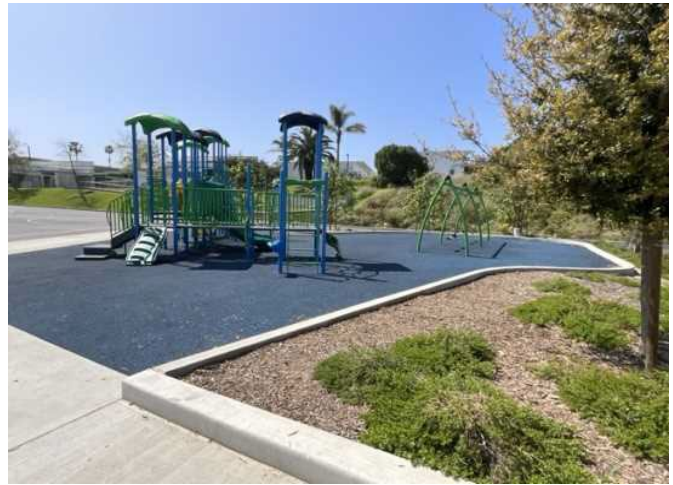
4 – PLAY GROUND

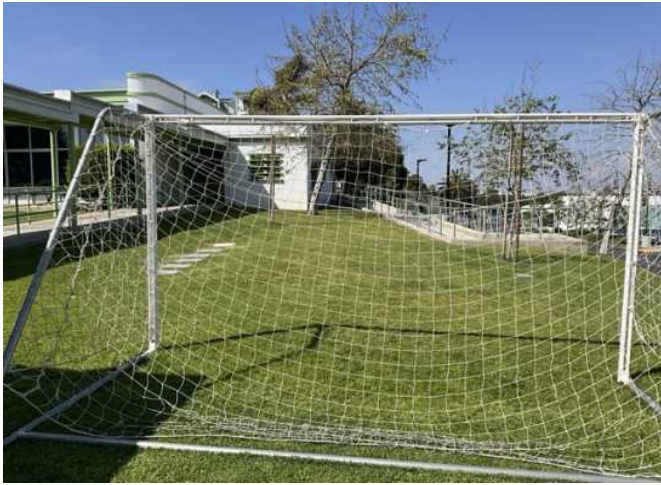
13 – SPORTS APPARATUS

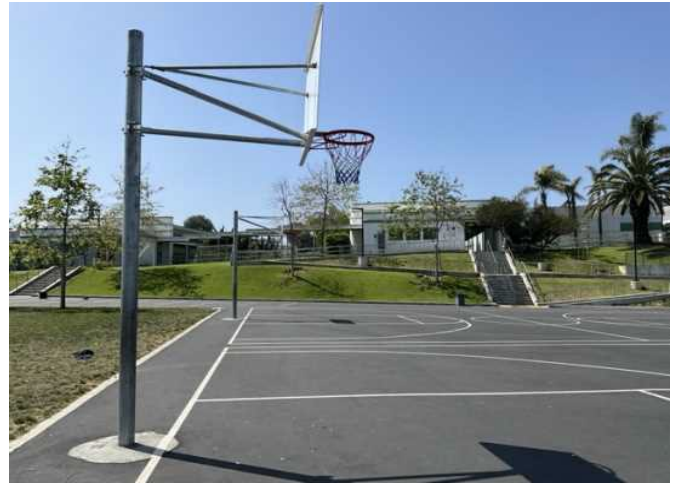
14 – SPORTS APPARATUS

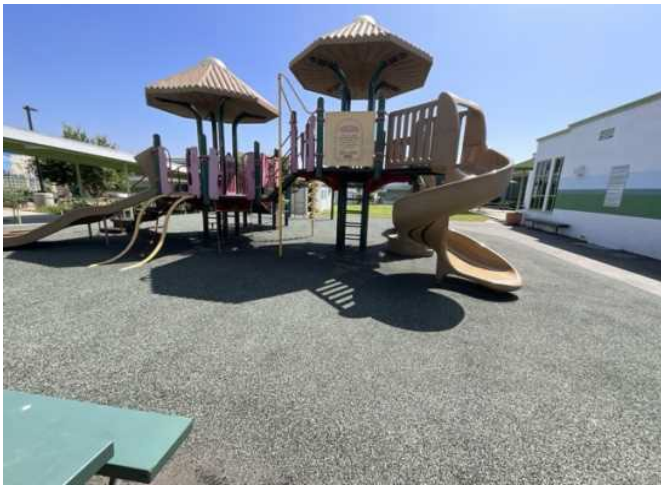
15 – PLAY STRUCTURE

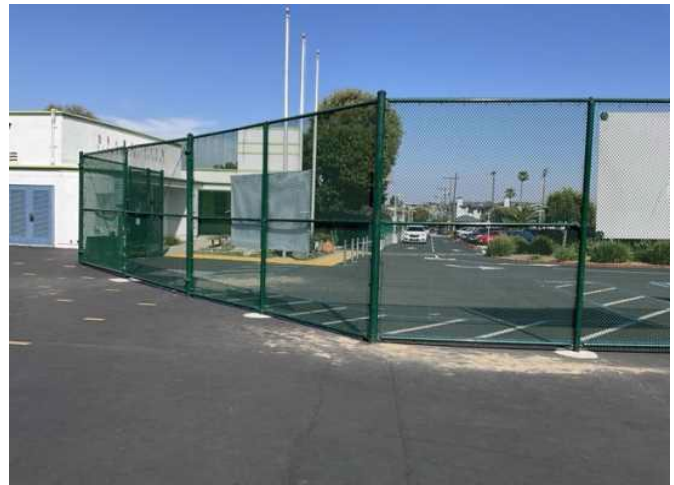
Fences & Gates in Poor condition.

The fences are corroded and at the end of their lifespan. - AssetCALC ID: 7471374

16 – FENCES AND GATES

Uniformat Code: G2060
Recommendation: **Replace in 2024**

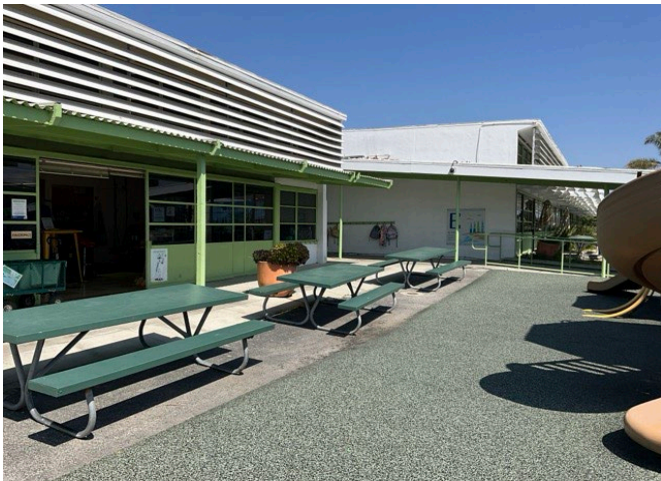
17 – PICNIC TABLE

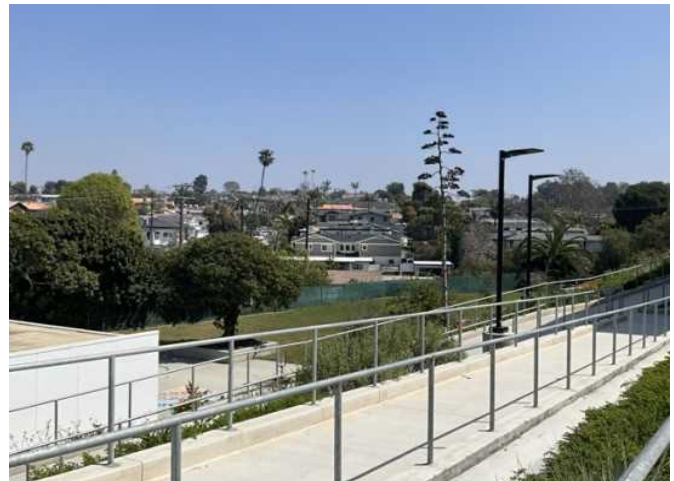
18 – POLE LIGHT FIXTURE W/ LAMPS

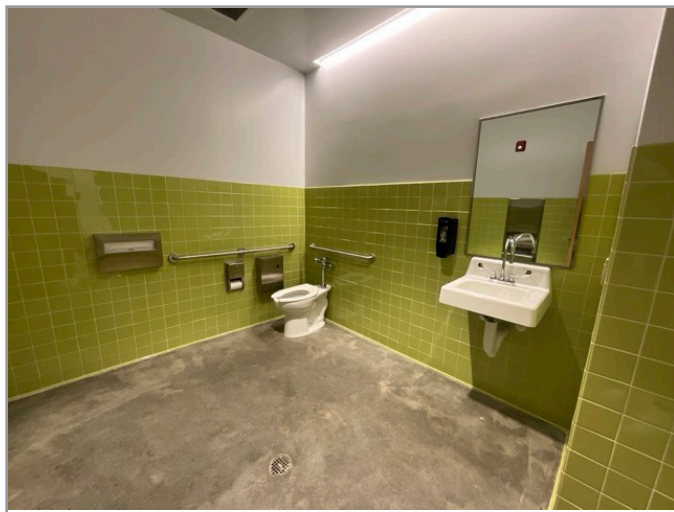
RESTROOM ACCESSORIES

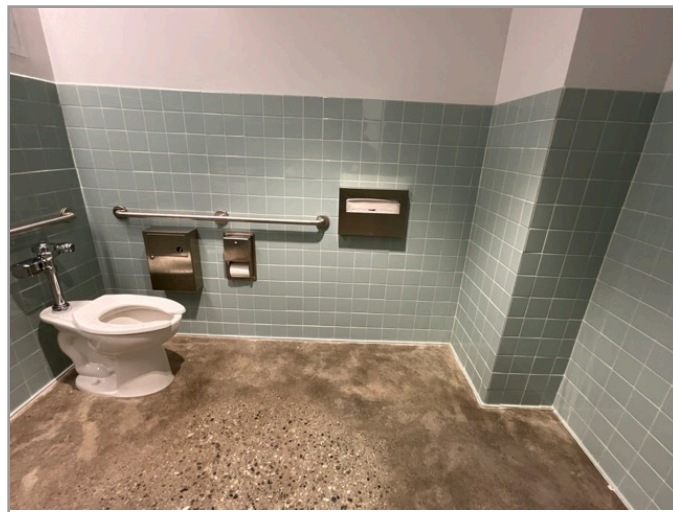
TOILET STALL OVERVIEW

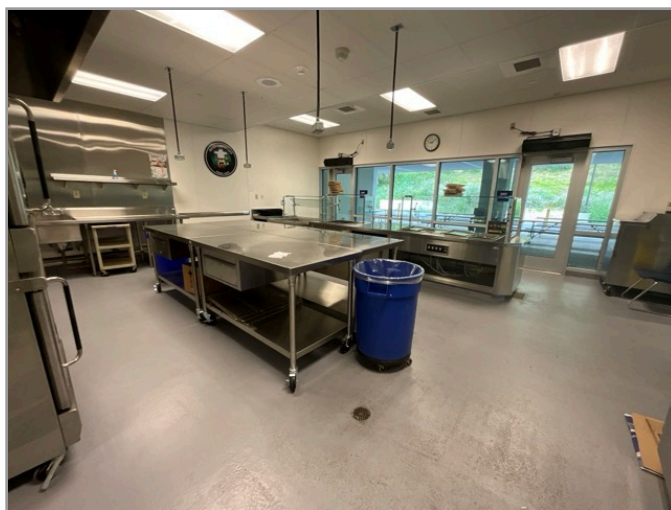
KITCHEN PATH OF TRAVEL

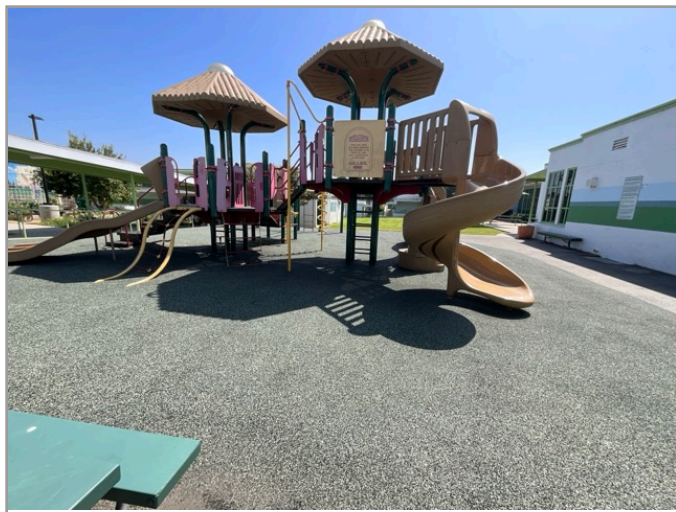
OVERVIEW OF PLAYGROUND

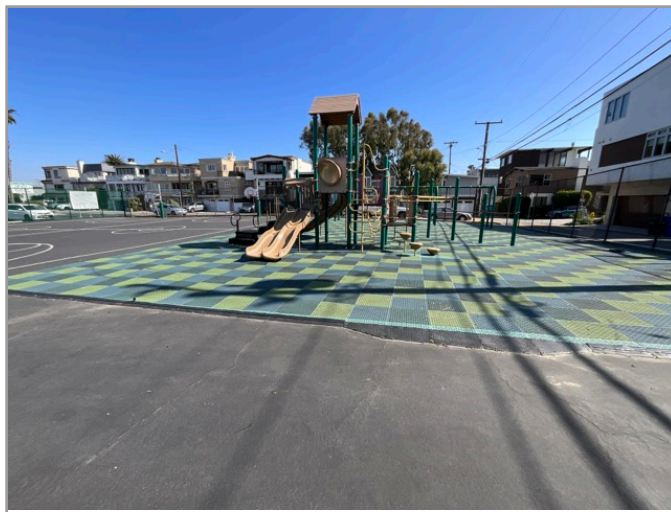
ACCESSIBLE ROUTE TO PLAYGROUND
