Executive Summary

Engineer's Foundation Evaluation

123 Sample Address, Your City, TX, 12345

On 4/1/2024 a foundation evaluation was performed at the property located at address 123 Sample Address, Your City, TX, 12345, which consists of a 2042 square-foot single family attached structure built in 2005 with a slab on grade foundation.

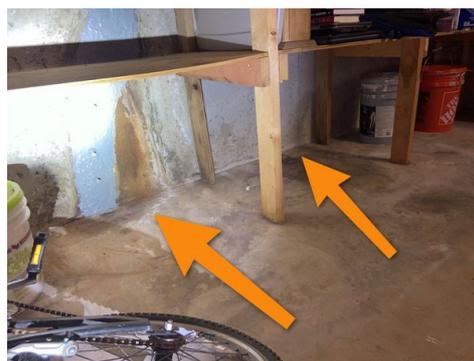
Basement walls and floor indicating standing water

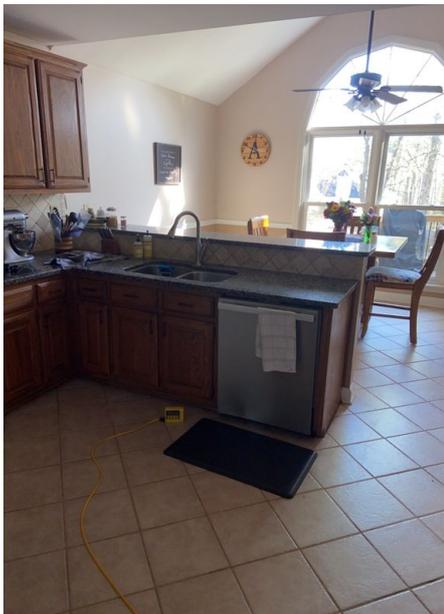
Kitchen & Nook: Front of sink elevation & photo

Kitchen
-0.1 inches

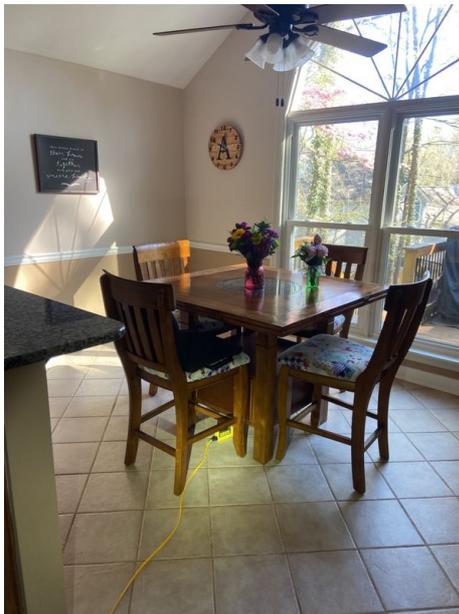
Kitchen & Nook: Middle of nook elevation & photo

Kitchen Nook
0 inches

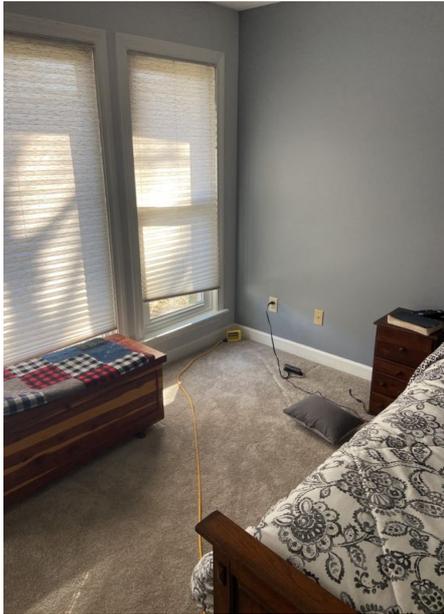
Primary Bedroom: Back-right elevation & photo

Primary Bedroom
0.4 inches

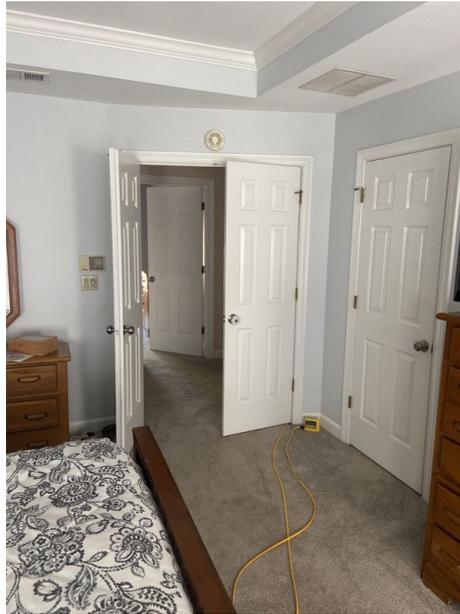
Primary Bedroom: Front-left elevation & photo

Primary Bedroom
0 inches

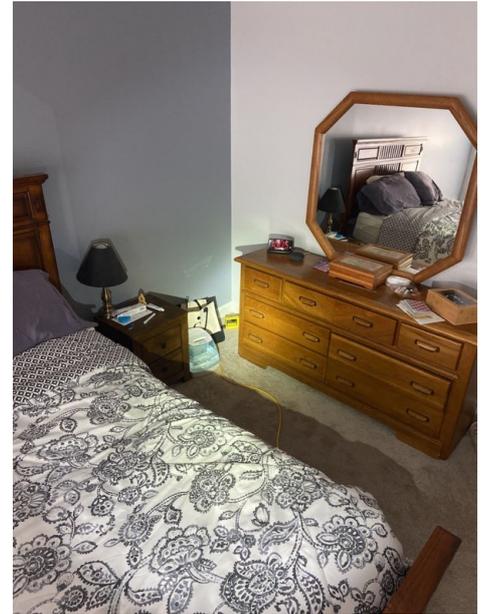
Primary Bedroom: Front-right elevation & photo

Primary Bedroom
0.2 inches

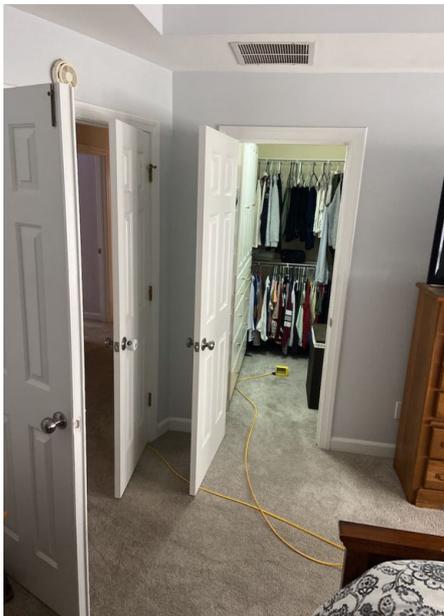
Primary Bedroom: Primary closet elevation 1 & photo

Primary Closet
0 inches

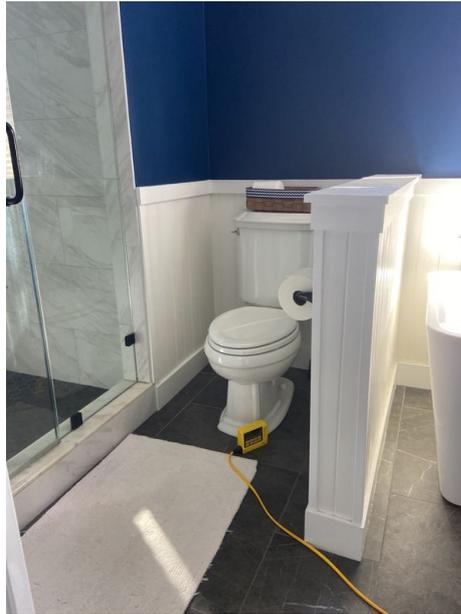
Primary Bathroom: Front of toilet elevation & photo

Primary Bathroom
-0.3 inches

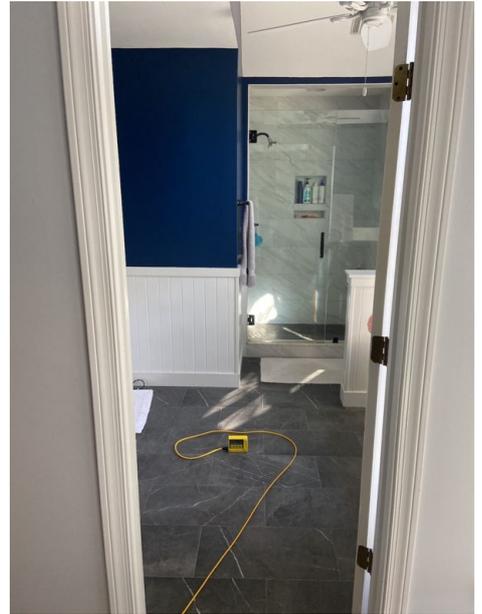
Primary Bathroom: Middle room elevation & photo

Primary Bathroom
-0.7 inches

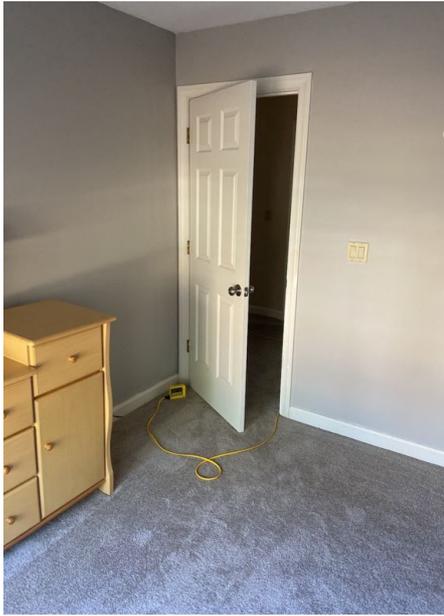
Bedroom: Back-left elevation & photo

Bedroom
0.2 inches

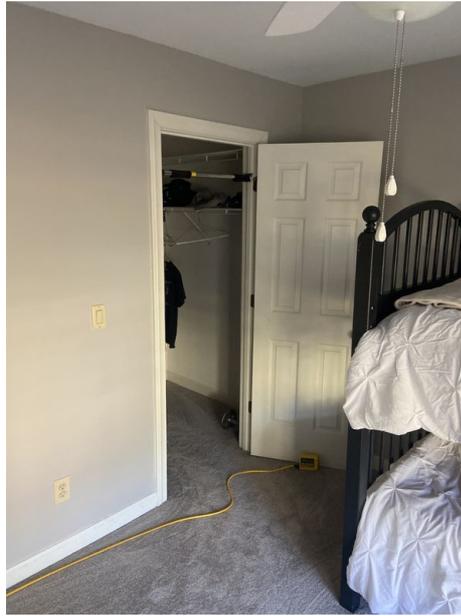
Bedroom: Back-right elevation & photo

Bedroom
0.3 inches

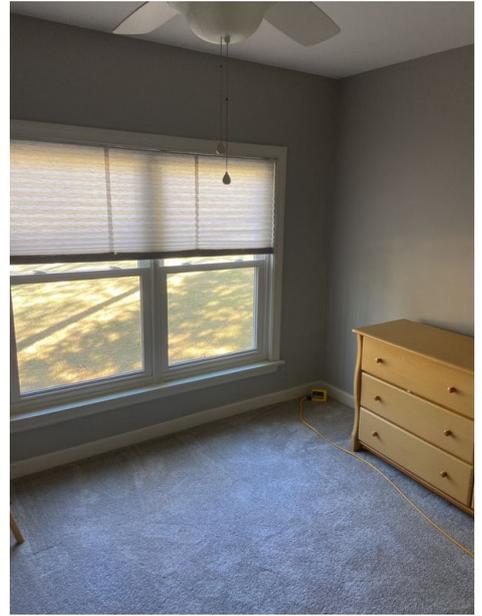
Bedroom: Front-left elevation & photo

Bedroom
0.4 inches

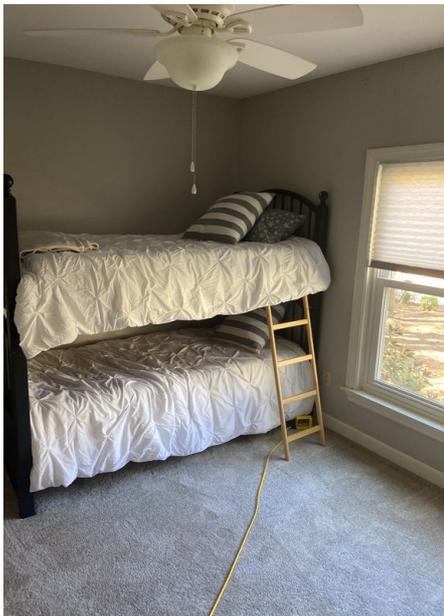
Bedroom: Front-right elevation & photo

Bedroom
0.4 inches

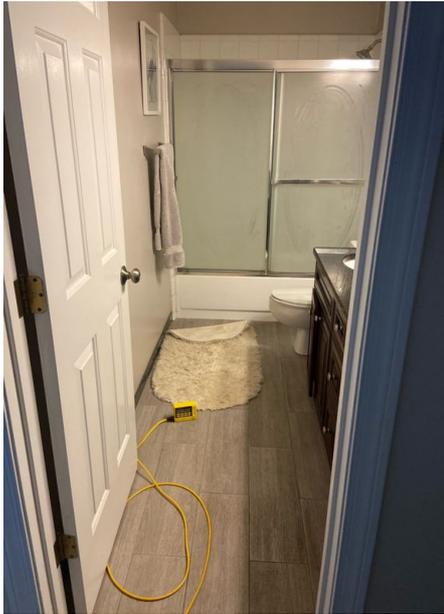
Bathroom: Mid-room elevation & photo

Bathroom
-0.2 inches

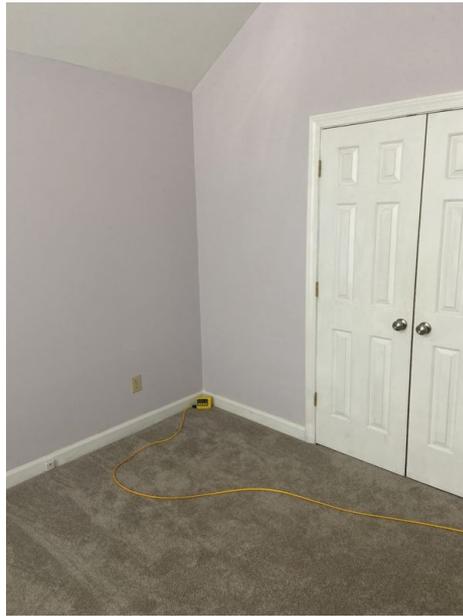
Bedroom: Back-left elevation & photo

0.2

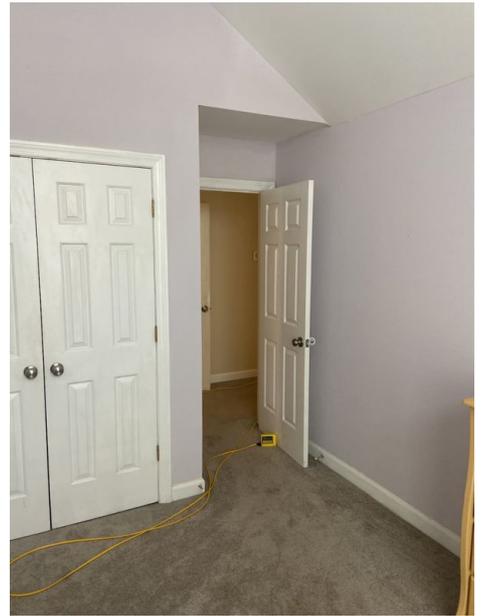
Bedroom: Back-right elevation & photo

0.2

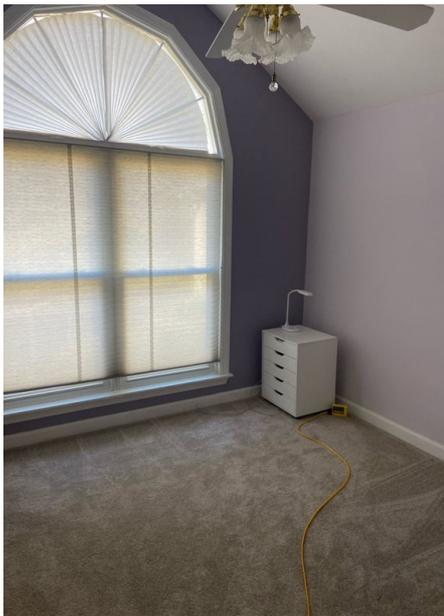
Bedroom: Front-left elevation & photo

0.4

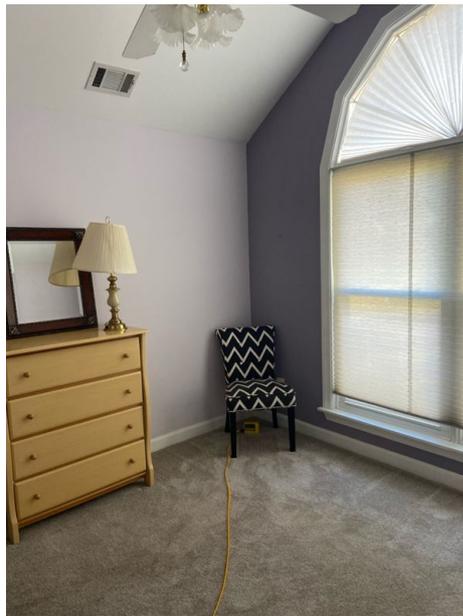
Bedroom: Front-right elevation & photo

0.2

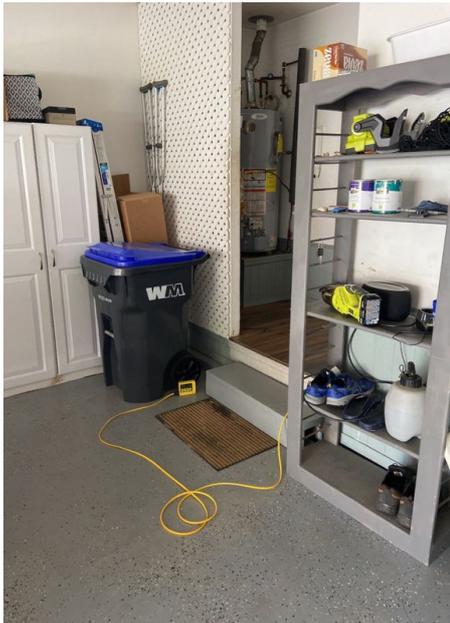
Garage: Back-right elevation & photo

Garage

-13.2 inches

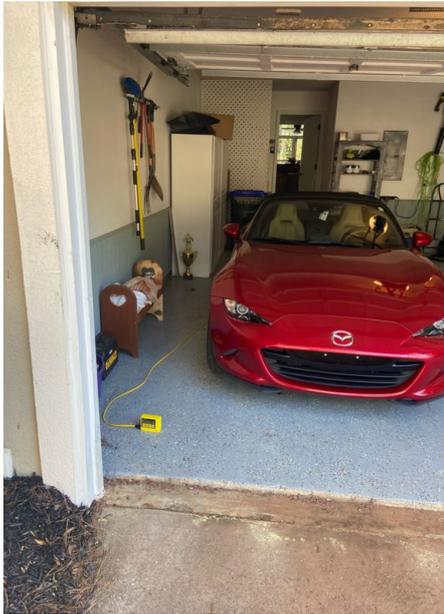
Garage: Front-left elevation & photo

Garage
-14.8 inches

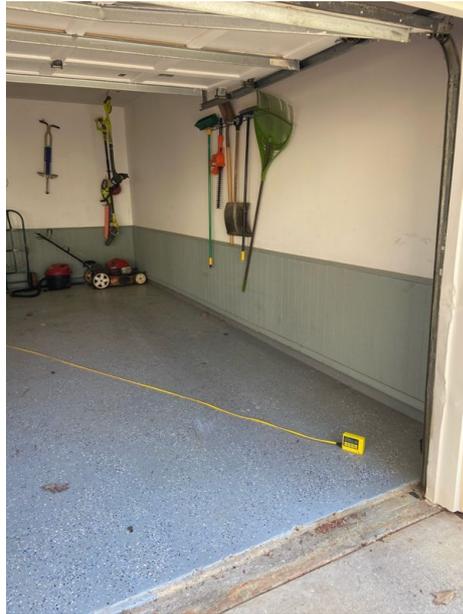
Garage: Front-right elevation & photo

Garage
-14.8 inches

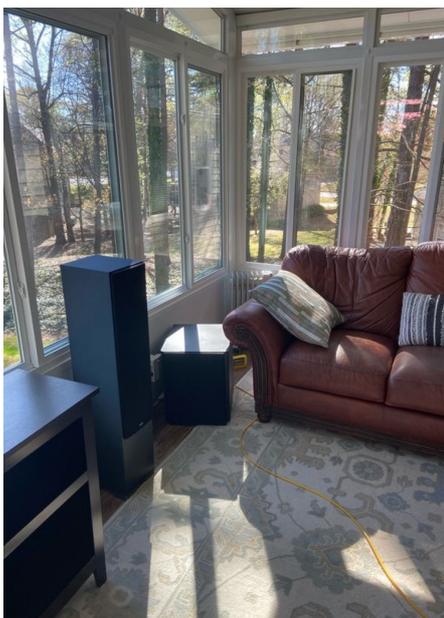
Sunroom: Room elevation 2 & photo

-0.3

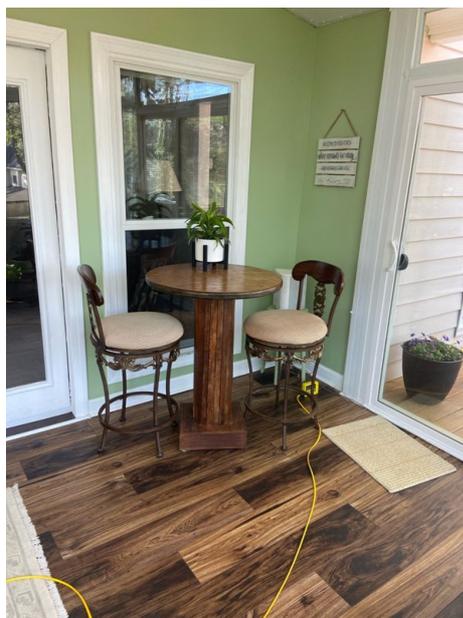
Sunroom: Room elevation 3 & photo

-0.3

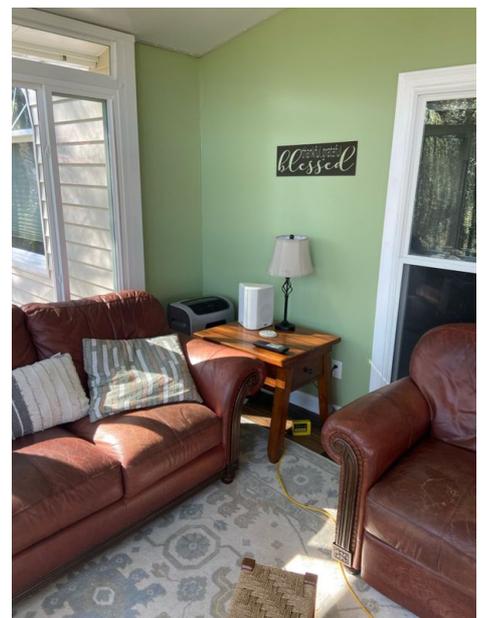
Sunroom: Room elevation 4 & photo

-0.5

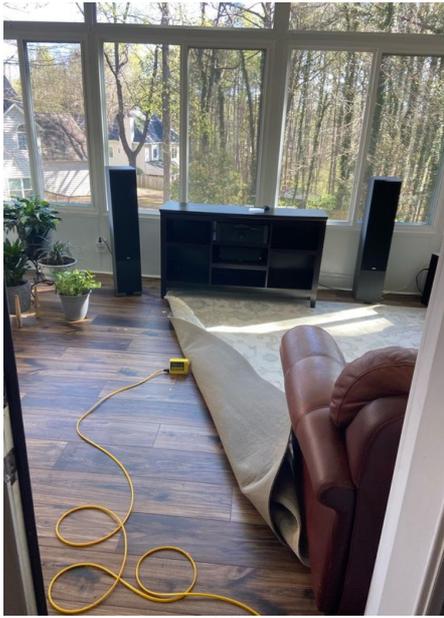
Sunroom: Room elevation 5 & photo

-0.4
