SLS Home Inspections

Property Inspection Report

, Bourbonnais, IL 60914
Inspection prepared for:
Real Estate Agent: -

Date of Inspection: 5/7/2025 Time: 4:00 PM
Age of Home: 1979 Size: 2292

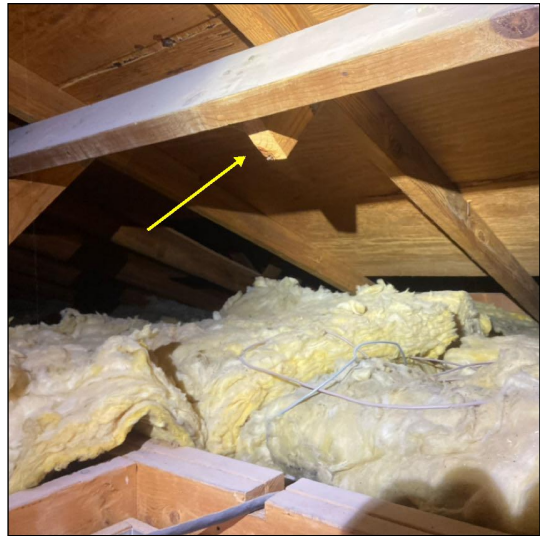
Page 17 Item: 5	Roof Framing Condition	<ul style="list-style-type: none">There are cut, modified or altered truss structural framing members. Truss framing is specifically engineered and should not be cut, modified or altered without the direction of a qualified design professional such as a structural engineer. This inspection cannot determine if these modifications were done under the watchful eye of a design professional. Evaluation is recommended by a design professional to determine if this poses any structural problems and/or to design a corrective solution. If correction is needed based on the design professional's opinion, corrective repair should be performed by a qualified contractor.
-----------------	------------------------	--

Cut truss

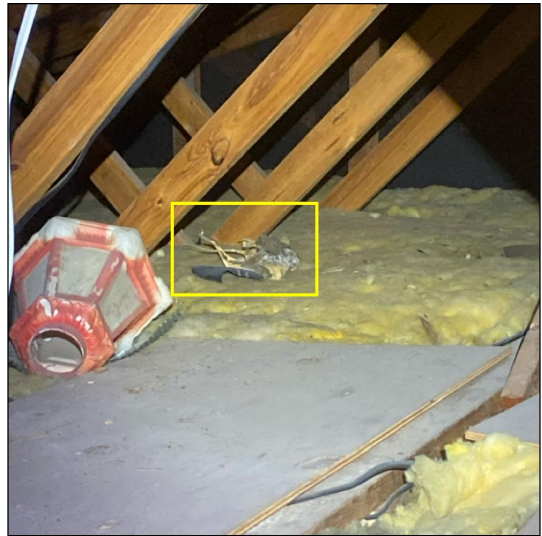
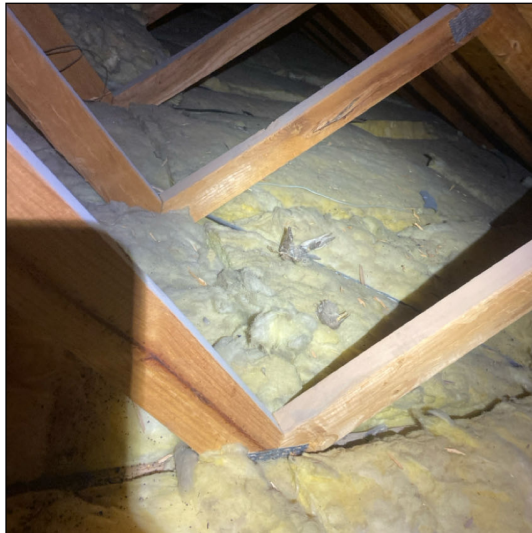
Dead birds in attic

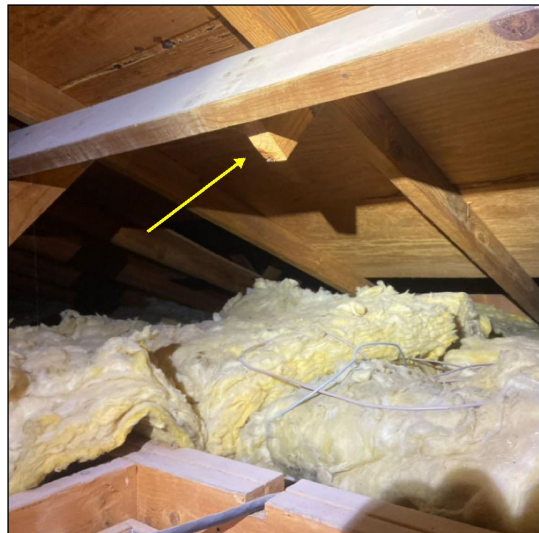
Cut truss

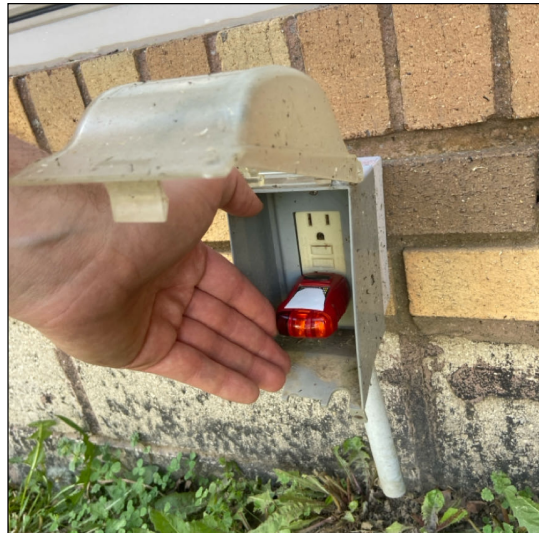
GFCI did not trip

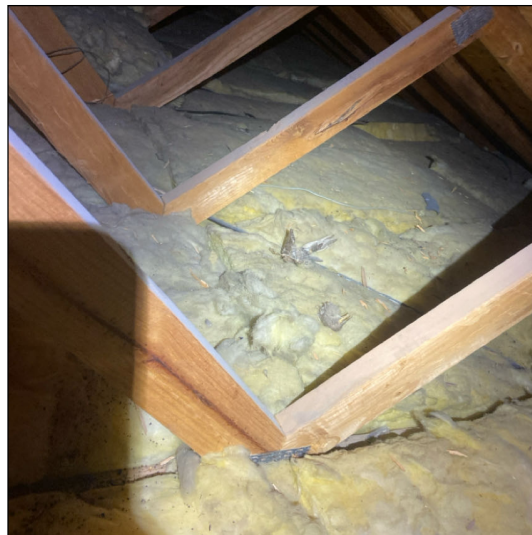
Dead birds in attic
