SBC Property Inspections

Condition and Status Report 123 Nightcliff Beach Drive, Nightcliff

Re: Building Condition Report for 123 Nightcliff Beach Drive, Nightcliff
Purchasers: S & B Summers

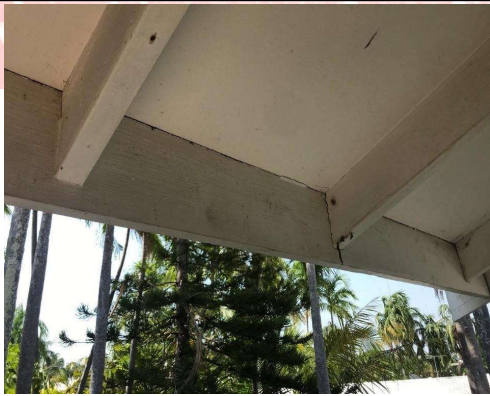
Minor movement in the fascia above B1 landing, this is common for the age of the building,

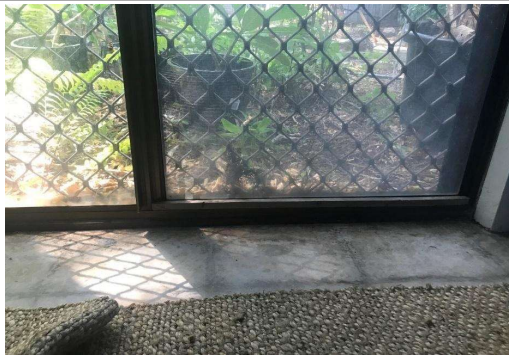
Ground level outside of B2 sliding door is higher than the floor level,

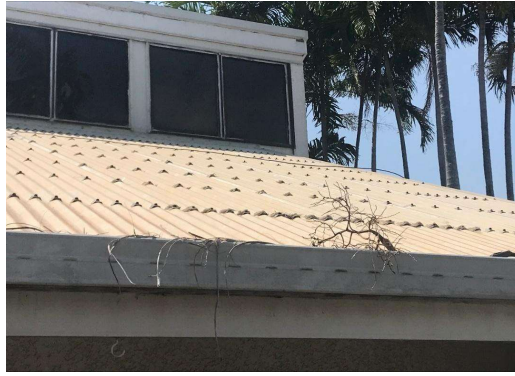
Gutters have a build leaf letter and require cleaning,

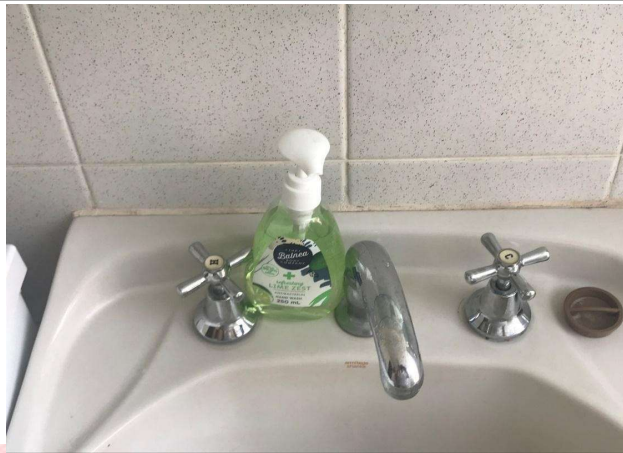
Bathroom / Laundry basin requires re sealing,

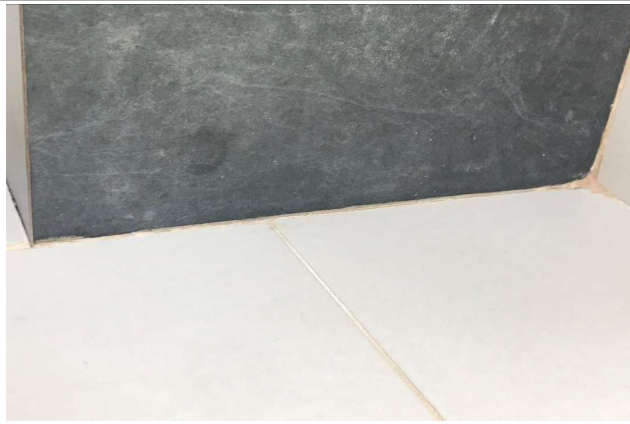
Esuite join between vanity bench and wall tiles requires sealing,
