# Condition Report

## 123 Nightcliff Beach Drive, Nightcliff

### **Re: Building Condition Report for 123 Nightcliff Beach Drive, Nightcliff Purchasers: S & B Summers**

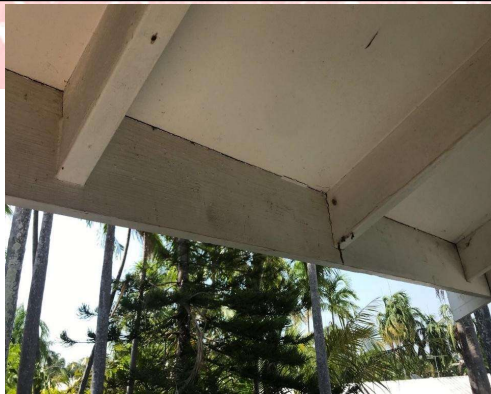
Minor movement in the fascia above B1 landing, this is common for the age of the building,

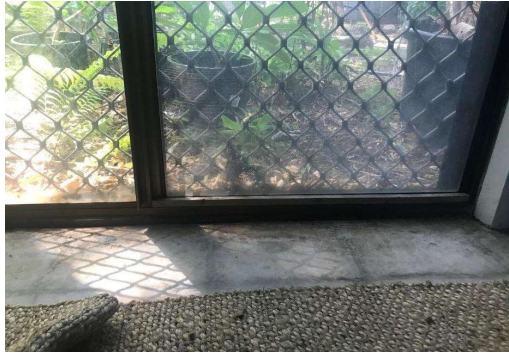
Ground level outside of B2 sliding door is higher than the floor level,

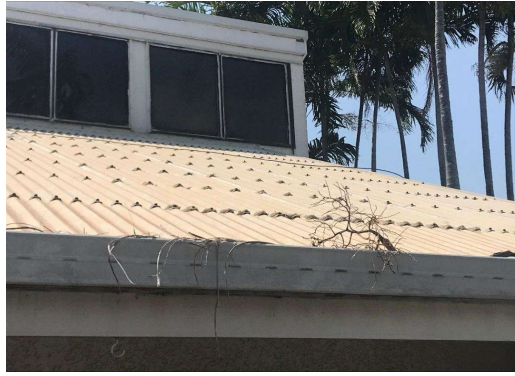
Gutters have a build leaf letter and require cleaning,

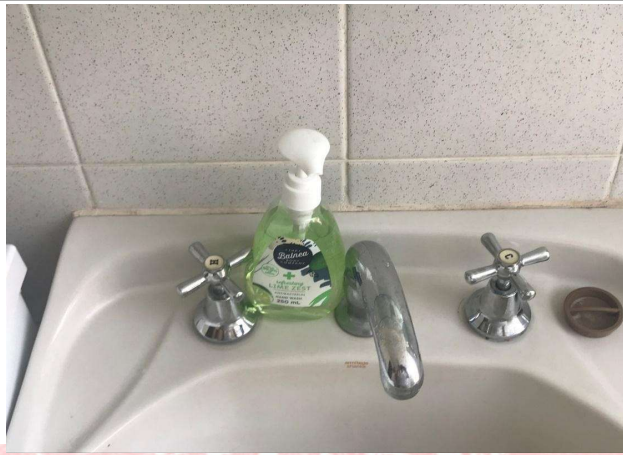
Bathroom / Laundry basin requires re sealing,

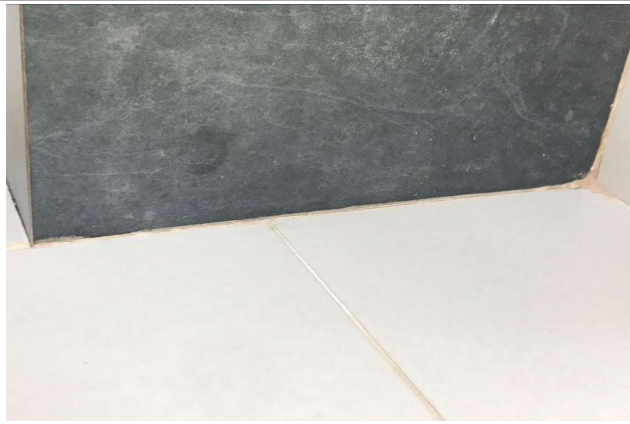
Esuite join between vanity bench and wall tiles requires sealing,
