Triple A Inspections
(502) 555-1234

Home Inspection Report

123 Example St

Prepared For: Demo Dan
Inspected On Mon, Oct 4, 2021 at 9:00 AM

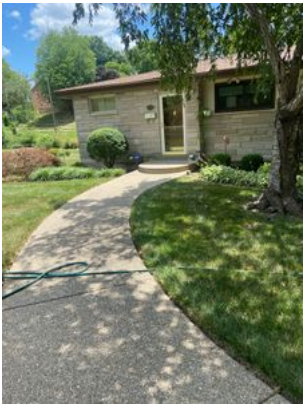
Condition: Satisfactory

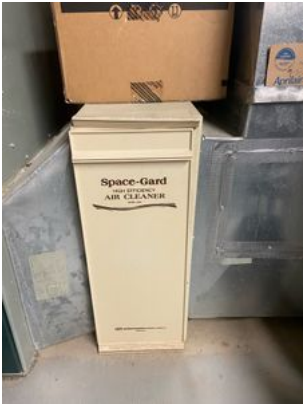
Disposable

Condition: Satisfactory
