Inspection Report

Sample Report

544 West Emerald
Street
Willard, OH 44890

**Wednesday
June 22, 2022**

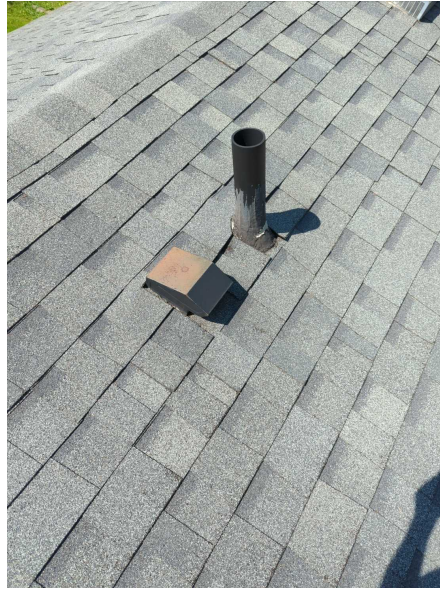
Unit 1

EVAL 17: The rubber boot is damaged and should be replaced. This will allow water to enter the structure

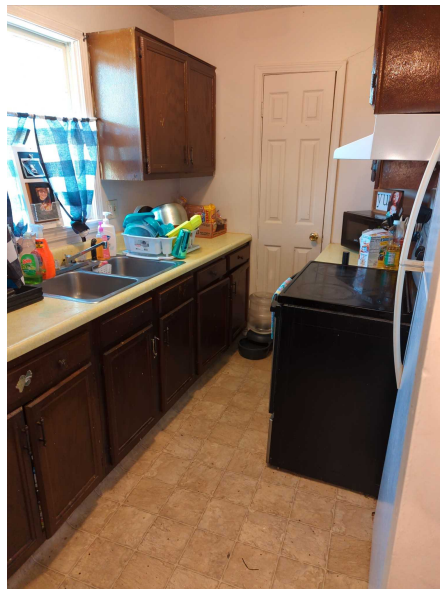
Kitchen unit 2

REPA **EVAL** **2:** The wall and ceiling surfaces appear to be properly installed and in good condition except in the kitchen. We recommend repair in that area to restore function and appearance.

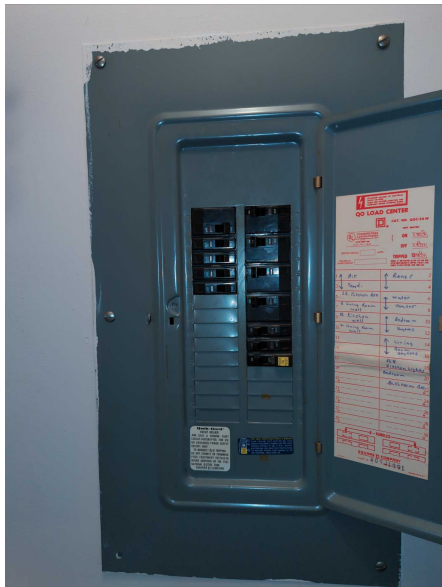
CB MAIN PANEL

The main service panel is in good condition with circuitry installed and fused correctly.

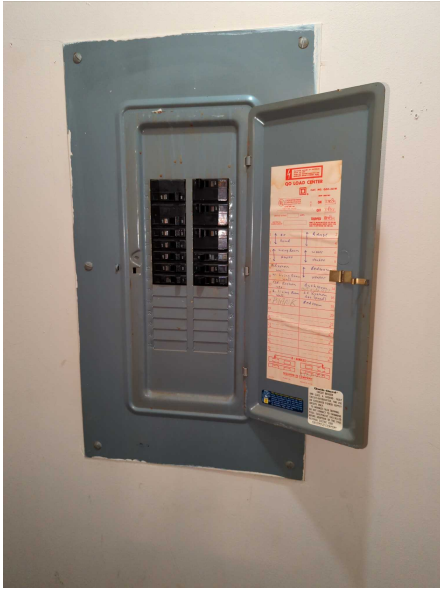
CB MAIN PANEL

The main service panel is in good condition with circuitry installed and fused correctly.
