BB2 Removal Project Impact Assessment and Mitigation, MCFCWCD, 2025

Building Bridge #2 Removal – Impact Assessment of Rise in Modeled Base Flood Elevation (BFE)

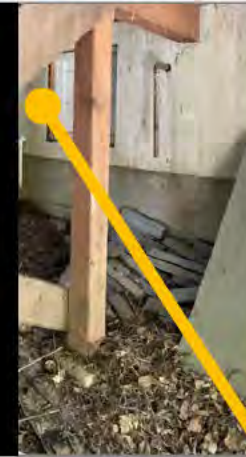
- Electrical outlet
- HVAC equipment

Mitigation includes: elevating electrical boxes; elevating HVAC equipment; installing flood openings for crawl space; and anchoring support beams and floor joists to concrete foundation.

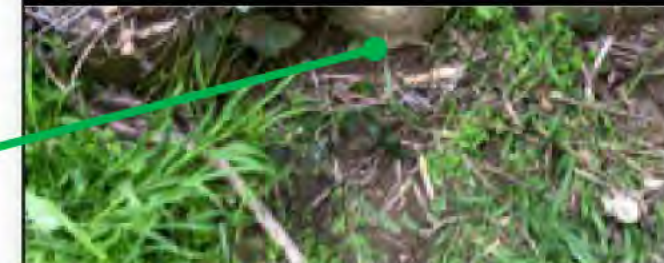
Exhibit No. 17: 82 Sir Francis Drake, Ross

Existing BFE 37.81'

FFF 38.66'

LAG 30.18'

Mitigation includes anchoring wooden beams to posts and concrete foundation.

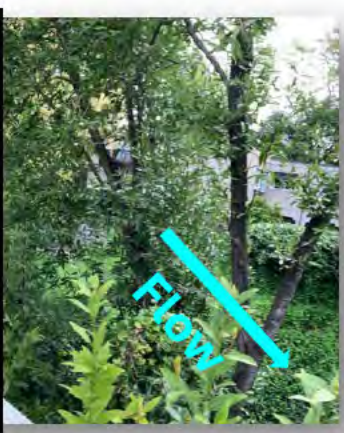
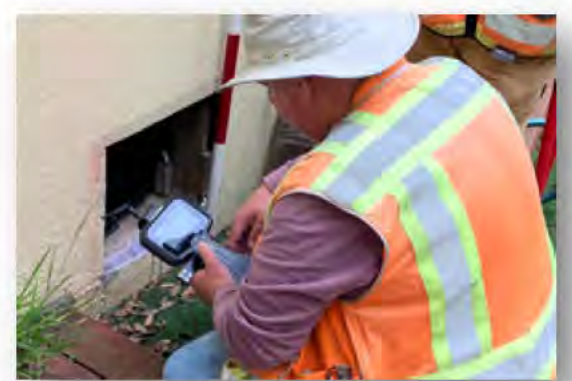
Exhibit No. 17: 82 Sir Francis Drake, Ross

Post BB2 BFE 37.29'
Existing BFE 37.25'

LAG 36.81'

Mitigation includes: elevating electrical boxes; and installing flood openings in crawlspace.

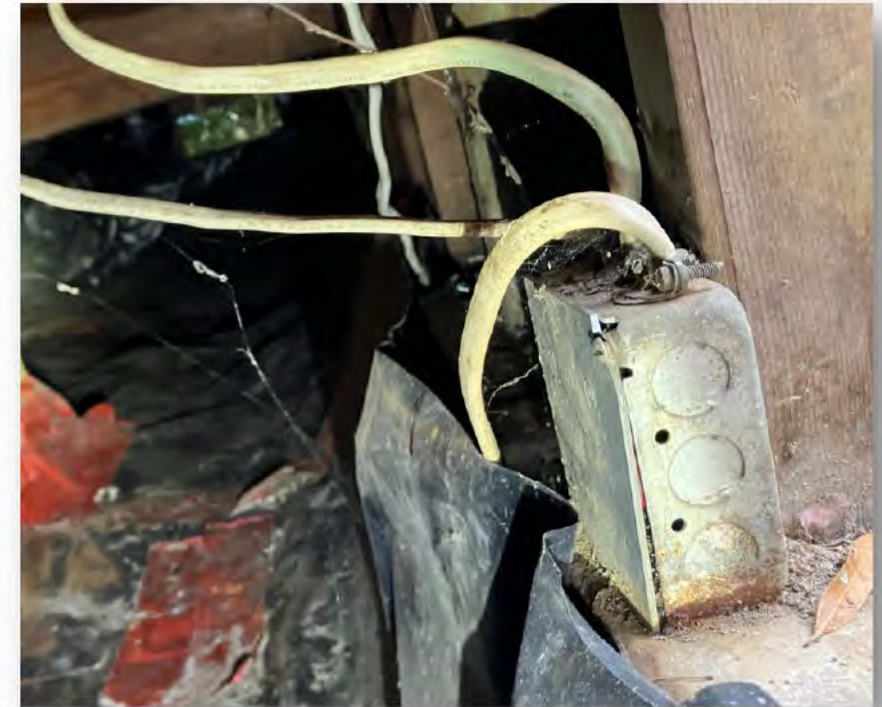
Electrical boxes

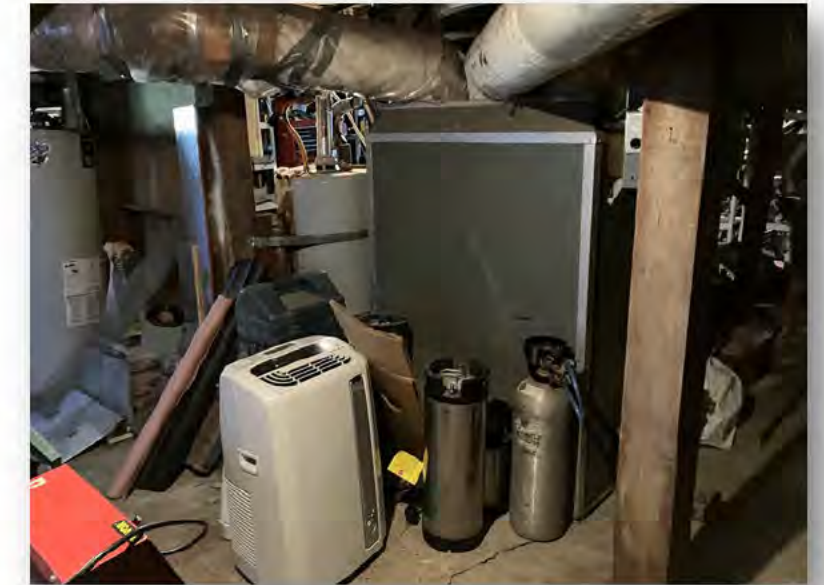
Post BB2 BFE 37.97'
Existing BFE 37.83'

LAG 37.09'

HVAC & water heater equipment

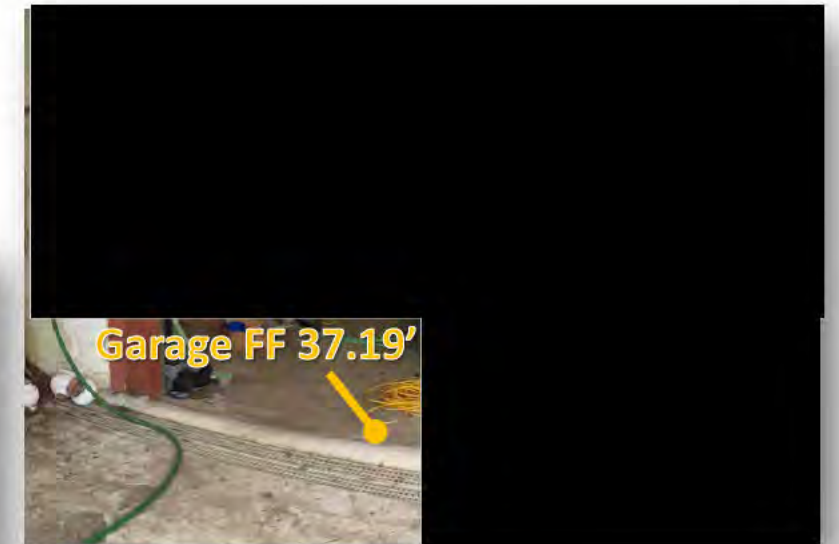
Garage

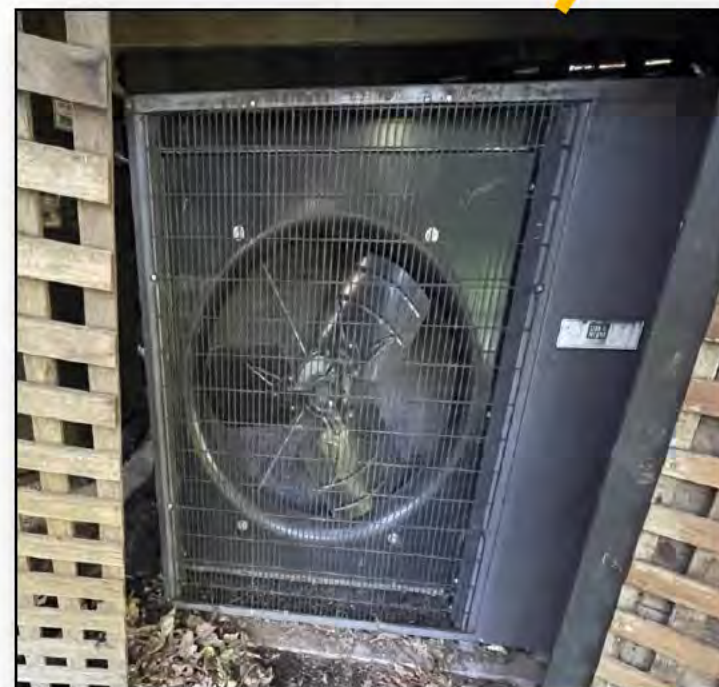
Exhibit No. 22: 42 Winship, Ross

Utility piping, electrical conduits, and tank

Fan
equipment

Mitigation includes: relocating fan equipment to higher elevation; elevating and securing utility piping to floor joists; anchoring tank to foundation; and installing flood openings for crawlspace.

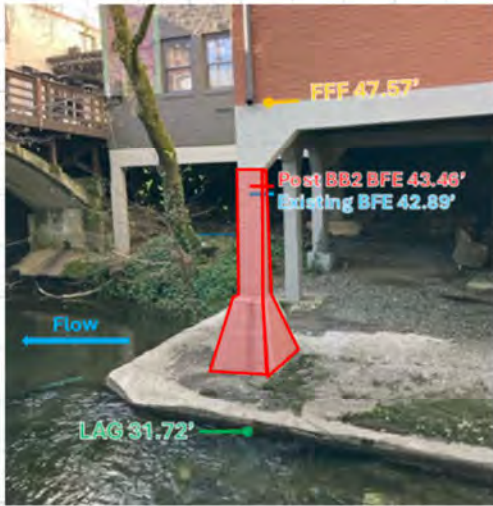
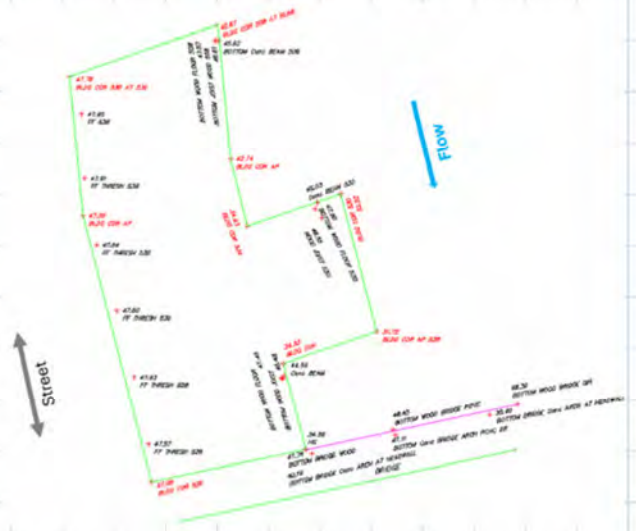
Location #2 Information for 12x16 Column

LOCATION #2:
SECTION: 12"x16" CONCRETE SECTION

Height = 16'-0"
Address: 528 San Anselmo Ave.
Creek Bed Elev: 30.13 ft

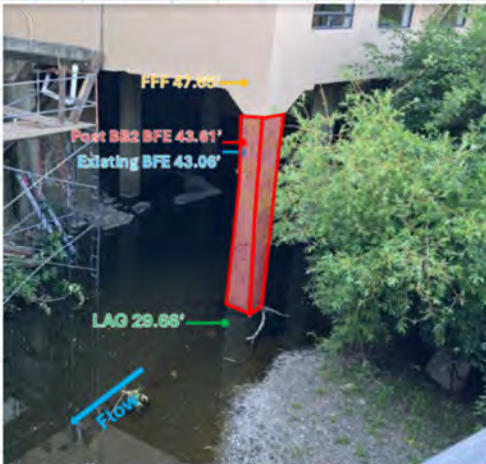
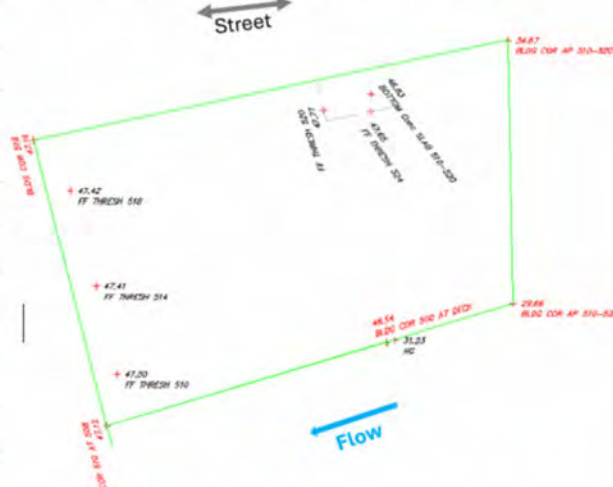
Location #3 Information for 20x20 Column

LOCATION #3:
SECTION: 20"x20" CONCRETE SECTION

Height = 17'-0"
Address: 510 San Anselmo Ave.
Creek Bed Elev: 29.66 ft

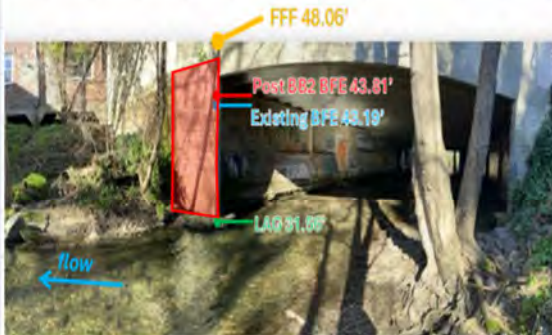
LOCATION #4:

SECTION: 7' WINGWALL

Height = 13'-0"

Address: 540 San Anselmo Ave.
