## ADDENDUM NO. 2

### D Street Bridge Electric and System Upgrades City Project No. C16101933

February 04, 2020

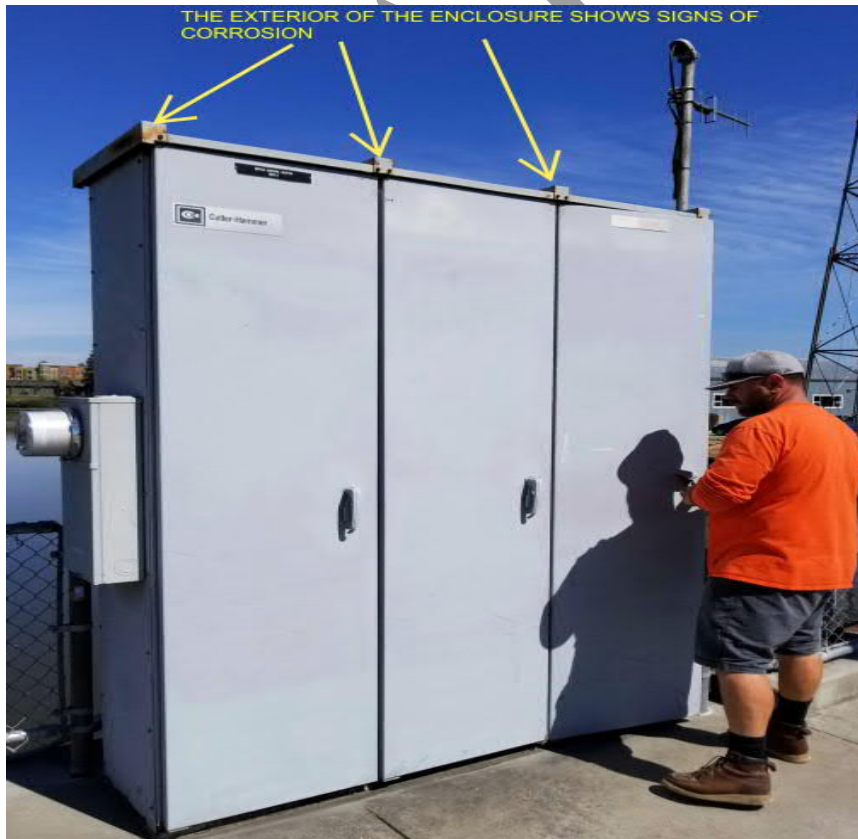
The existing 600A switchboard houses a 400A (200A fused) disconnect which was installed about 18 years ago. It shows signs of metal skin deterioration due to corrosion on portions of the exterior, interior, below the ceiling, and handles of the enclosure. Rust corrosion on the metal skin of the enclosure may indicate internal electrical parts with possible moisture and condensation of water. Circuit breakers and other tripping devices damaged by water condensation may not trip when an electrical overload occurs creating an unsafe condition for personnel. The enclosure was not identified with an Arc Flash Label which is required by NFPA-

Photo E- 4  
Exterior Service Entrance Switchboard Skin Door.

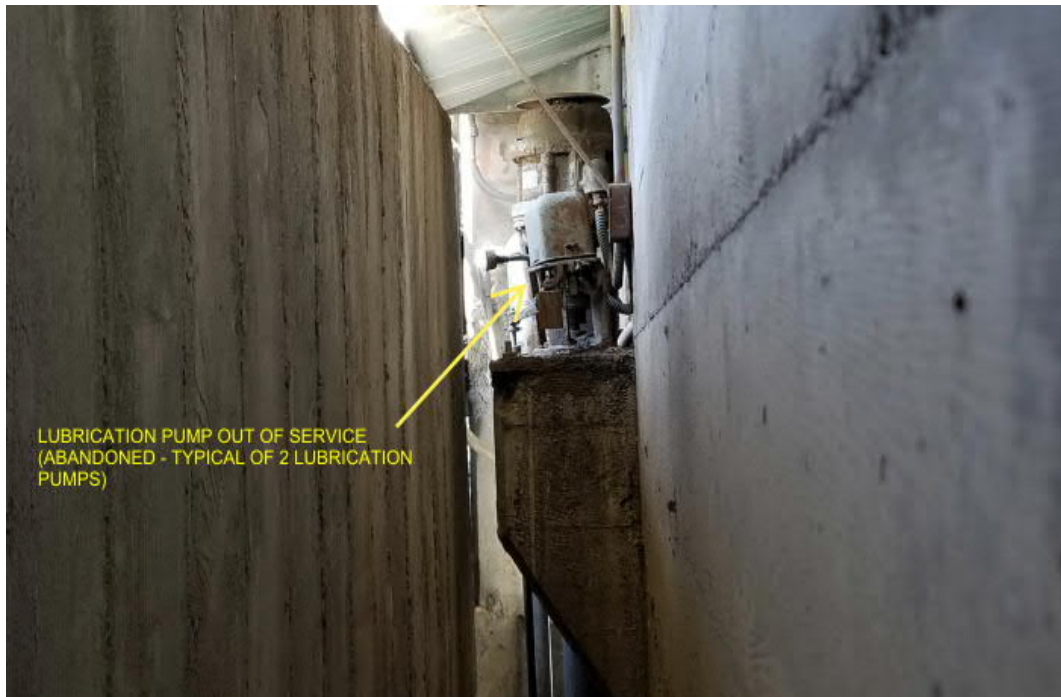
Photo E-29

LUBRICATION PUMP OUT OF SERVICE  
(ABANDONED - TYPICAL OF 2 LUBRICATION  
PUMPS)

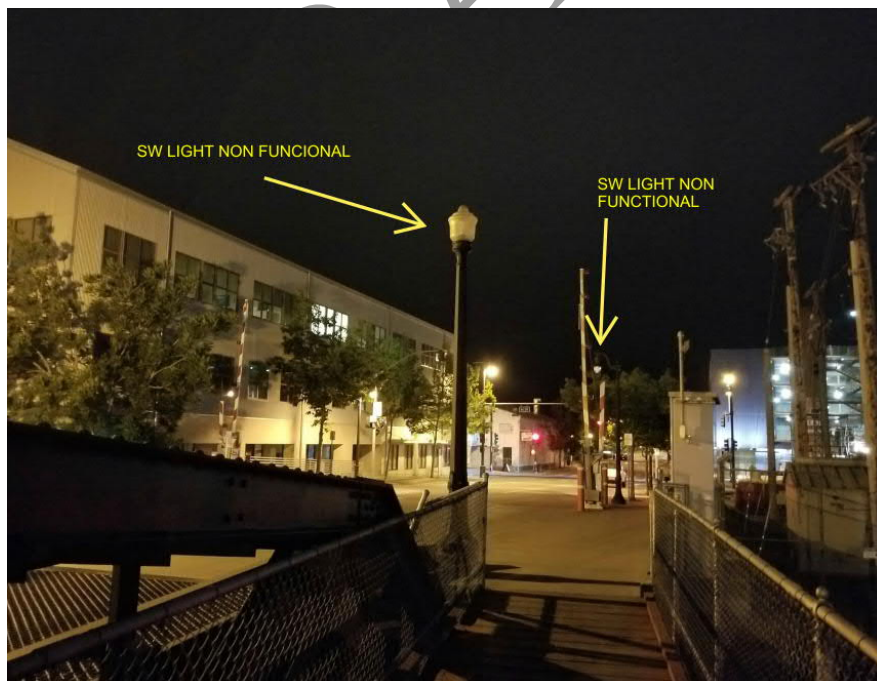
Photo E- 30

SW LIGHT NON FUNCIONAL

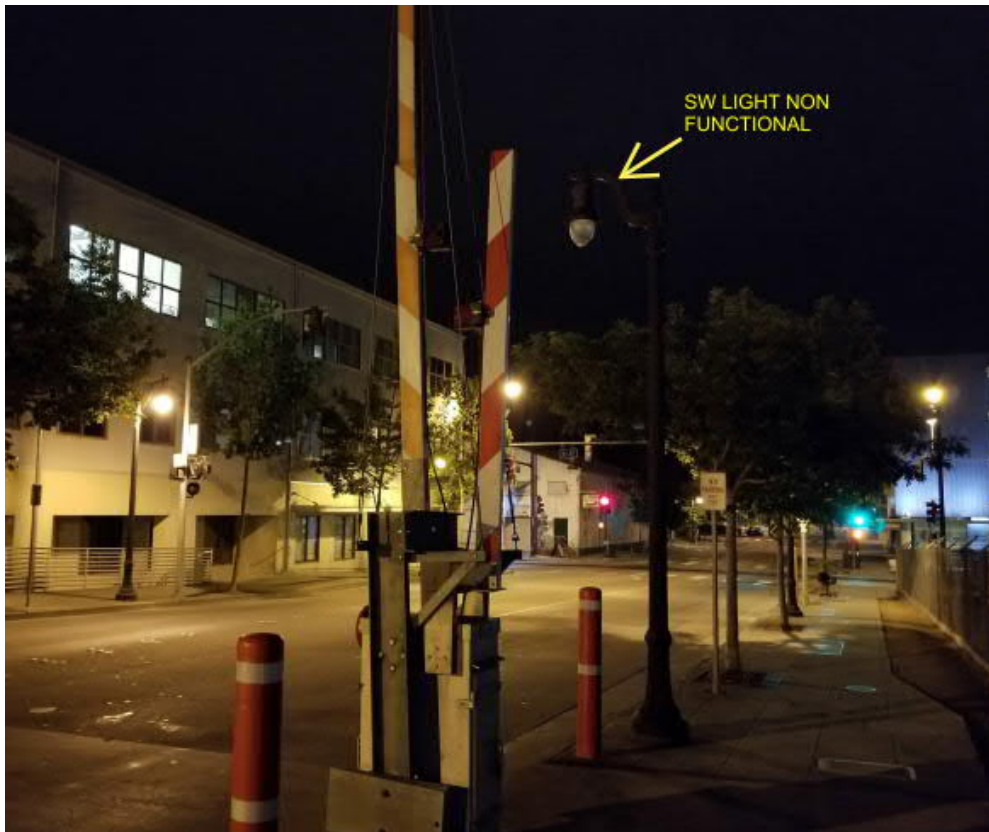
Photo E- 31

SW LIGHT NON  
FUNCTIONAL
