**SAN RAFAEL
PUBLIC LIBRARY
FACILITIES PLANNING
PROJECT**

**EXISTING FACILITIES
REPORT**

**City of San Rafael
California**

July 2019

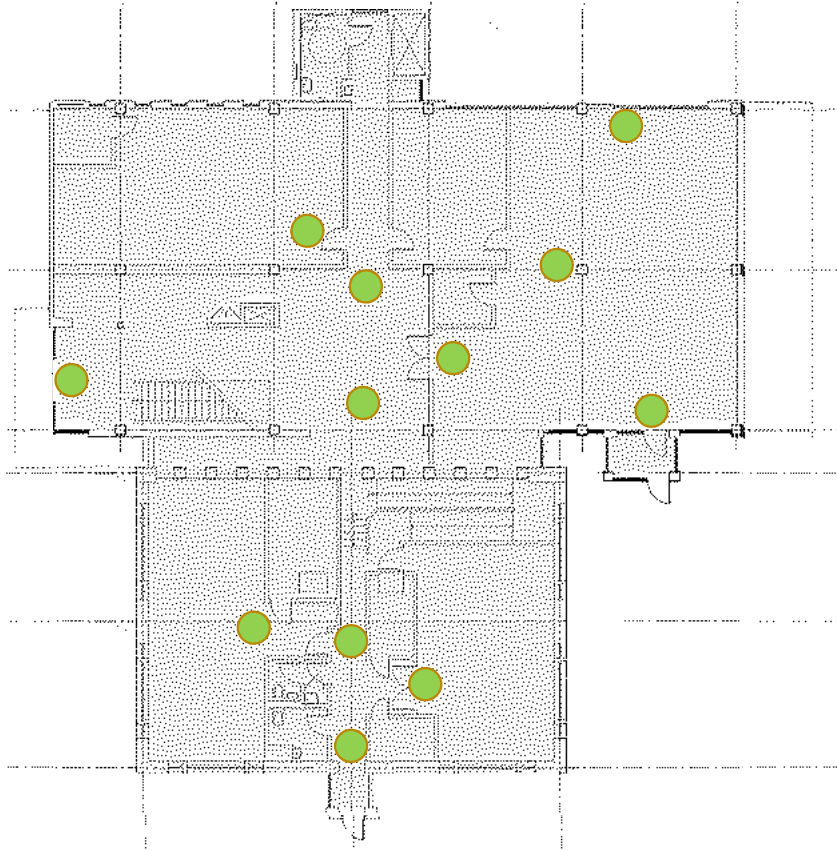
EXISTING LEVEL ONE FLOOR PLAN

It is determined that illuminated exit signs are required throughout the building in locations as indicated.

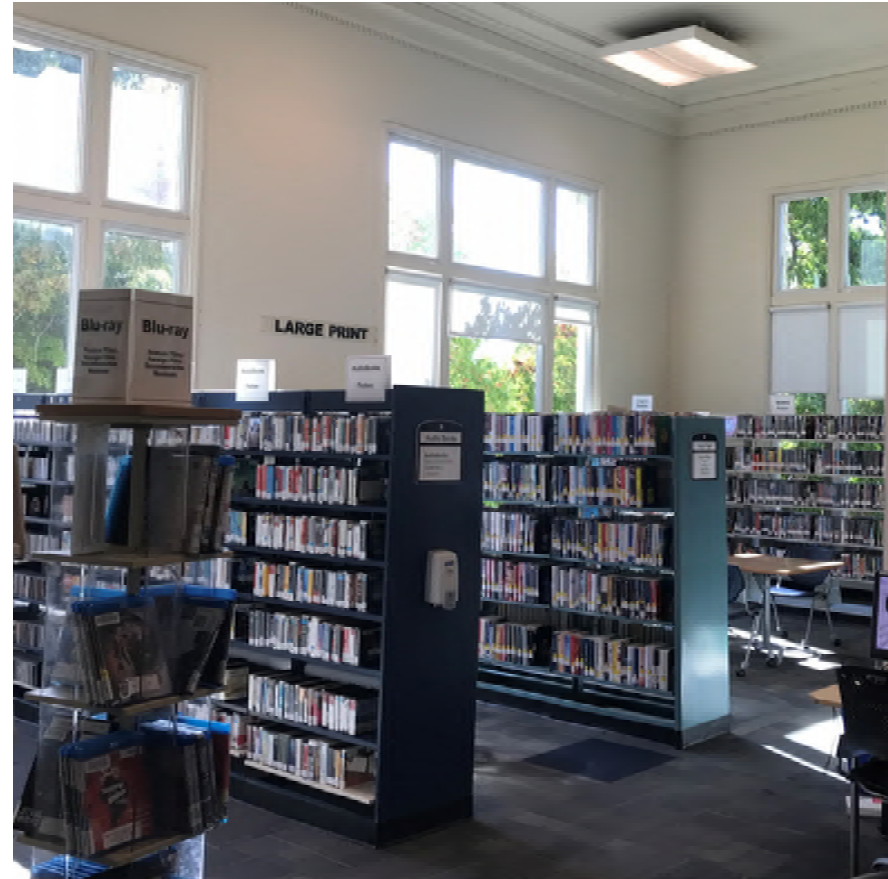
- Several Library Stacks in reading area on second floor were not structurally braced to the main structure or to each other. Based on their loading these stacks appear to require bracing. These stacks are 73” and 77” high.
- Per 2016 C.B.C 1010.1.1 The height of door openings cannot be less than 80”. *Interpretation:* one can pass under an 80” high “opening” for a temporary period of time. If these 73” high stacks are braced to each other at the top of the stacks they will not be in code compliance for access.

Determination: Replace existing stacks with 4'-0” high lower stacks that do not require to be braced. Alternatively brace the stacks from above or below.

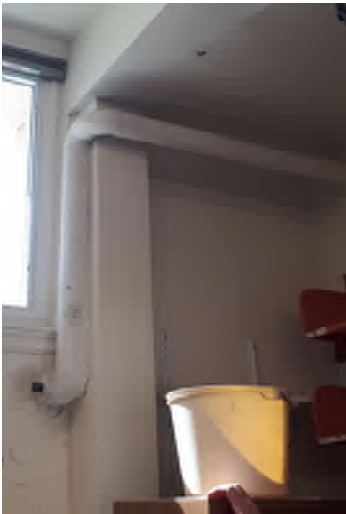
LEVEL TWO CIRCULATION DESK

- Level One Entry lobby has evidence of leaks in the ceiling in two locations.
- Level One has a leak in ceiling within office space
- Level Two circulation desk: leaks occurring above circulation desk – captured in plastic bag.

Determination: Determine cause of leaks and repair all affected ceilings.

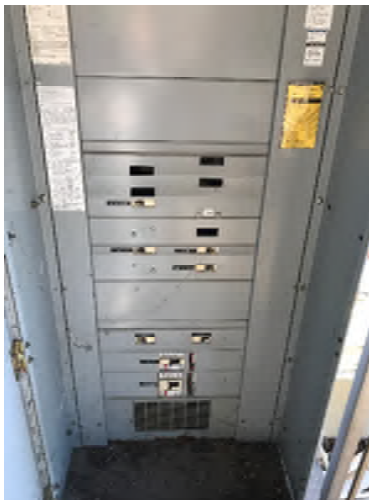
Distribution Section 2

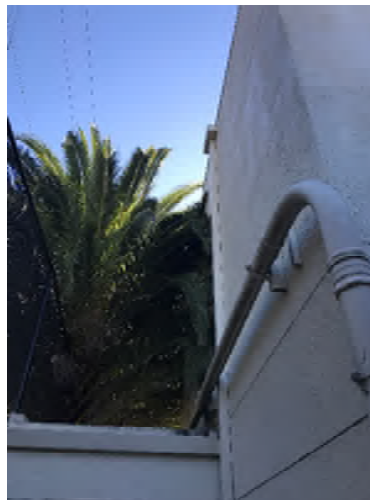
The original building switchboard is located at the North/West exterior by the rear door of the Circulation Desk / Office area and is sub-fed via an exterior conduit routed along the exterior. It includes existing original sub-feeders to original branch panels inside the original library. These original panels (including the original switchboard) are rather old and near the end of their useful life. They should be replaced with any modernization or upgrade of the existing building.

Exterior Feeder to Old Service

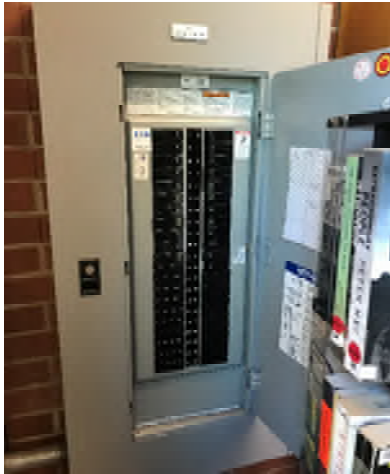
The condition of the existing sub-feeders could not be evaluated for this visual review, but the (2) newer branch panelboards appear to have been maintained well and are in good condition. These panels can remain in their current locations and can be re-used, if accommodated in the new design layouts. Panel M1 is at the lower level of the newer building area (old parking Garage) at the far North/East corner of the building and was installed at the same time as the exterior service upgrade. Panel M2 is in the same location on the upper level, directly above Panel M1.

Newer Panel M1 (Lower)

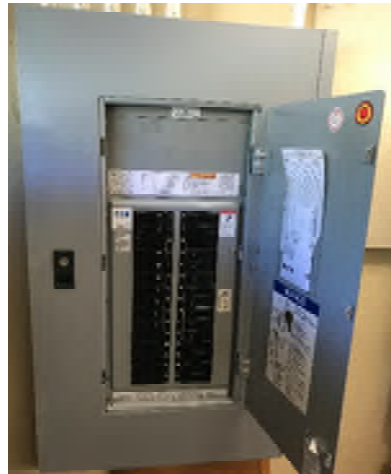
Newer Panel M2 (Upper)

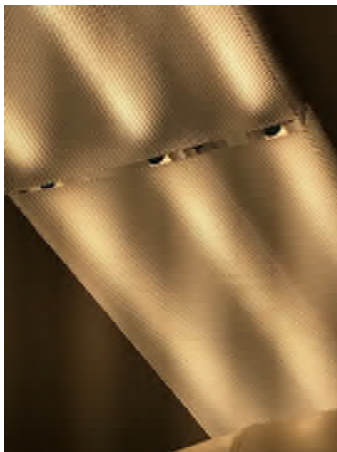
The existing lighting systems at the Library are a mix of recessed and surface mounted lensed and open T8 fluorescent fixtures, with some very old fixtures still active in small closets and storage rooms. Most point source fixtures that were originally incandescent have been replaced with screw-in LED's.

T8 Fluorescent Lamping

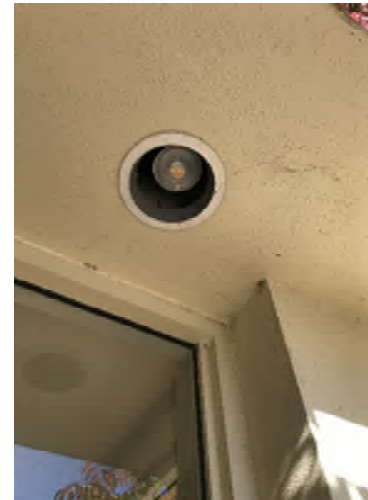
There are numerous exterior wall and under-canopy mounted lighting units on the building exterior, near the front and rear entrances, which appear to have been replaced with LED screw- in sources.

Exterior Lighting

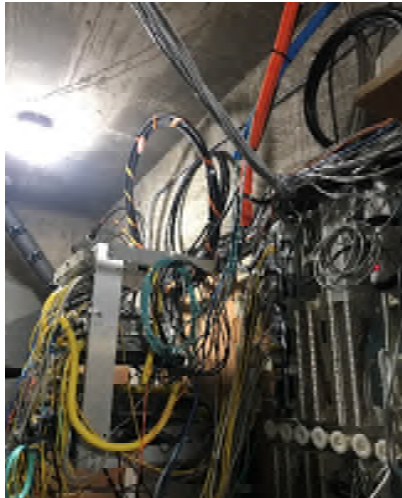
The MDF is currently located in a shared Storage / Mechanical Room and has numerous stored boxes and misc. equipment stored in the same room. The MDF should be provided with a dedicated space in the same location. The basic telecom distribution system is in good condition, but it includes older style Category 5 and 5e cabling that limits the bandwidth capability of the system. The system can be expanded with new components and wiring, such as higher category rated cabling to bring the system into current-day telecom standards.

Cramped MDF Space.

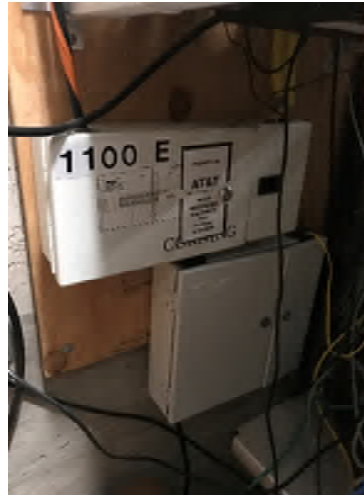
AT&T Fiber Service

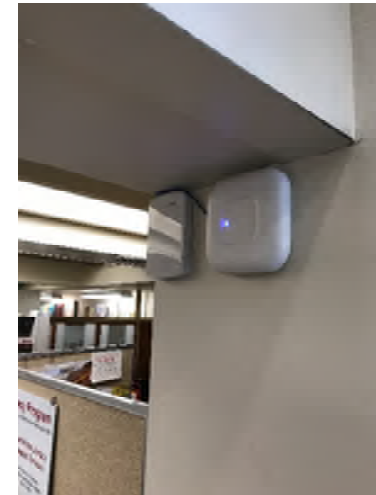
Wireless Access Points
