FACILITY CONDITION ASSESSMENT

SACRAMENTO CITY UNIFIED SCHOOL DISTRICT
5735 47th Avenue
Sacramento, California 95824

JOHN STILL MIDDLE (EAST CAMPUS)
2250 John Still Drive
Sacramento, California 95832

June 11, 2020

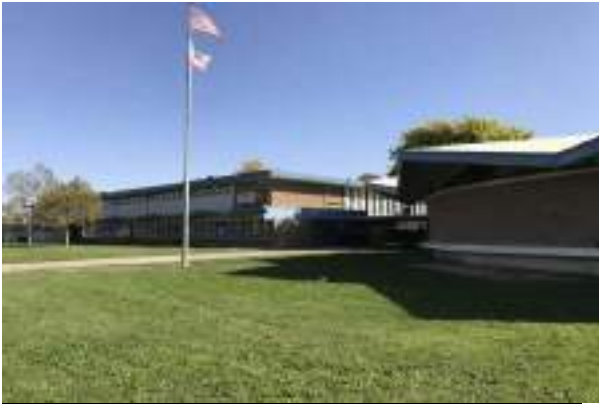
#1	SCHOOL ENTRY AT JOHN STILL DRIVE
----	----------------------------------

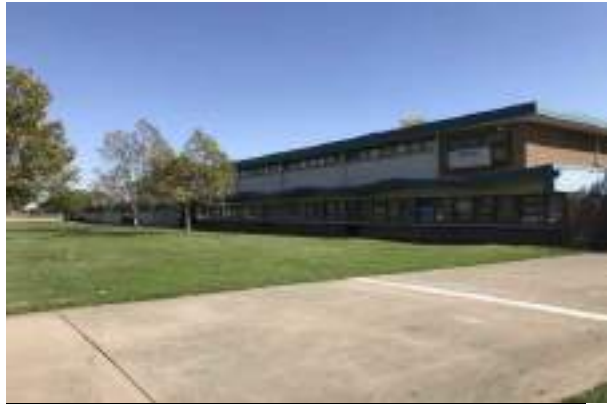
#2	BUILDINGS B AND A
----	-------------------

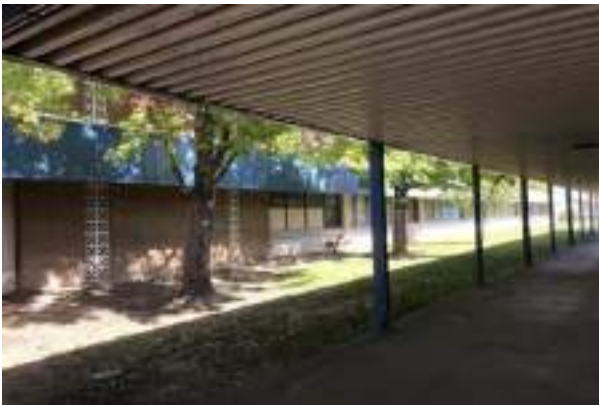
#3	BUILDING A REAR ELEVATION
----	---------------------------

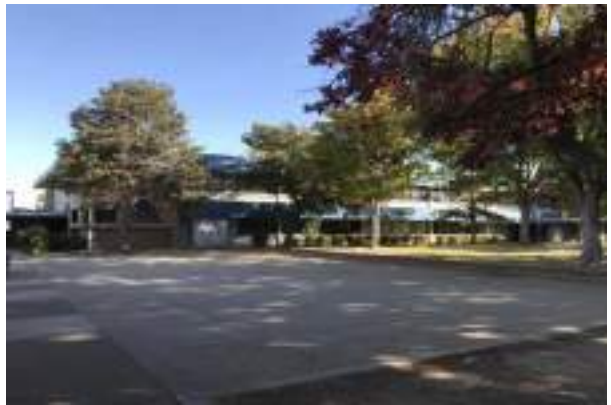
#4	BUILDING B
----	------------

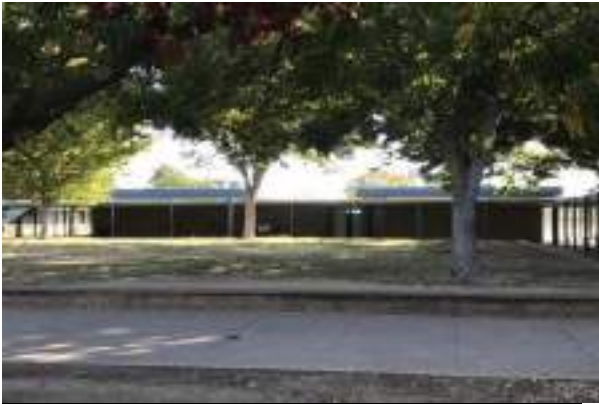
#7	BUILDING C
----	------------

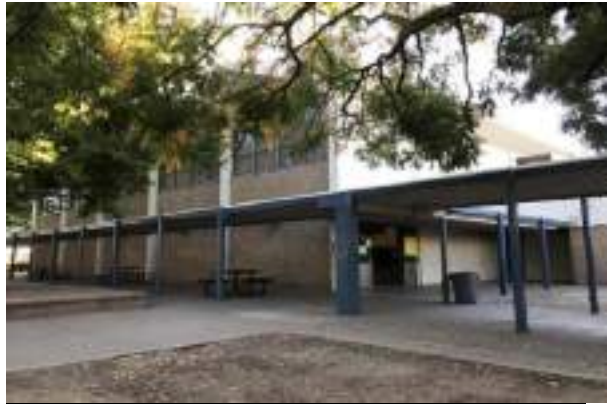
#8	BUILDING D
----	------------

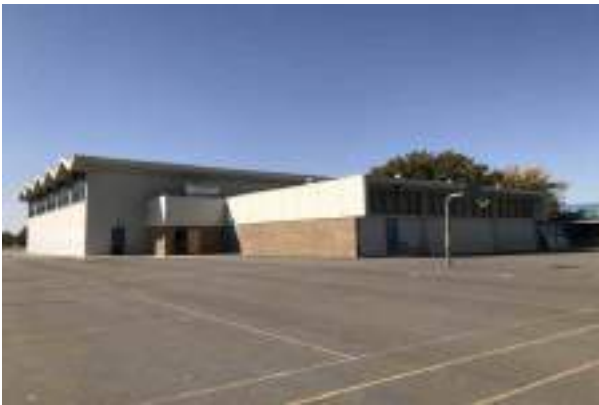
#9	BUILDING D
----	------------

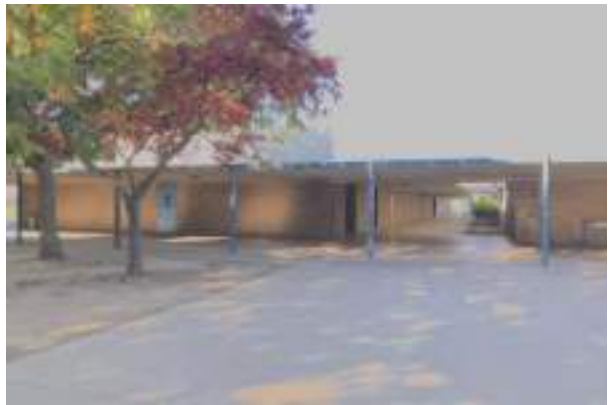
#10	BUILDING E
-----	------------

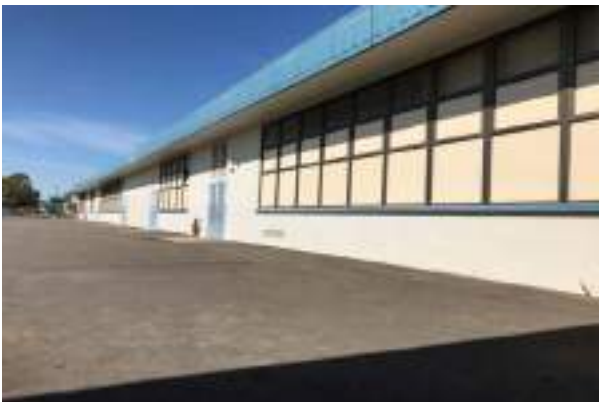
#11	BUILDING E, REAR
-----	------------------

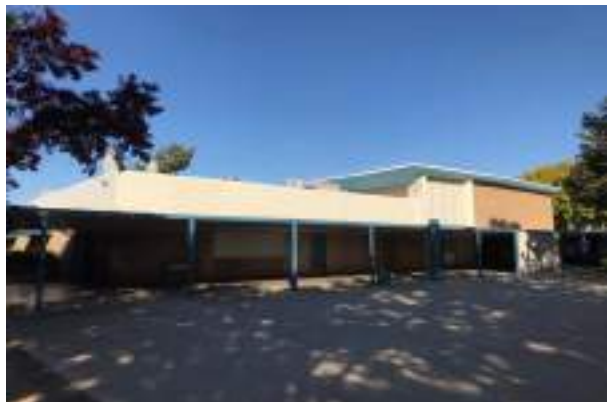
#12	BUILDING F
-----	------------

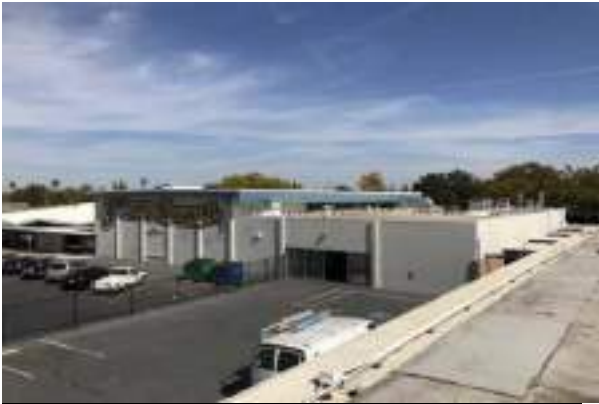
#13	BUILDING F
-----	------------

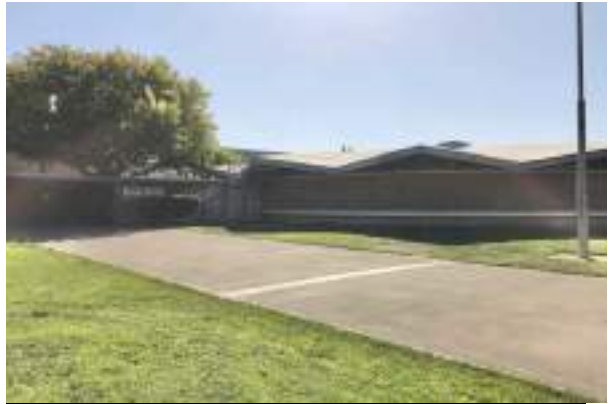
#14	BUILDING G
-----	------------

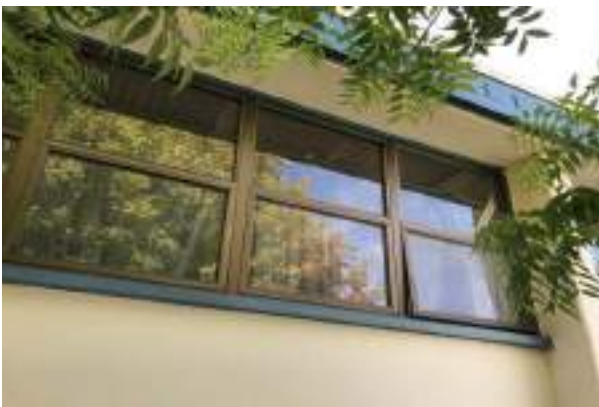
#21	WINDOWS, TYPICAL
-----	------------------

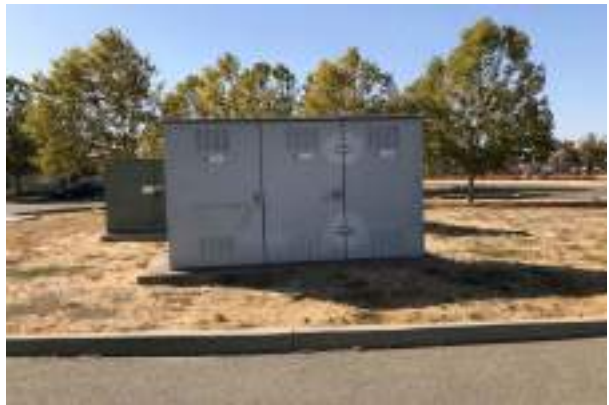
#28	BUILDING/MAIN SWITCHBOARD
-----	---------------------------
