FACILITY CONDITION ASSESSMENT

SACRAMENTO CITY UNIFIED SCHOOL DISTRICT
5735 47th Avenue
Sacramento, California 95824

ALBERT EINSTEIN MIDDLE SCHOOL
9325 Mirandy Drive
Sacramento, California 95826

June 10, 2020

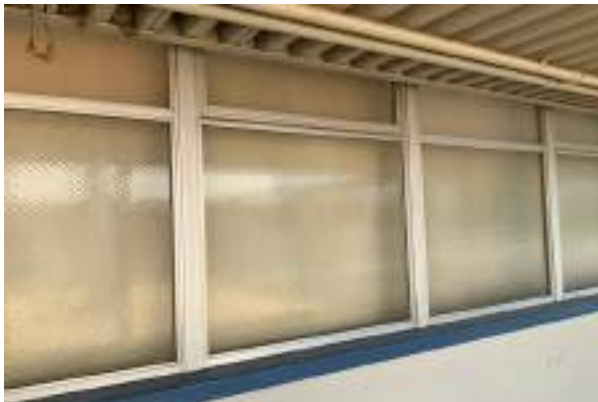
#11	WINDOW, ALUMINUM SINGLE-GLAZED
-----	--------------------------------

The main buildings are aging, but in fair condition. The portables are also in fair condition. The buildings had a seismic retrofit in 2005. Exterior finishes such as paint on exterior walls and windows are in fair condition but will need attention in a few years. Most of the buildings have an aging modified bituminous roof, with spots of blistering and damaged sealant. The windows are aluminum-framed and in fair condition. Other windows showed no visible deterioration of the seals between the windows and frame, but the glazing was single-pane glass and not ideal for energy efficiency.

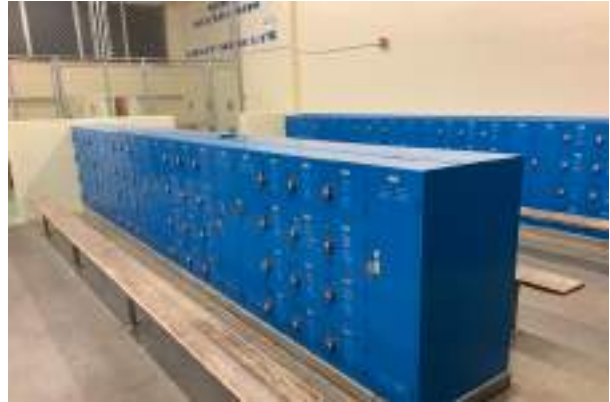
#19	INTERIOR FLOOR FINISH, MAPLE SPORTS FLOOR
-----	---
