FACILITY CONDITION ASSESSMENT

Tommie Kunst Junior High
930 Hidden Pines Way
Santa Maria, California 93458

158764.22R000-013.017

February 23, 2023

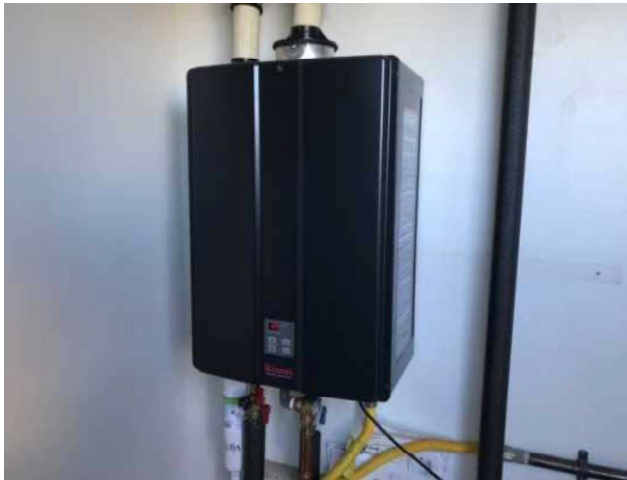
25 - TANKLESS WATER HEATER

Component Condition Report Tommie Kunst Junior High / Building A-MPR						
UF L3 Code	Location	Condition	Asset/Component/Repair	Quantity	RUL	ID
C2030	Kitchen	Fair	Flooring, Quarry Tile	412 SF	31	5248344
C2030	Stage	Fair	Flooring, Wood, Strip	740 SF	11	5248147
C2030	MPR	Fair	Flooring, Vinyl Tile (VCT)	2,880 SF	7	5248129
C2030	Stage	Fair	Flooring, Wood, Strip, Refinish	740 SF	3	5248779
C2030	Restrooms	Fair	Flooring, Ceramic Tile	600 SF	21	5248210
C2050	Stage, kitchen	Fair	Ceiling Finishes, any flat surface, Prep & Paint	2,145 SF	5	5248225
Conveying						
D1010	Stage	Fair	Vertical Lift, Wheelchair, 5' Rise, Renovate	1	6	5248275
Plumbing						
D2010	MPR	Fair	Toilet, Commercial Water Closet	8	11	5248347
D2010	Janitorial	Fair	Sink/Lavatory, Service Sink, Floor	1	16	5248307
D2010	MPR	Fair	Sink/Lavatory, Wall-Hung, Vitreous China	7	11	5248160
D2010	Exterior utility closet	Good	Water Heater, Gas, Tankless, 6.5 to 9.5 GPM	1	10	5248353

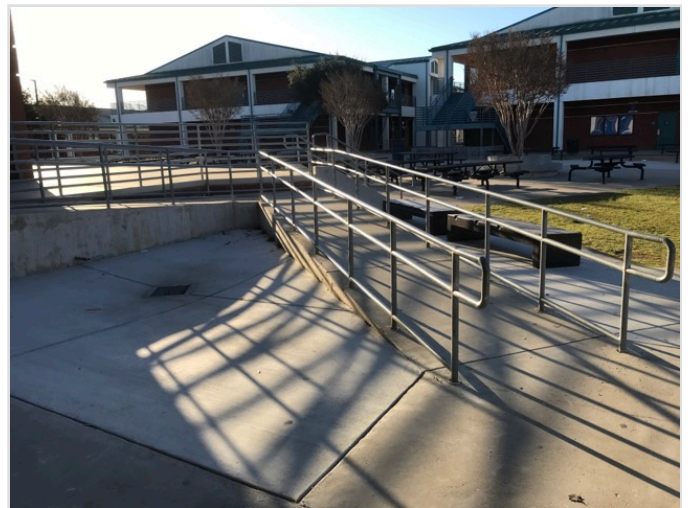
Site ramp
