# FACILITY CONDITION ASSESSMENT

## **DLR Group**

Bruce Elementary  
601 West Alvin Avenue  
Santa Maria, California 93458

*February 21, 2023*

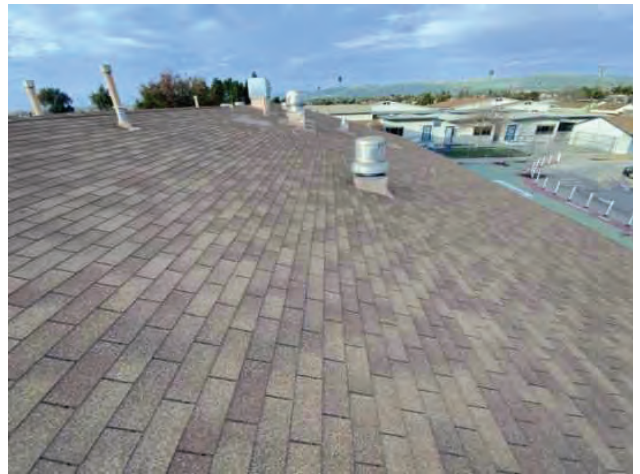
10 - ROOFING

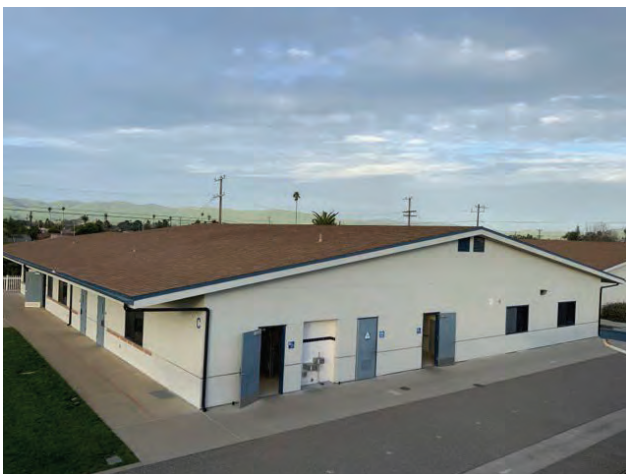
11 - ROOFING

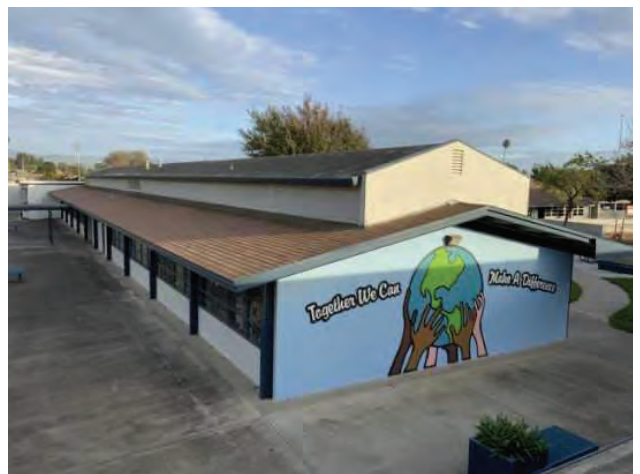
12 - ROOFING

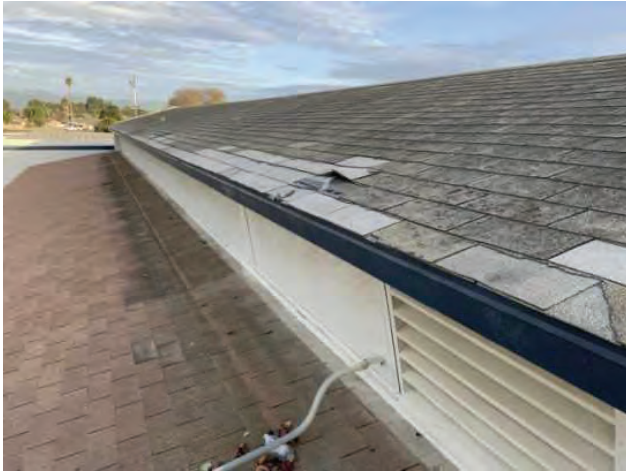
Roofing has failed in several large areas and needs replacing. - AssetCALC ID: 4866316

13 – ROOFING ISSUE

Uniformat Code: B3010  
Recommendation: **Replace in 2023**

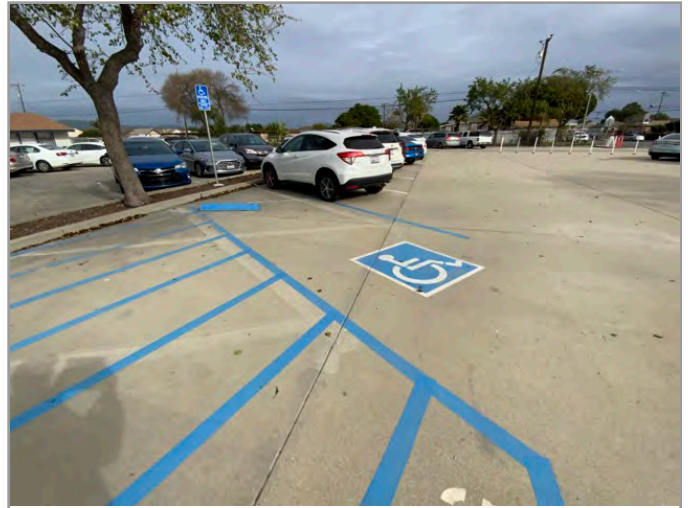
CLOSE-UP OF STALL

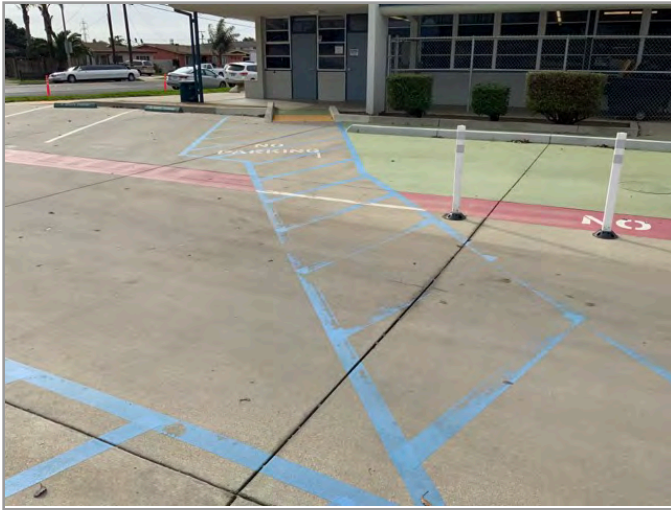
ACCESSIBLE PATH

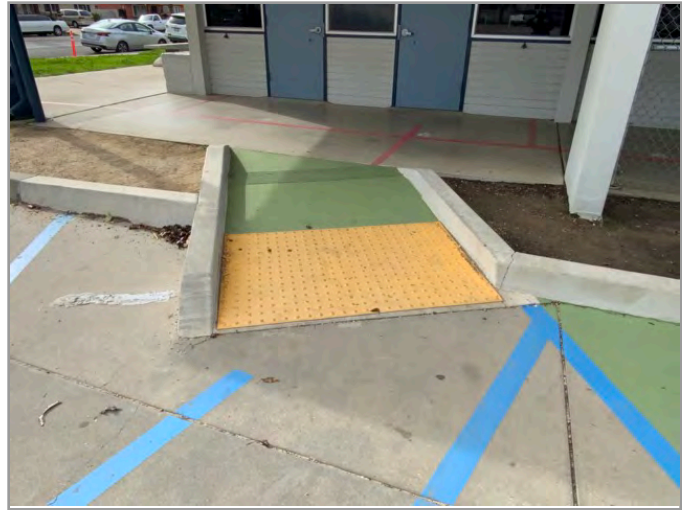
CURB CUT

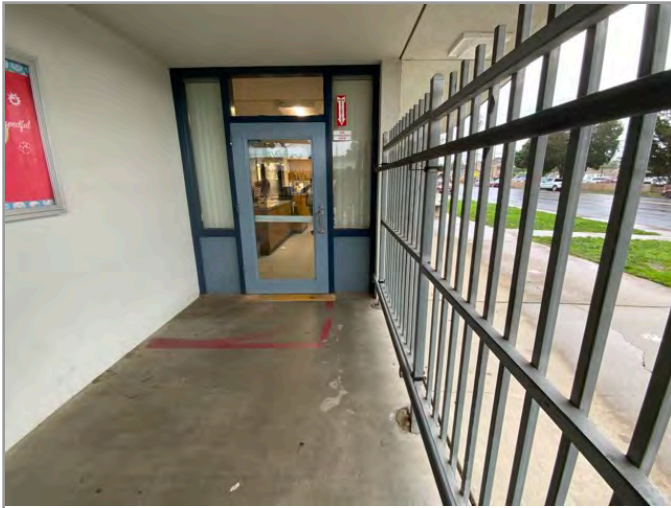
MAIN ENTRANCE

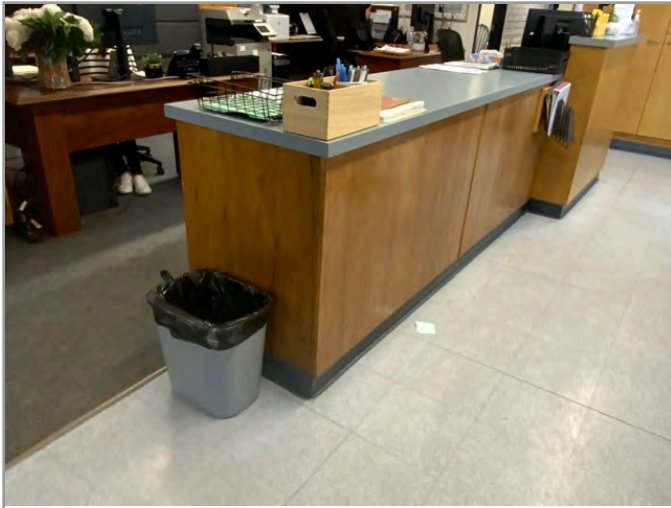
SELF-SERVICE AREA

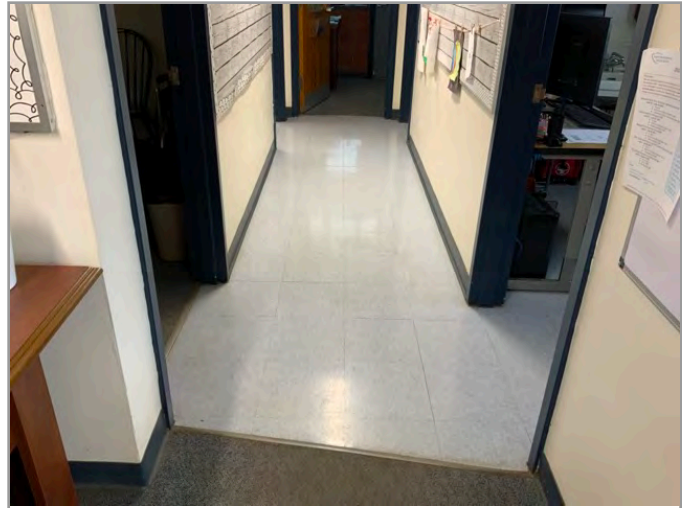
ACCESSIBLE INTERIOR PATH

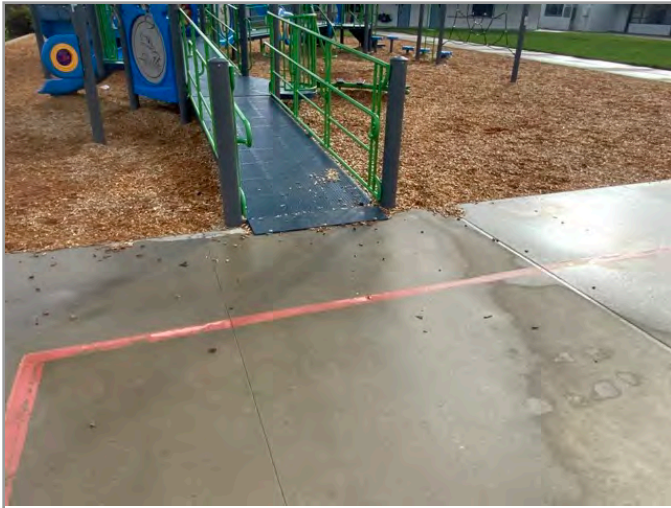
ACCESSIBLE ROUTE TO PLAYGROUND

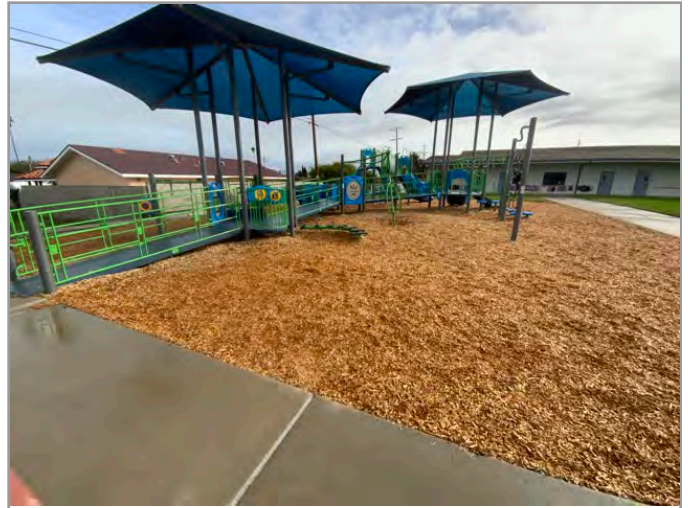
OVERVIEW OF PLAYGROUND
