FACILITY CONDITION ASSESSMENT

DLR Group

Paloma Elementary
42940 Via Rami
Temecula, California 92592

September 2, 2021

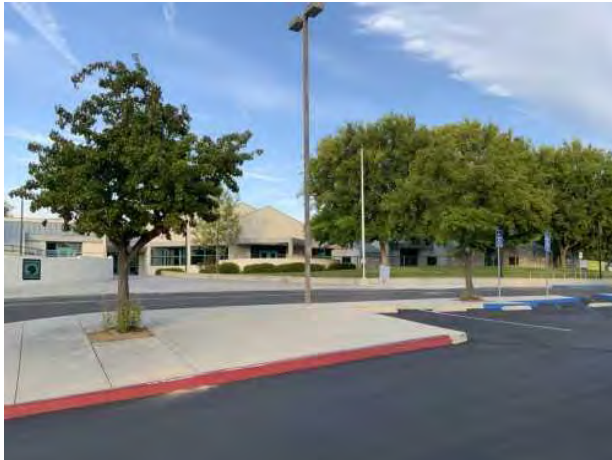
#1:	MAIN BUILDING - FRONT ELEVATION
-----	---------------------------------

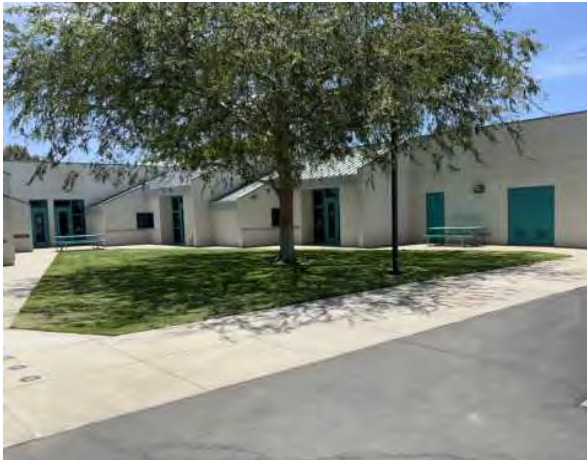
#2:	MAIN BUILDING - LEFT ELEVATION
-----	--------------------------------

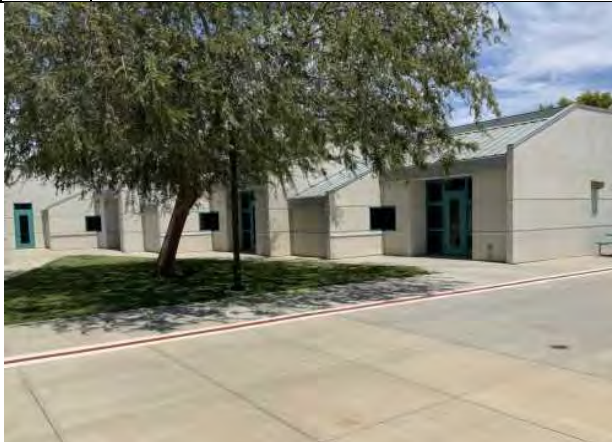
#3:	MAIN BUILDING - RIGHT ELEVATION
-----	---------------------------------

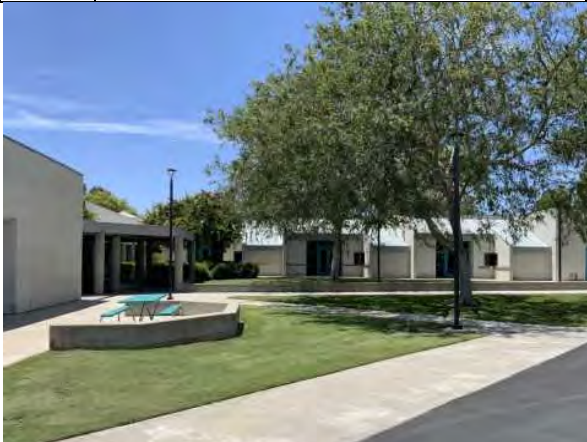
#4:	MAIN BUILDING - REAR ELEVATION
-----	--------------------------------

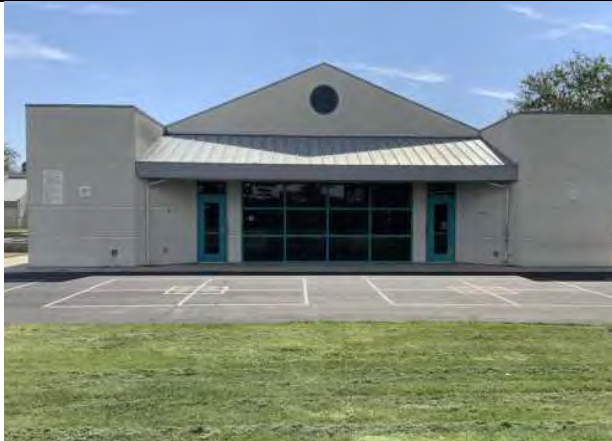
#5:	MULTIPURPOSE BUILDING FRONT
-----	-----------------------------

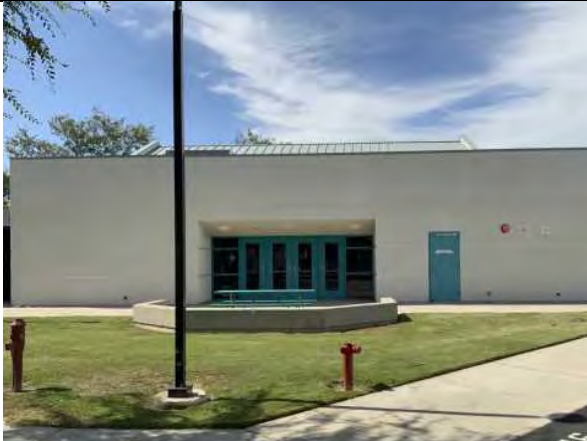
#6:	MULTIPURPOSE BUILDING RIGHT
-----	-----------------------------

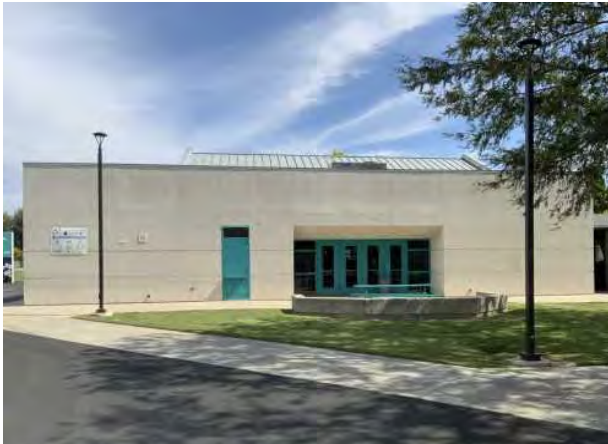
#7: MULTIPURPOSE BUILDING REAR

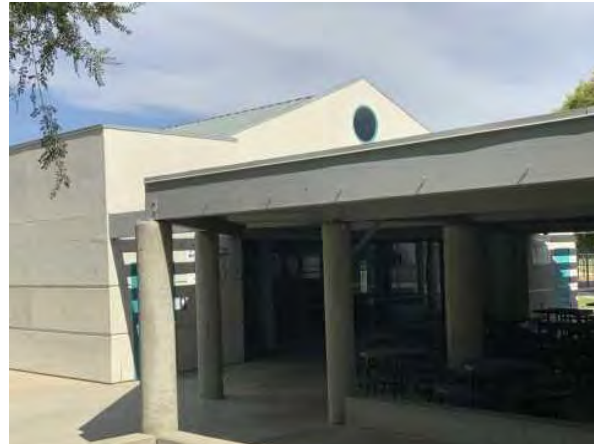
#8: MULTIPURPOSE BUILDING LEFT

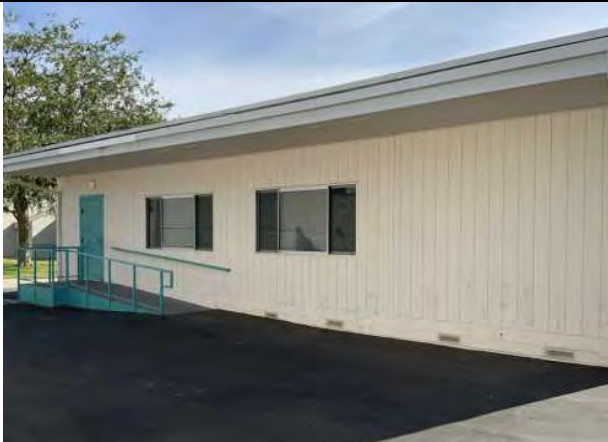
#9: CHILDCARE - FRONT ELEVATION

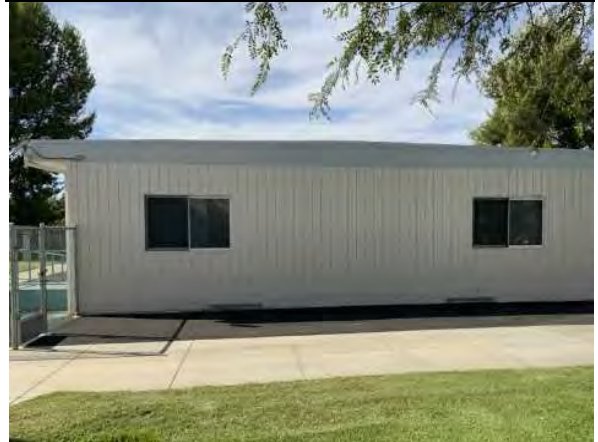
#10: CHILDCARE - LEFT ELEVATION

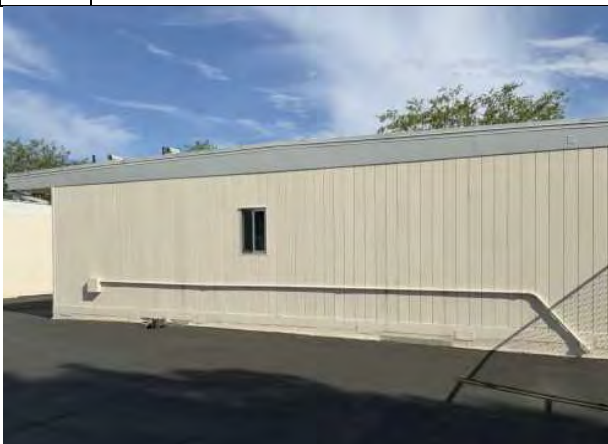
#11: CHILDCARE - RIGHT ELEVATION

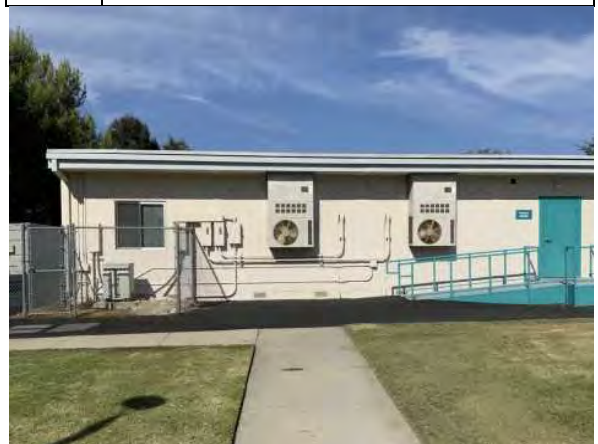
#12: CHILDCARE - REAR ELEVATION

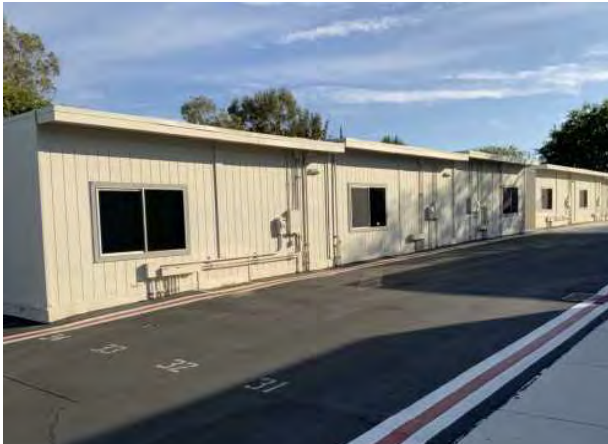
#13: PORTABLES 23-34 - FRONT ELEVATION

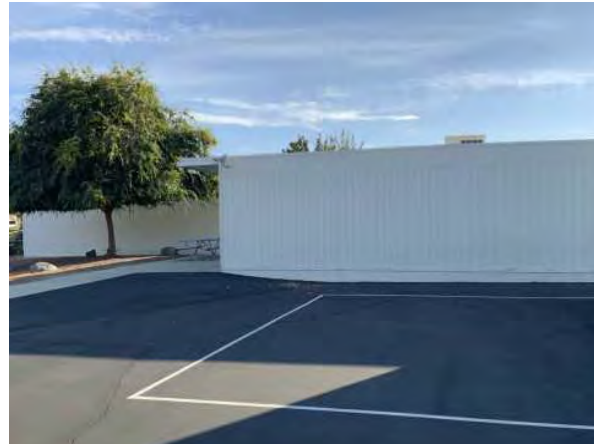
#14: PORTABLES 23-34 - LEFT ELEVATION

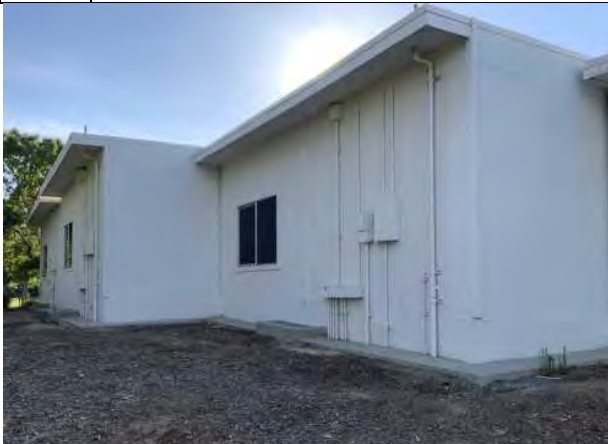
#15: PORTABLES 23-34 - REAR ELEVATION

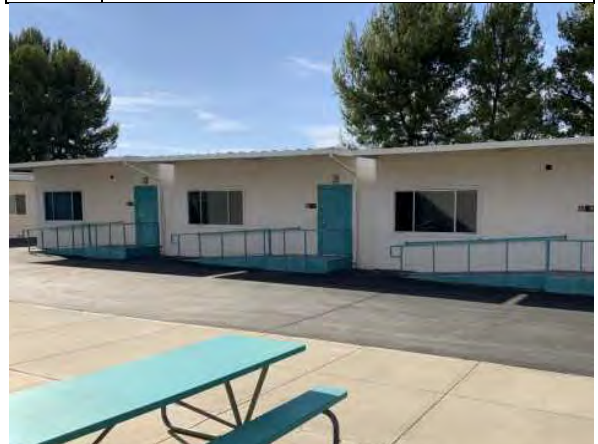
#16: PORTABLES 35-37 - FRONT ELEVATION

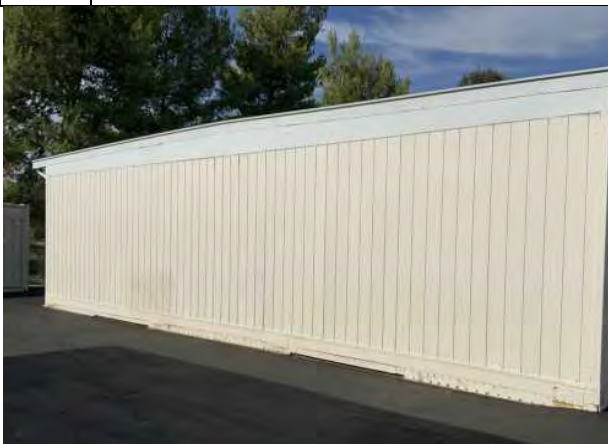
#17: PORTABLES 35-37 - LEFT ELEVATION

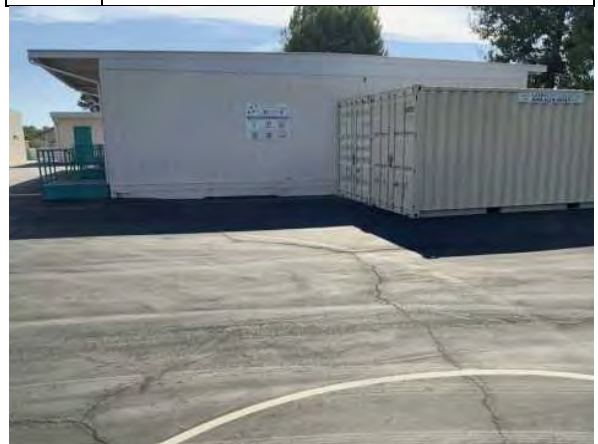
#18: PORTABLES 35-37 - RIGHT ELEVATION

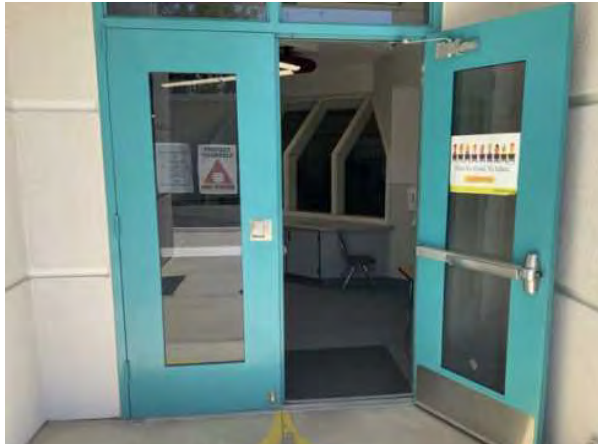
#19: EXTERIOR STEEL-FRAMED AND GLAZED DOOR

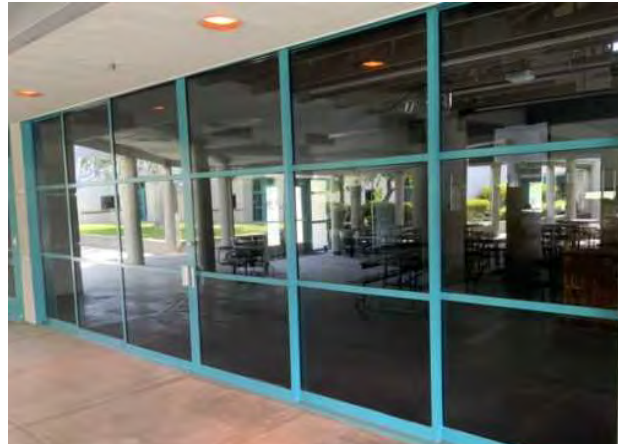
#20: EXTERIOR GLAZED LARGE SLIDING DOOR

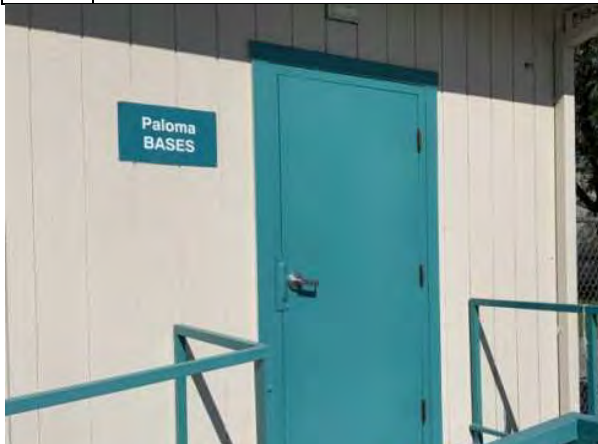
#21: EXTERIOR STEEL DOOR

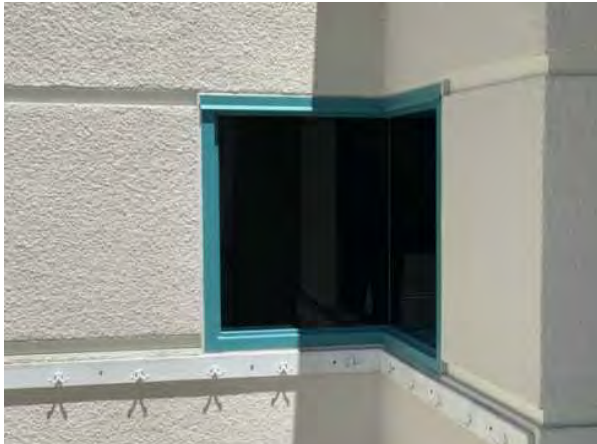
#25: STEEL WINDOW
