FACILITY CONDITION ASSESSMENT

DLR Group

Temecula Luiseno Elementary
45754 Wolf Creek Drive North
Temecula, California 92592

August 5, 2021

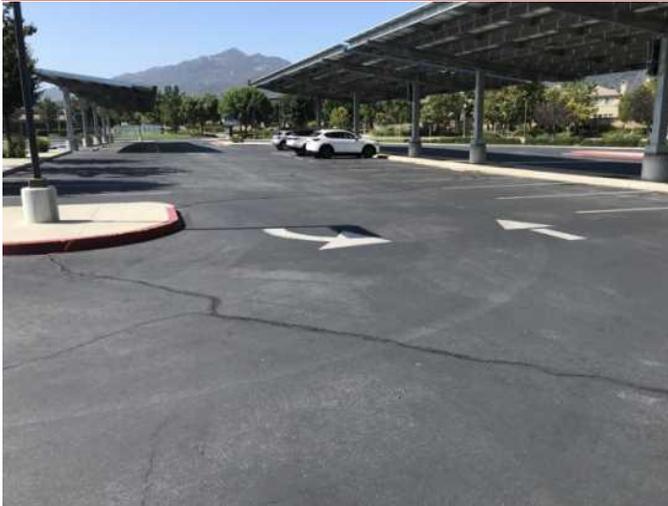
7 - PARKING LOTS

Parking Lots in Poor condition.

Isolated areas of longitudinal cracks. - AssetCALC ID: 3166129

Uniformat Code: G2021
Recommendation: **Repair in 2021**

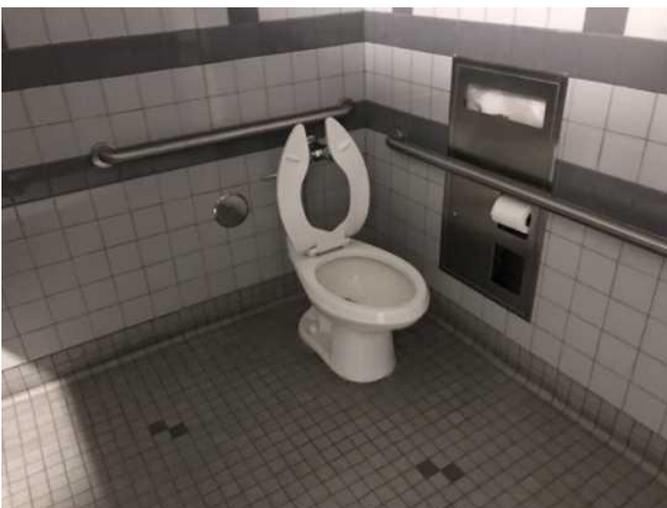
53 - TOILET, CHILD-SIZED, REPLACE

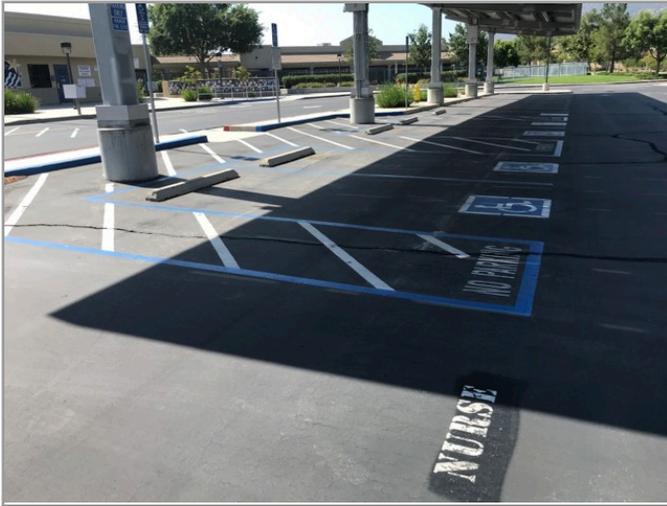
Overview of accessible parking area

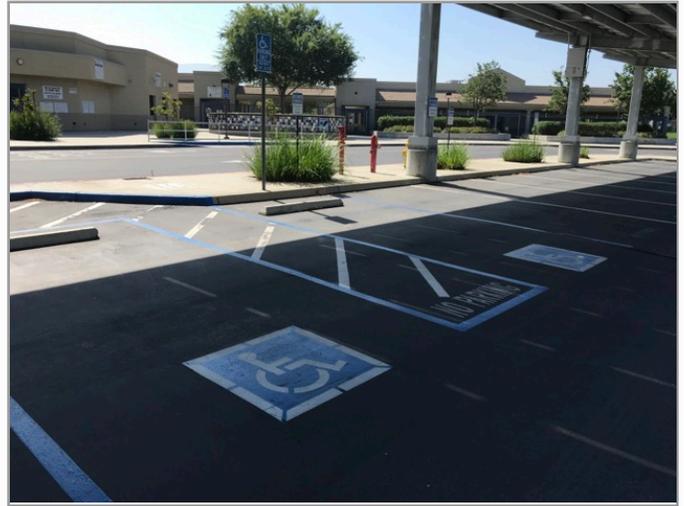
Close-up of stall area of accessible parking

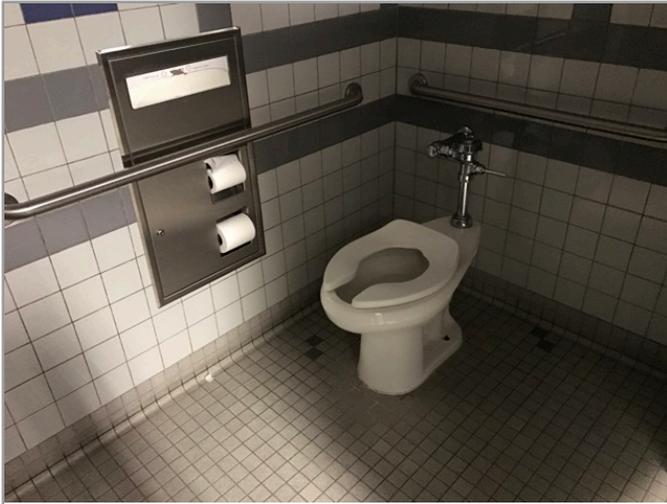
Toilet stall overview

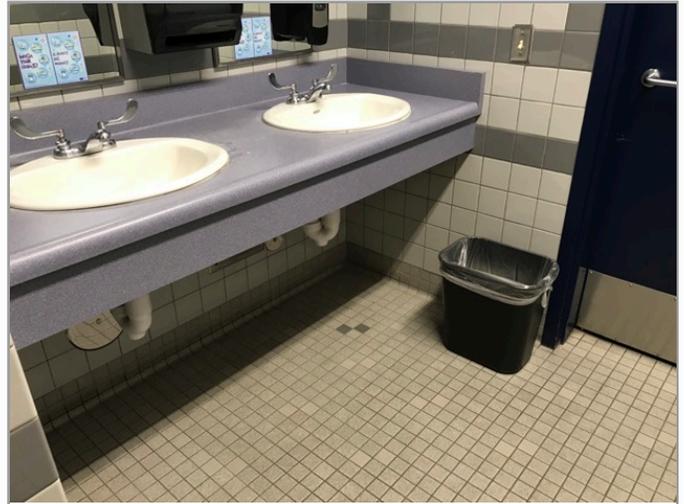
Sink, faucet handles and accessories

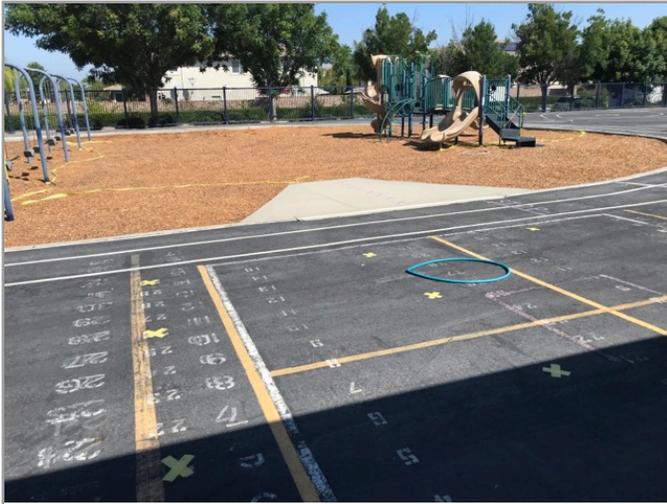
Accessible route to playground

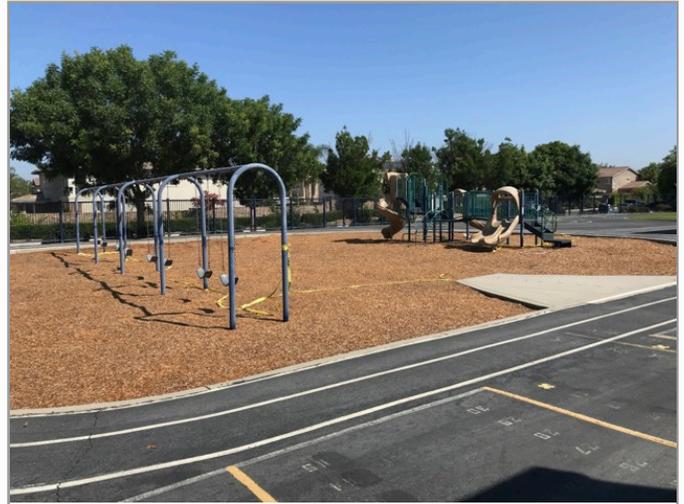
Overview of playground
