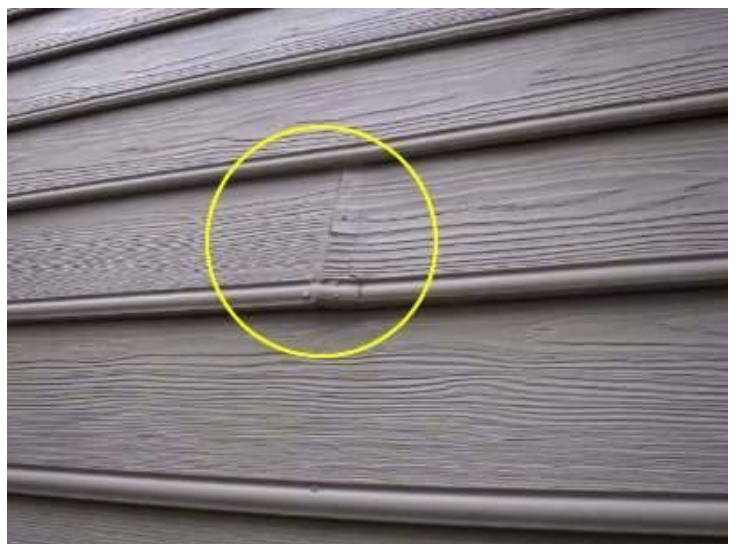
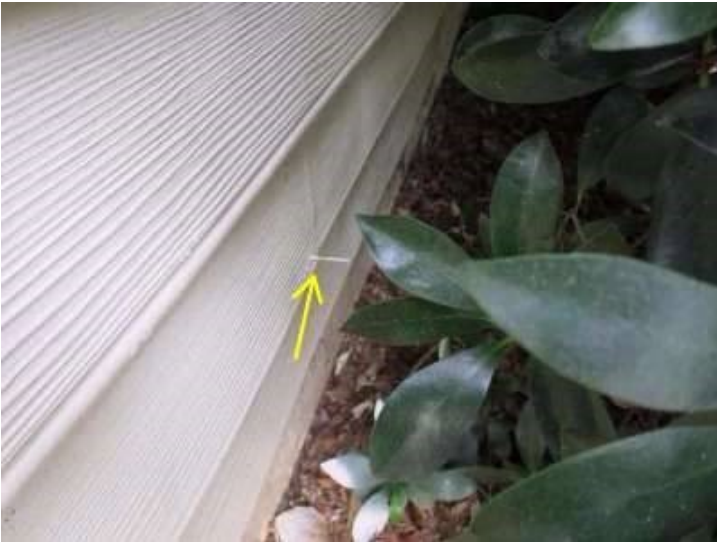
Some nail heads at the composition wood siding were protruding from the wood, or had been nailed in so as to break the surface of the siding, and caulk was missing. Most manufacturers of composition wood siding specify that nail heads should be flush with the surface, and that the surface of the siding should not be broken. If broken, then caulk should be applied to the nail heads to prevent water penetration and subsequent deterioration of the siding. Recommend that a qualified person repair per the siding manufacturer's specifications.

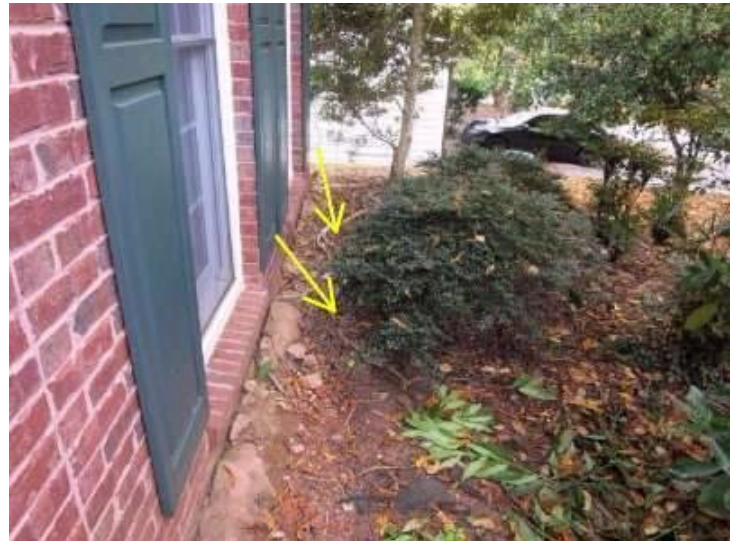
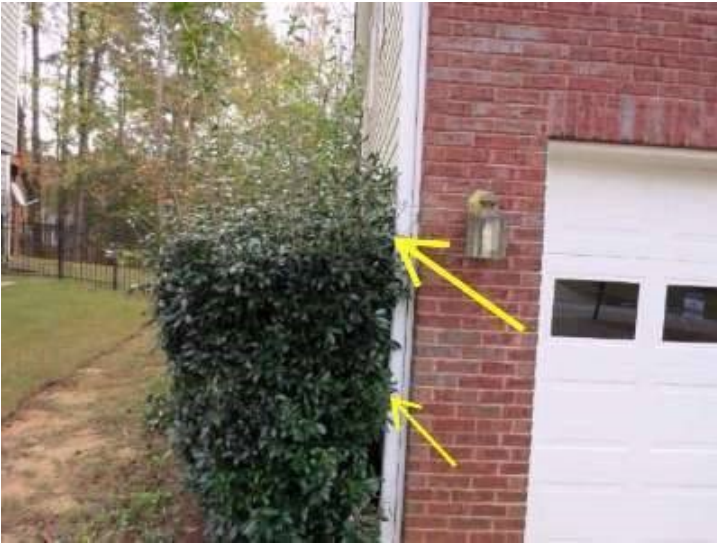
Vegetation such as trees, shrubs and/or vines was in contact with or close to the building exterior. Vegetation can serve as a pathway for wood-destroying insects and can retain moisture against the exterior after it rains. This is a conducive condition for wood-destroying organisms. Recommend pruning, moving or removing vegetation as necessary to maintain at least 6 inches of space between it and the building exterior. A 1-foot clearance is better.

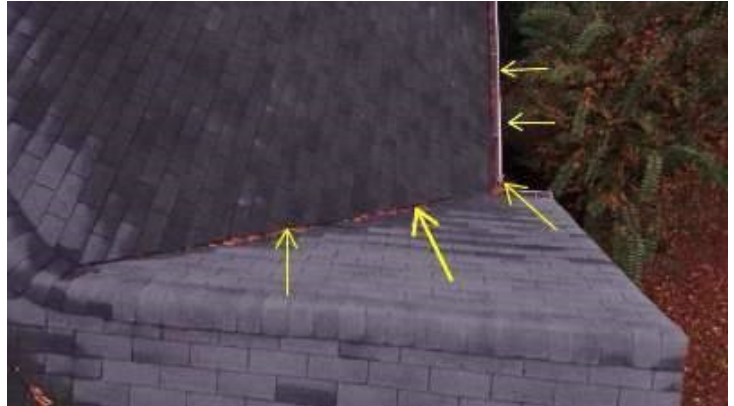
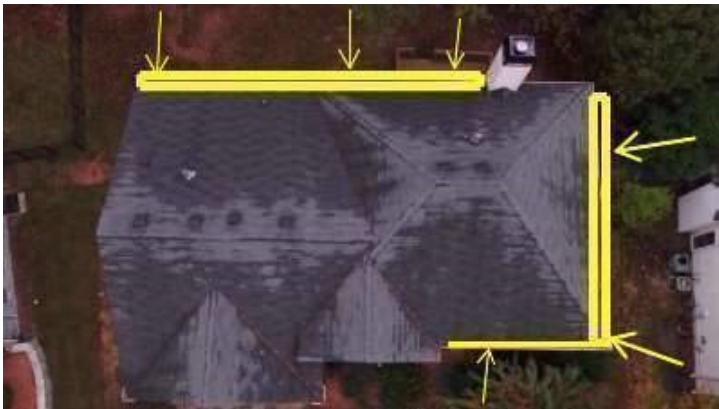
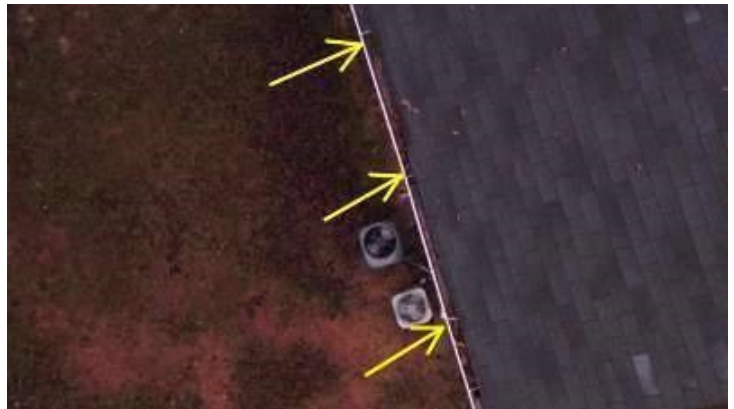
Significant amounts of debris have accumulated in one or more gutters or downspouts. Gutters can overflow and cause water to come in contact with the building exterior, or water can accumulate around the foundation. This is a conducive condition for wood-destroying organisms. Recommend cleaning gutters and downspouts now and as necessary in the future.

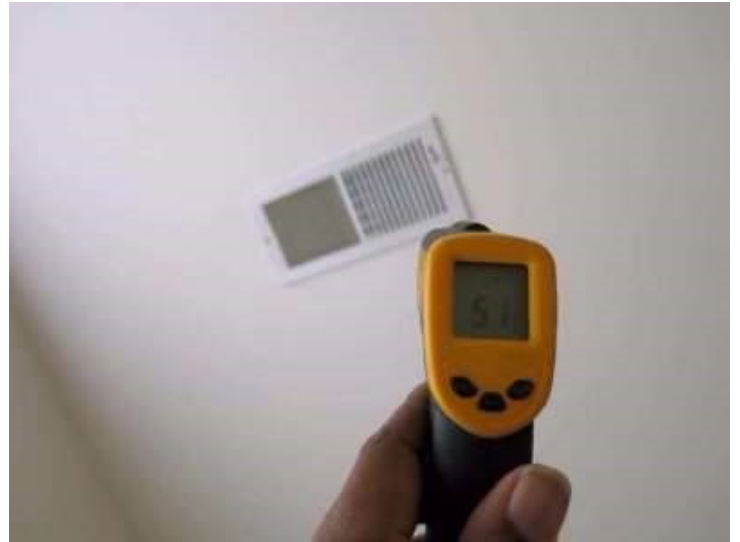
Photo 33-6
A/C 51 °F

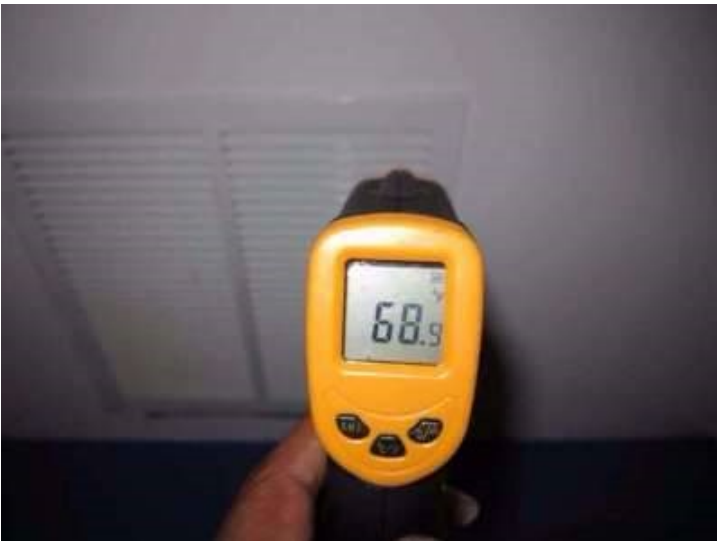
Photo 33-7
A/C Return 17 degree different
Appeared serviceable

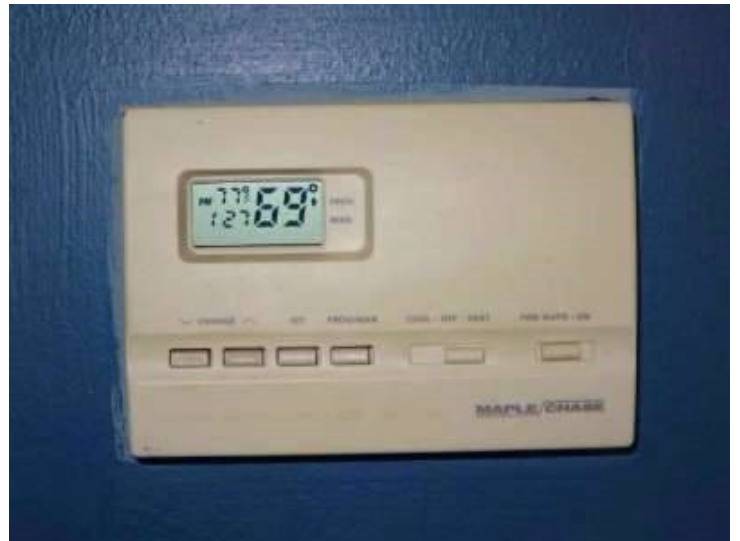
Photo 33-8
Appeared serviceable

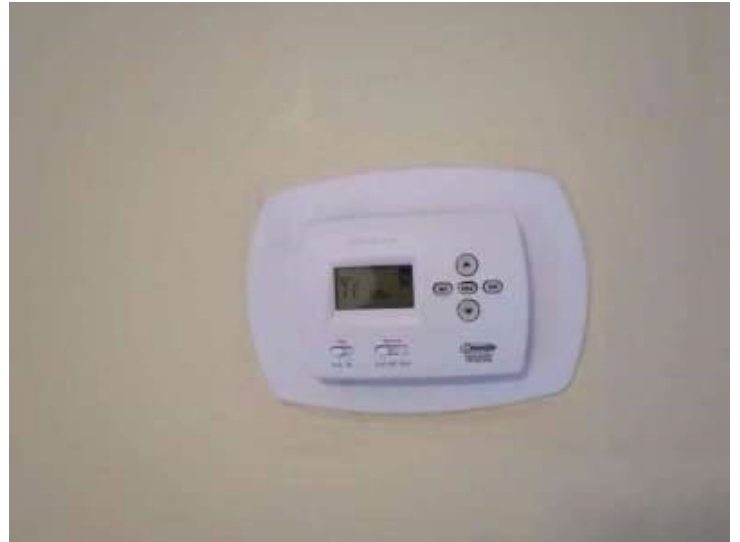
Photo 33-10
Appeared serviceable

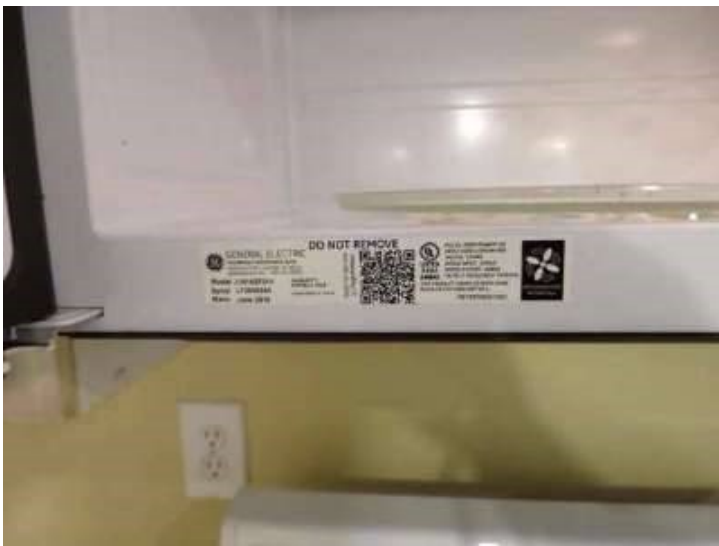
Photo 40-1

The microwave oven was Serviceable

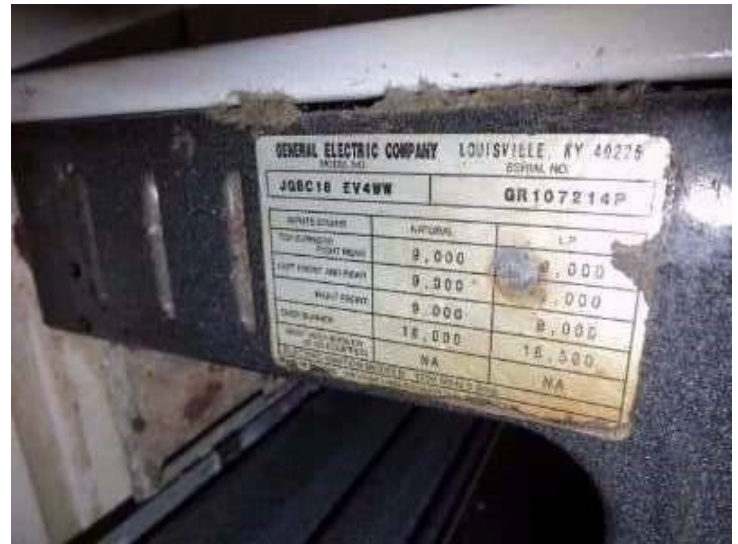
Photo 42-1

The oven bake function appeared to be inoperable. Consult with the property owner. If necessary, a qualified person should repair.

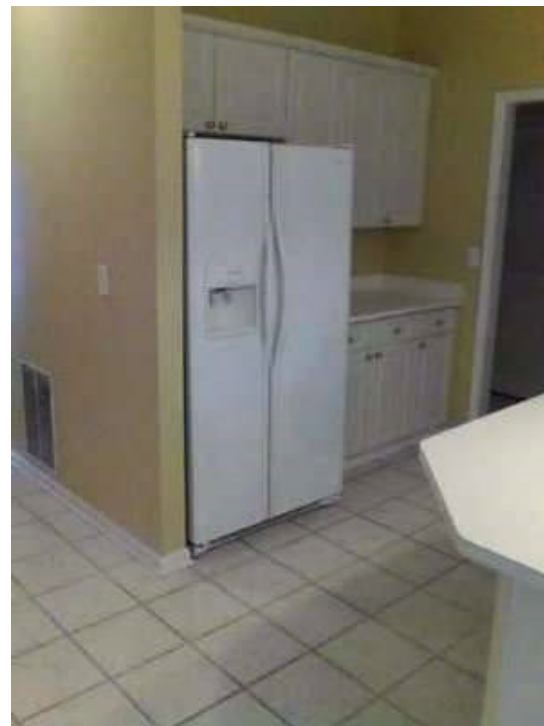
Photo 43-1

43) The refrigerator was Serviceable

Clean the coils may be needed
Recommend that a qualified person repair as necessary.

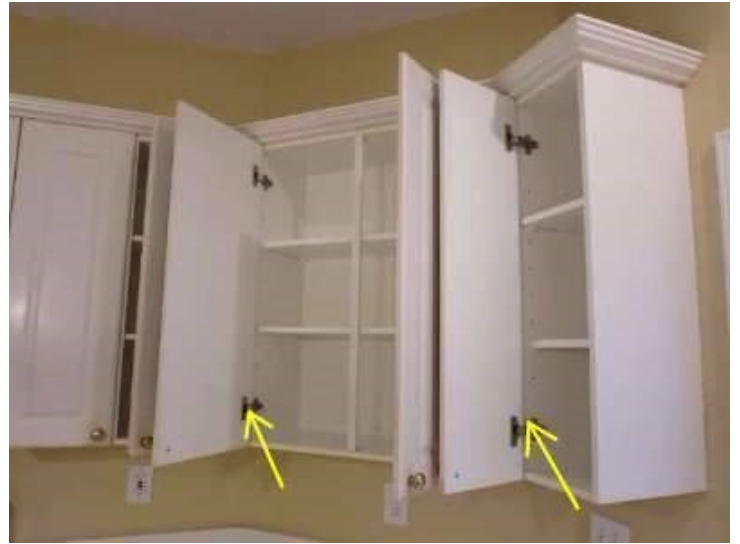
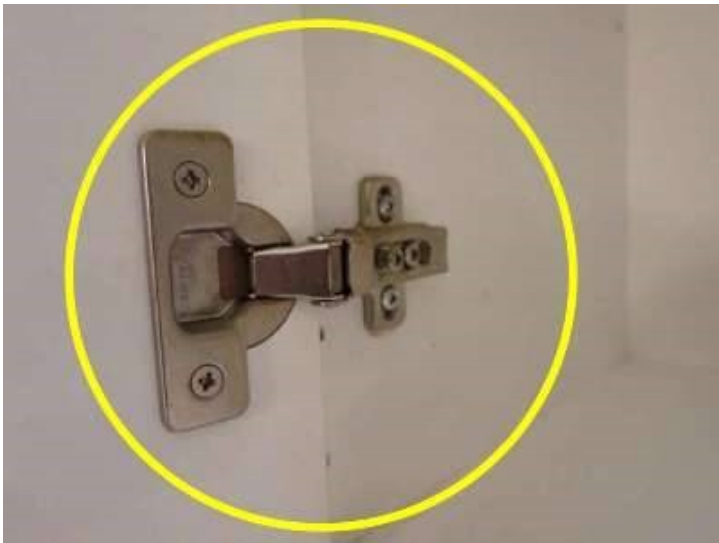
44) One or more cabinets were loose, or were secured with too few or substandard fasteners. An adequate number of appropriate fasteners should be used. For wall-hung cabinets, inadequate fasteners can pose a safety hazard if cabinets fall. Recommend that a qualified person repair as necessary.

Recommend that a qualified person repair as necessary

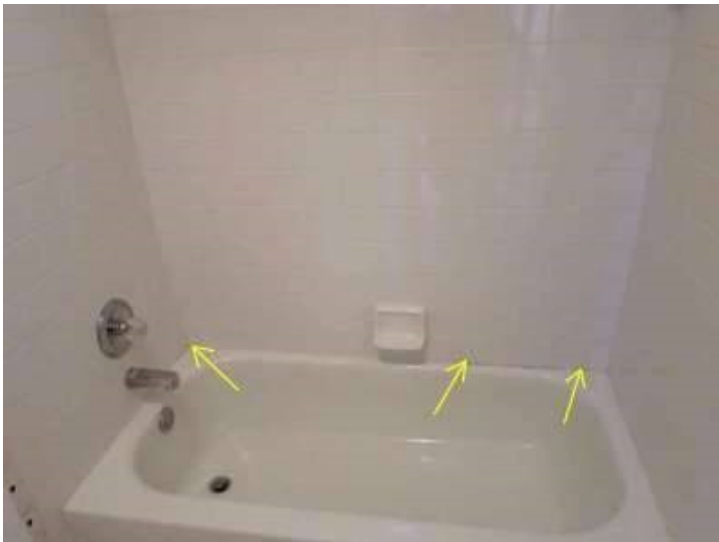
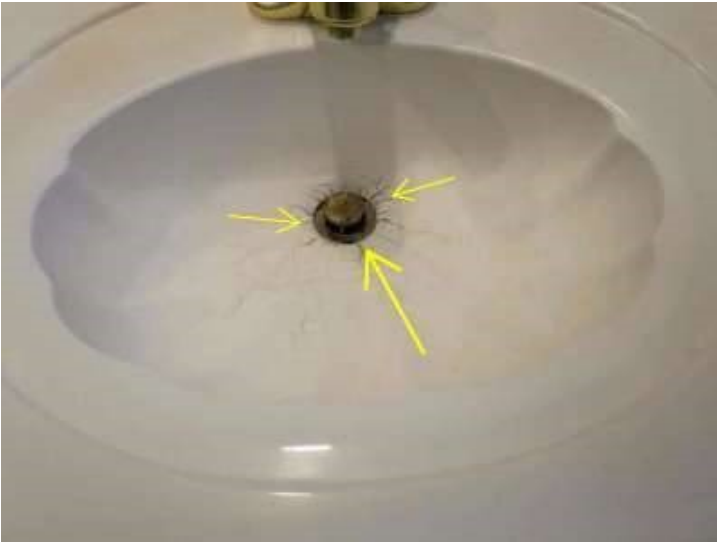
Stains were found in the shelving or cabinets below the sink at location(s) #B. Plumbing leaks may have occurred in the past. Consult with the property owner about this, and if necessary that a qualified person evaluate and repair.

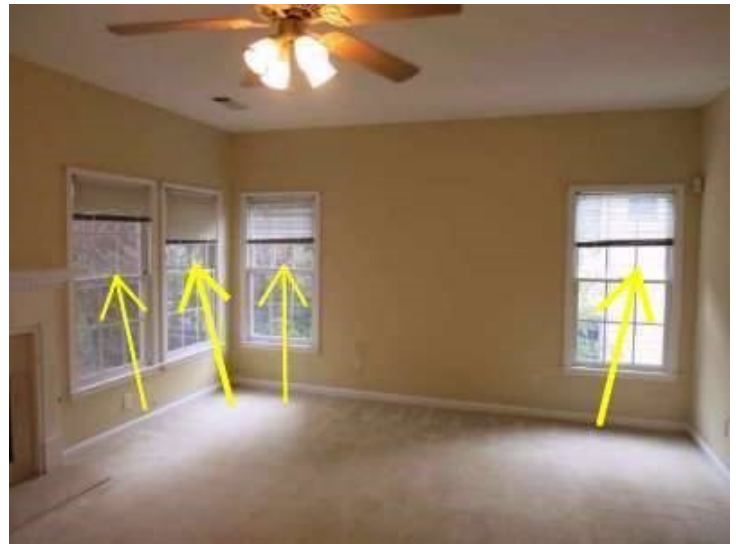
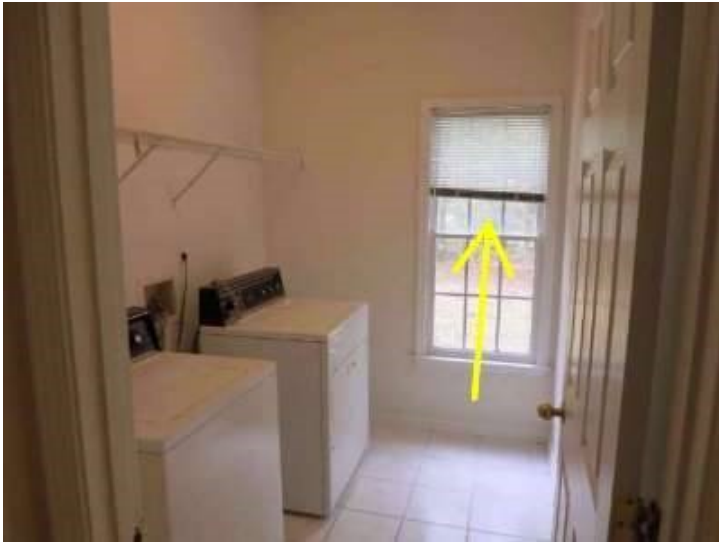
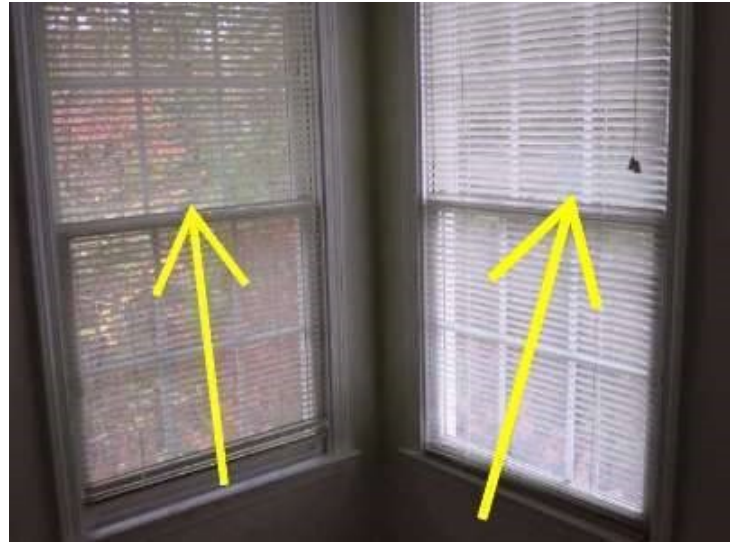
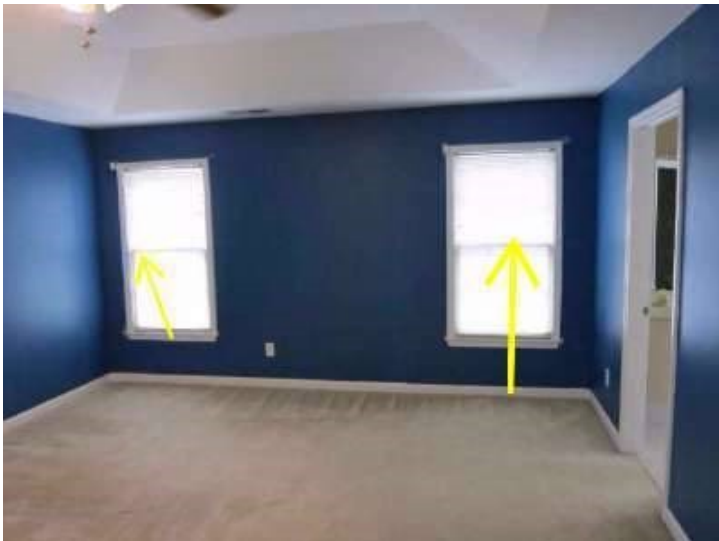
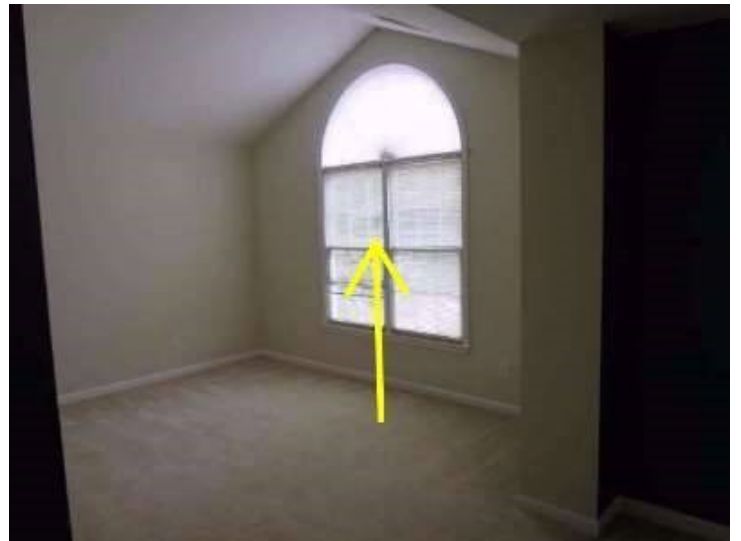
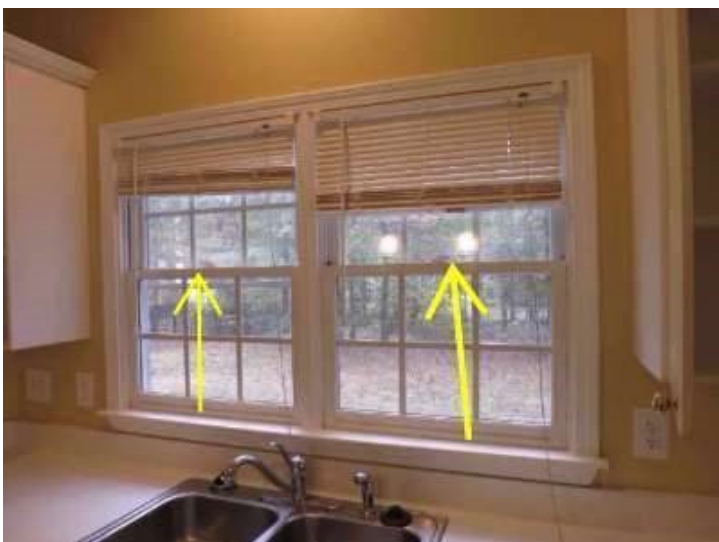
52) 🛠️🔑🔍 One or more windows that were designed to open and close were stuck shut. Recommend that a qualified person repair windows as necessary so they open and close easily.
