Your Inspection Report

11554 136 Street
Surrey, BC V3R 3C2

Thursday, July 21, 2016

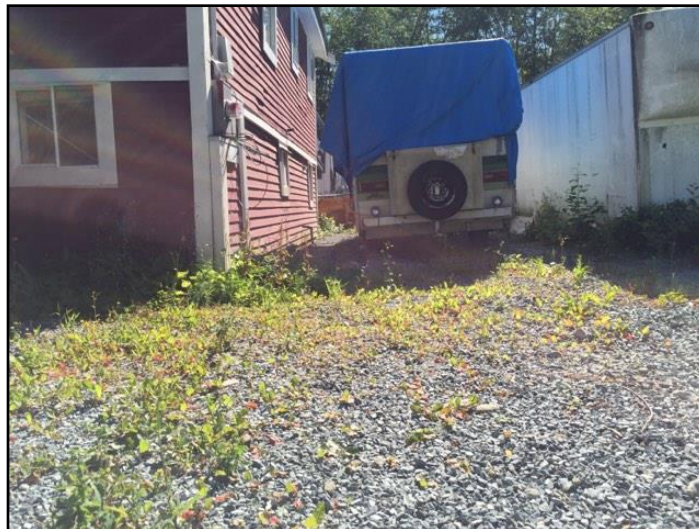
8. Towards building

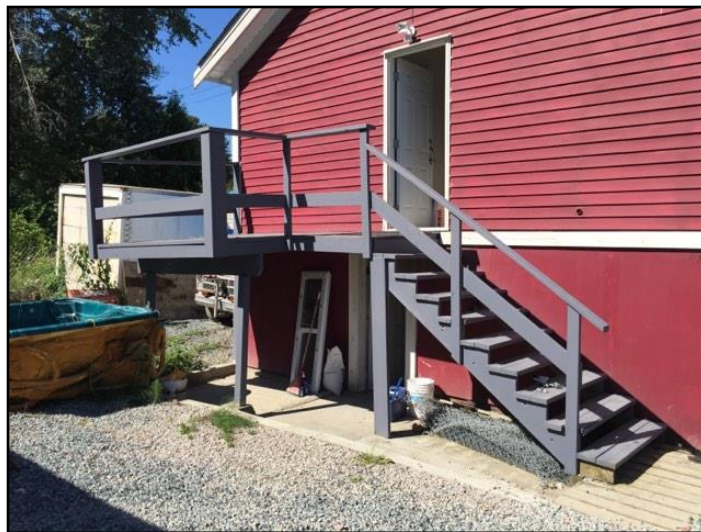
14. Wood Deck at Back

7. • The back deck has been poorly constructed. It is a safety hazard as it stands now and should not be used until made safe by a qualified carpenter or contractor. It has been attached to the house using only wood screws. The best way is to through-bolt the ledger to the rim joist of the house. The main beam has no bracing to prevent it from toppling over. The deck is tilting away from the house. The guardrails and banisters are missing pickets which pose a falling hazard. This is an unsafe arrangement that needs to be addressed. A carpenter or contractor should be brought in to fix these issues so this deck is safe to use. The siding has been patched together using at least four different materials. The vinyl siding is coming away from the building in areas. There needs to be some time spent installing appropriate drip flashings and caulking by a contractor.

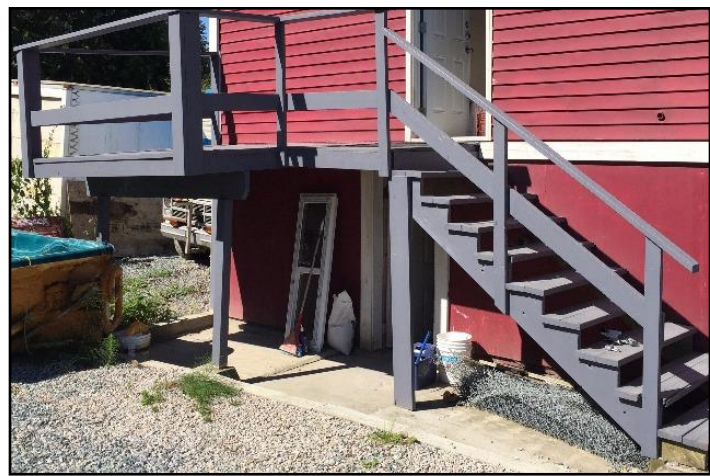
18. Condition: • [Spindles too far apart](#)

28. Spindles too far apart

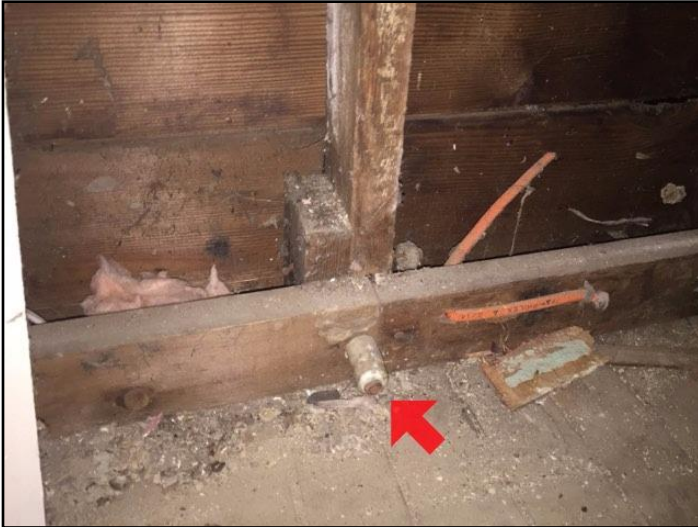
Abandoned

45. Copper - knob and tube

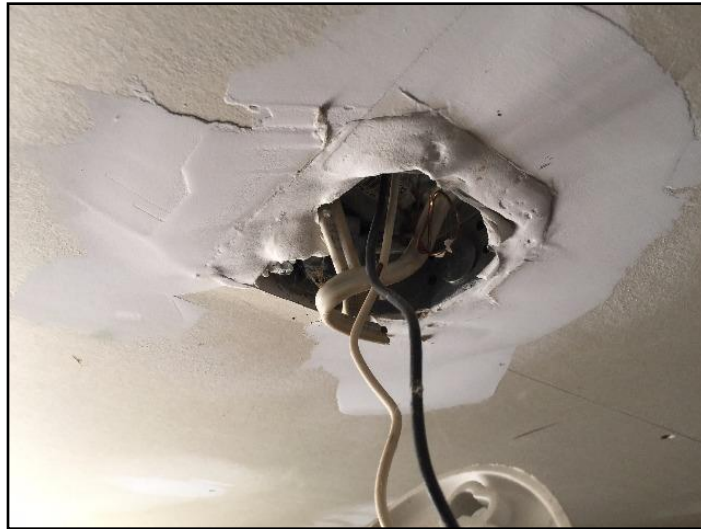
56. Exposed wiring

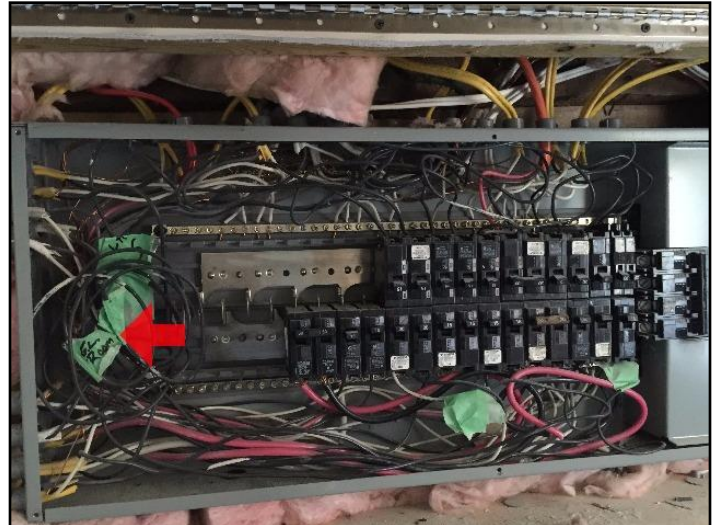
59. Abandoned wire

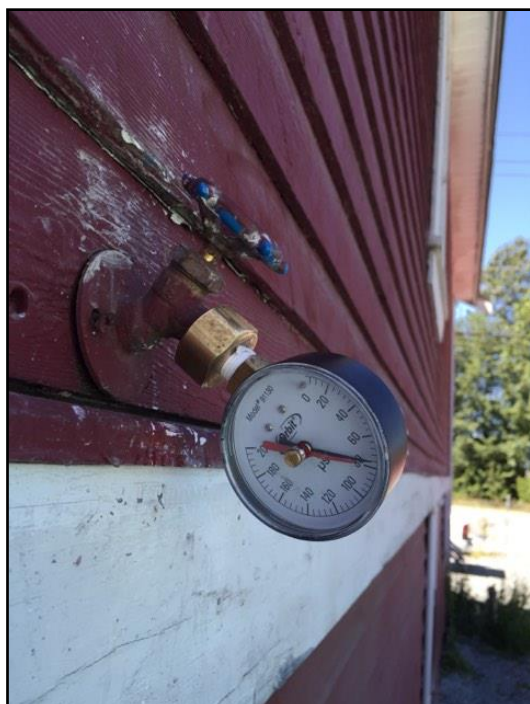
71. Water Pressure 80psi

This is quite a discrepancy in pressure.

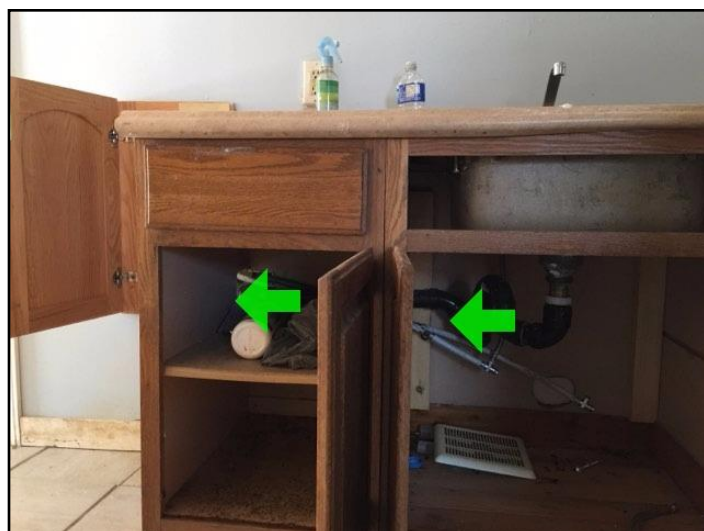
84. Flow of Drain

53. Condition: • Sink drain inoperative. This unusual installation seems to defies gravity.
