Inspection Report

Property Address:
444 Somewhere Ln.
Anywhere NE 12345

Handy Home Inspection Services, LLC

Date: 3/28/2017	Time: 02:20 PM	Report ID: Sample 2
Property: 444 Somewhere Ln. Anywhere NE 12345	Customer: Mr. John Smith

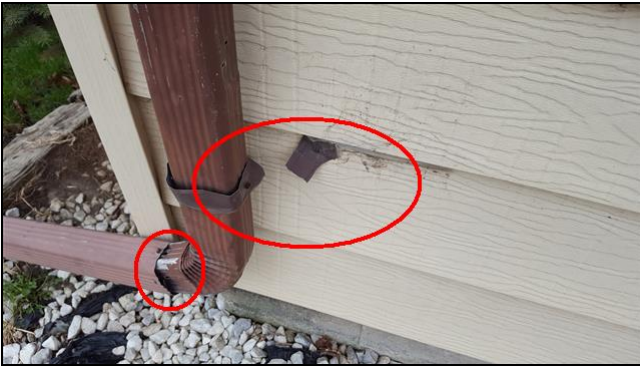
1.4 Item 2(Picture)

1.4 Due to the lack of recent rain, I am unable to determine if gutters leak at seams or spills water. There are several location where the gutter is bent or not attached properly to the house. The downspouts are not secured properly or have broken away from their brace. Large gaps between the pipes could potentially allow water to leak out of the downspout near the foundation of the house.

There was a little bit of standing water on the front west corner of the house at the time of inspection. This would suggest the gutter is sagging or was not installed with the proper slope. If you notice water coming out of the gutter during a rainfall, I recommend getting all gutters replaced.

The drip edge is beginning to rust. The drip edge prevents ice damming and helps direct water into the gutters. If the drip edge fails due to the rusting, the fascia will be susceptible to rot.

On the south east corner of the house I **recommend running the downspout past the retaining wall**. The water can penetrate between the retaining wall and soil and cause damage/cracking on the retaining wall.

Estimated remaining life on current gutters is short. I recommend budgeting for new gutters in the near future.

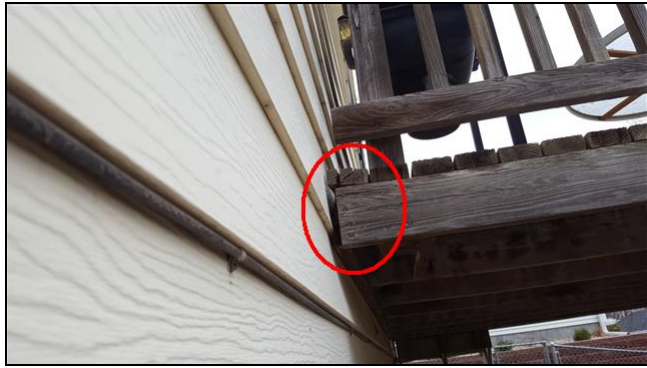
2.3 Item 3(Picture) Ledger

The ledger is not flush with the house. It appears that the top is pulling away from the house. **Recommend** having structure evaluated and repaired by a professional contractor.

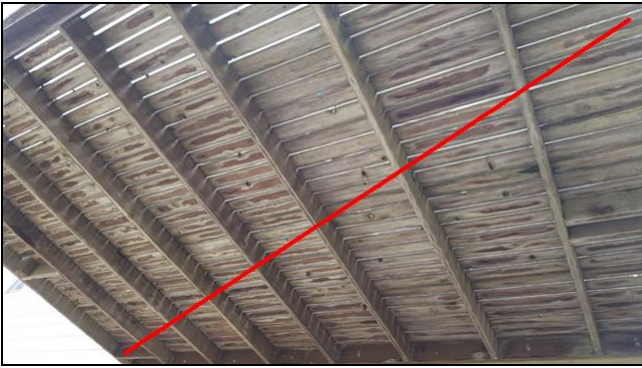
2.3 Item 4(Picture) Underneath deck

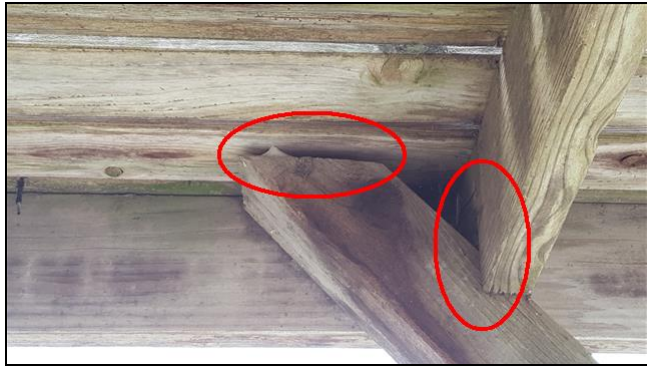
2.3 Item 5(Picture)

There were 25+ nails popped on the deck and guardrail. This is a tripping hazard as well as a structural hazard.

Several boards had cracks 1/4" or more deep which would indicate some rot.

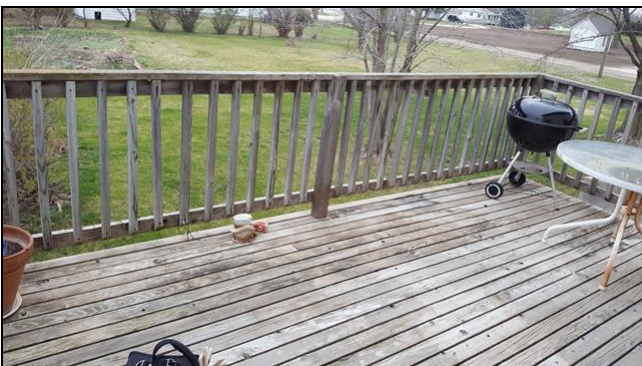
The guardrail should have support posts every 6'. The maximum space between spindles should be no more than 4" for safety. They are currently spaced at 4.75" with an inadequate number of support posts.

2.3 Item 8(Picture) Guardrail

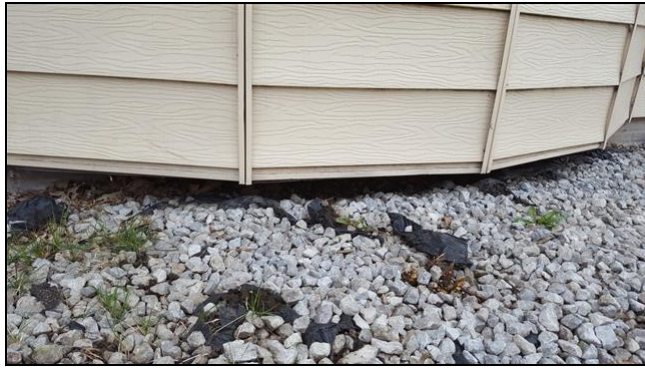
2.4 Item 2(Picture) Sinking under bay window

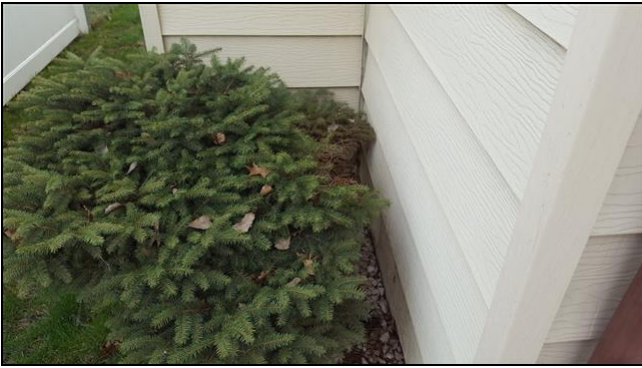
2.4 Item 3(Picture) Vegetation against house

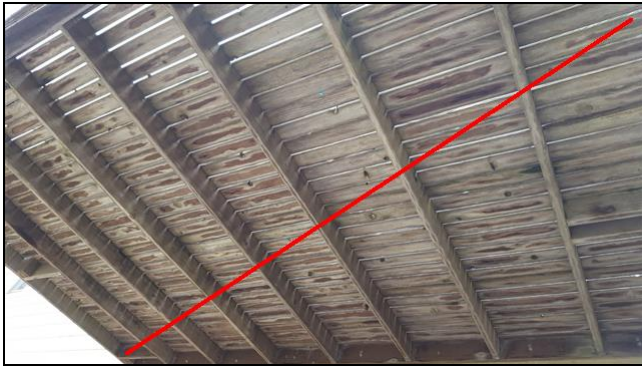
2.3 Item 4(Picture) Underneath deck

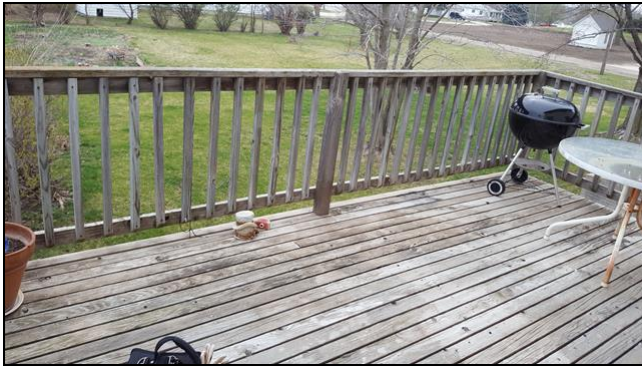
2.3 Item 8(Picture) Guardrail
