# **Inspection Report**

12345 Mountain Orchard Dr., Lake County, California 12345

**Inspection Date** March 16, 2018 **Inspector** Keith Henry 707.354.4472 keithrhenry22@gmail.com

**Henry Home Inspections**

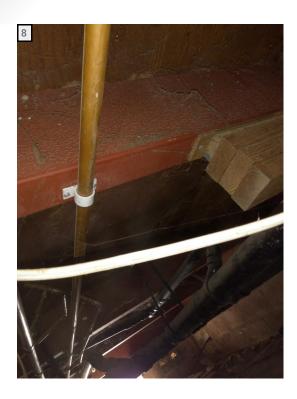
**Location** Crawl Space

## **Satisfactory**

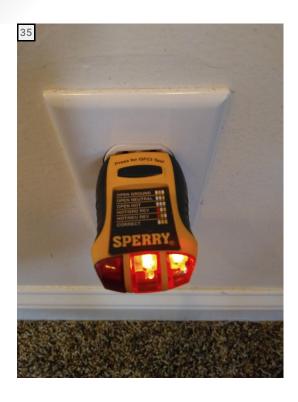
**Location** Living Room

#### **All outlets correct**

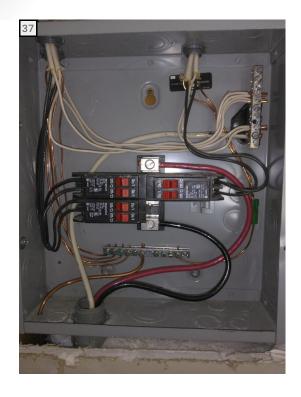
# Wiring is satisfactory Location Detached Garage

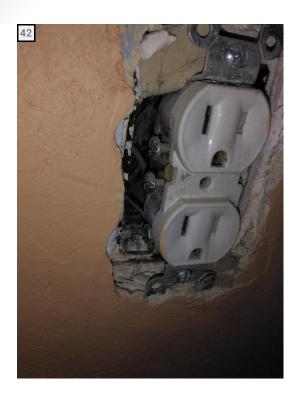
Location 1st Bedroom (Master Bedroom bedroom)

## **Copper wiring**

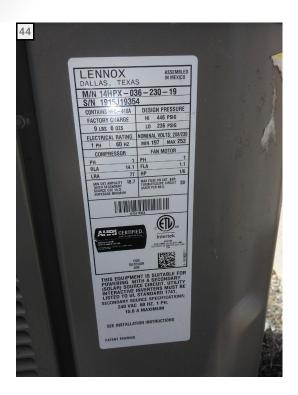
**Location** Exterior: Ground View

## Manufacturer data plate

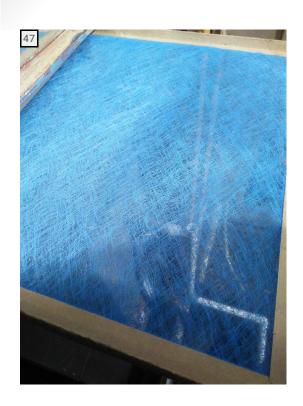
**Location** Exterior: Ground View

## Air filter is clean

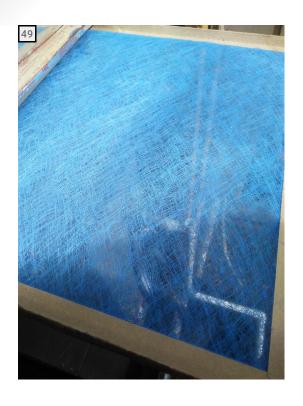
**Location** Exterior: Ground View

#### **Size 20x20x1**

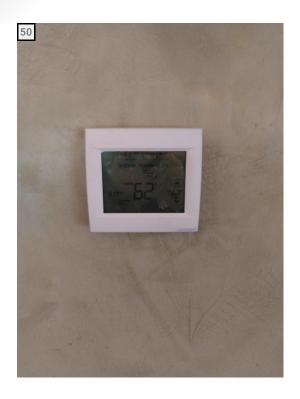
**Location** Kitchen (Wall between kitchen and dining room)

#### In working order

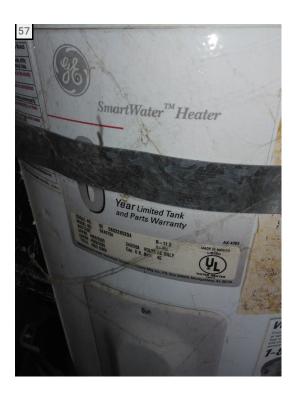
**Location** Exterior: Ground View

## Manufacturer data plate
