# Inspection Report

1122 Behind the Moon Blvd., Northern, California 12345

**Inspection Date** March 28, 2018  
**Inspector** Keith Henry  
707.354.4472  
[keithrhenry22@gmail.com](mailto:keithrhenry22@gmail.com)

**Henry Home Inspections**

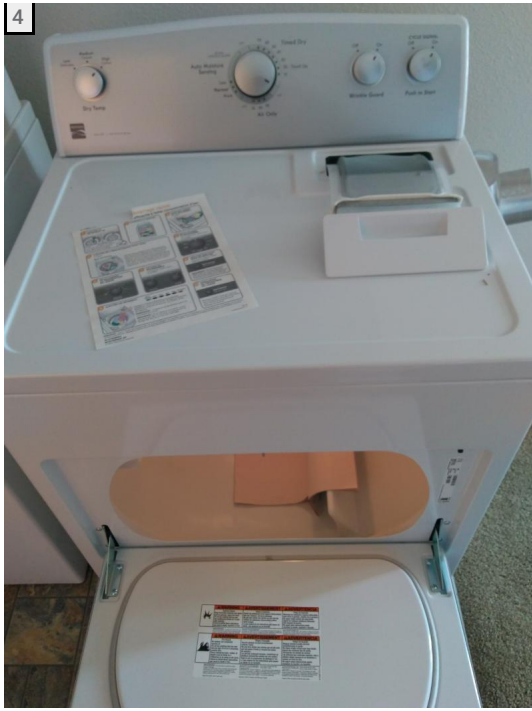
Location Laundry Room / Mudroom, Hallway and Stairs

**Unit is in working order**

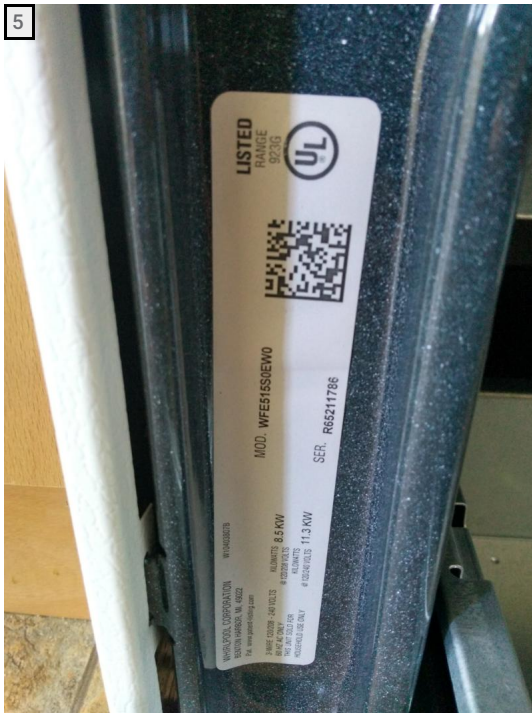
Location Kitchen

**Manufacturer data plate**

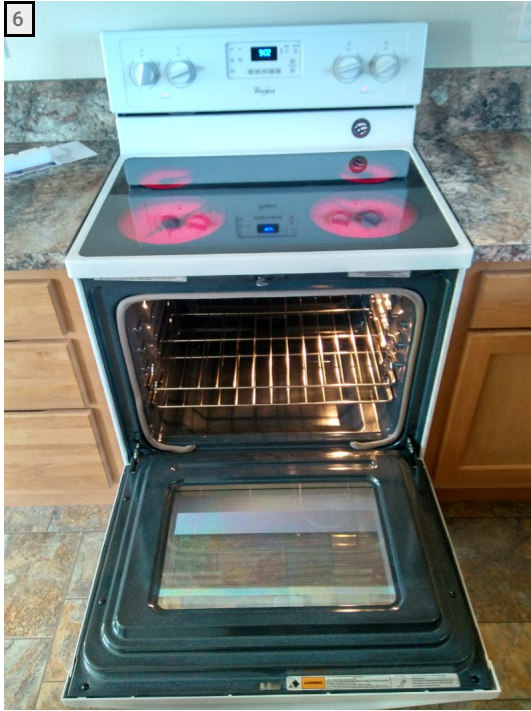
Location Kitchen

**Unit is in working order**

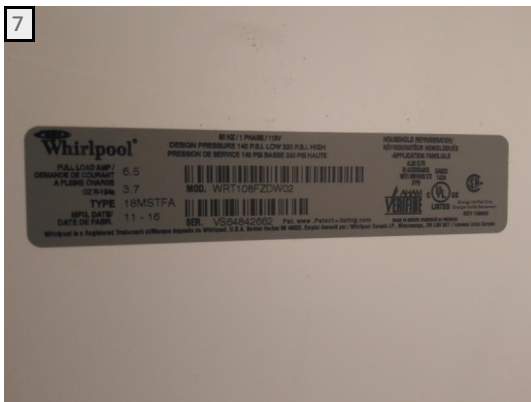
Location Kitchen

**Manufacturer data plate**

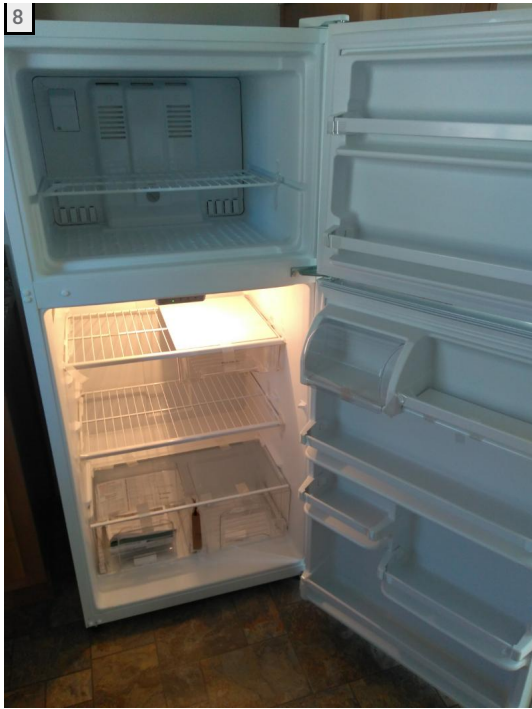
Location Kitchen

**Unit is in working order**

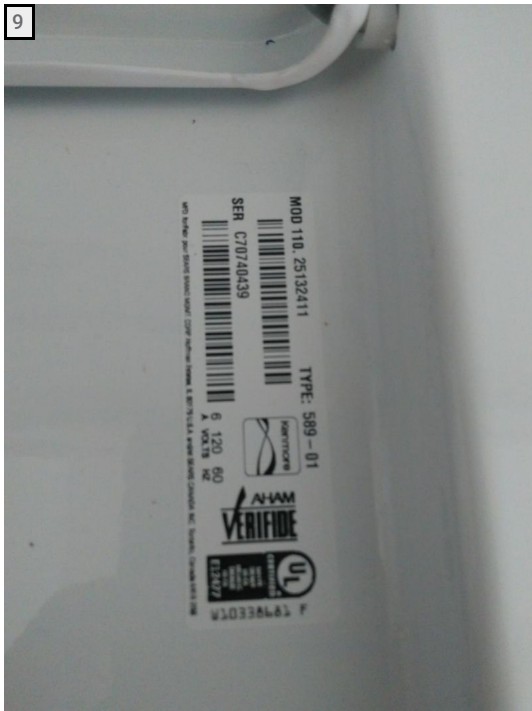
Location Laundry Room / Mudroom

Manufacturer data plate

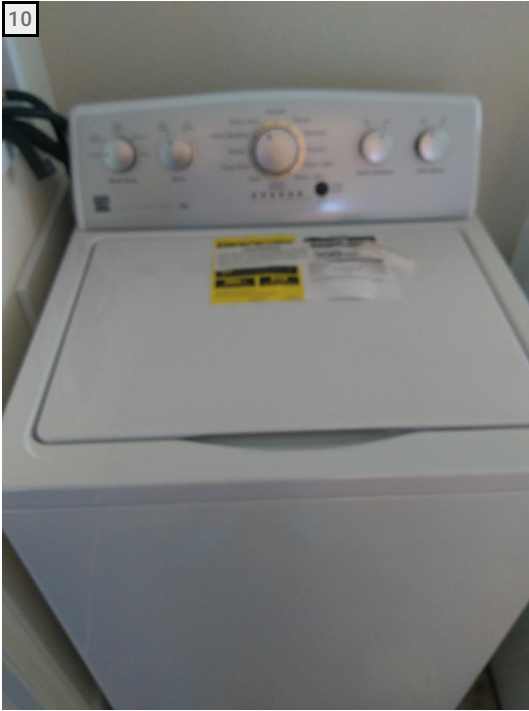
Location Laundry Room / Mudroom

**Unit is in good condition**

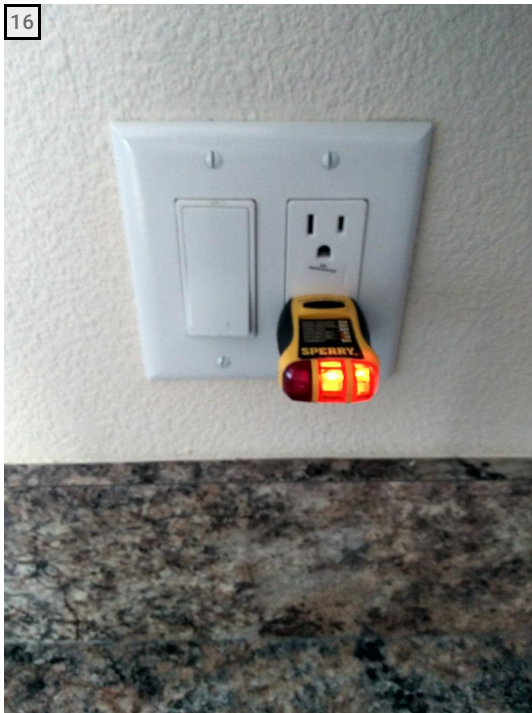
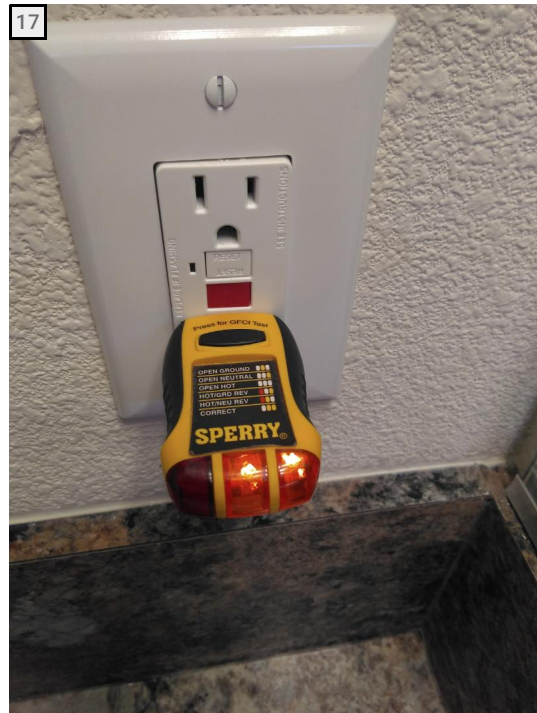
Location Kitchen (Kitchen outlets), 1st Bathroom

Wired correctly and is GFCI protected

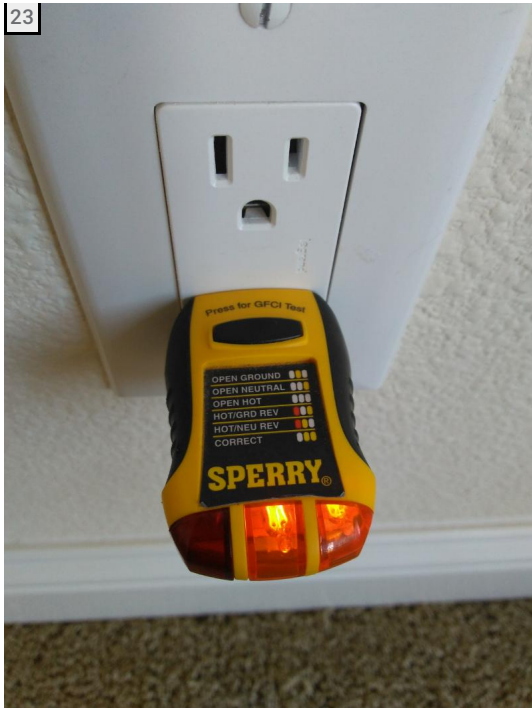
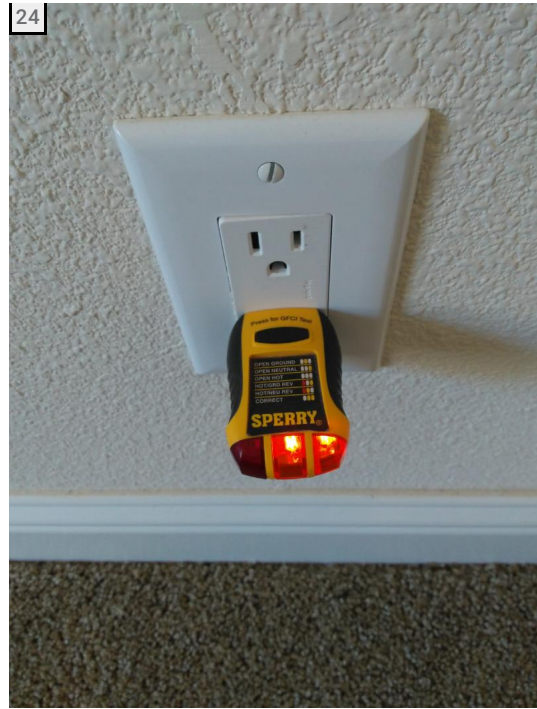
Location Living Room (Front room living room), 2nd Bedroom (Master bedroom, east side of house bedroom)

**All outlets correct**

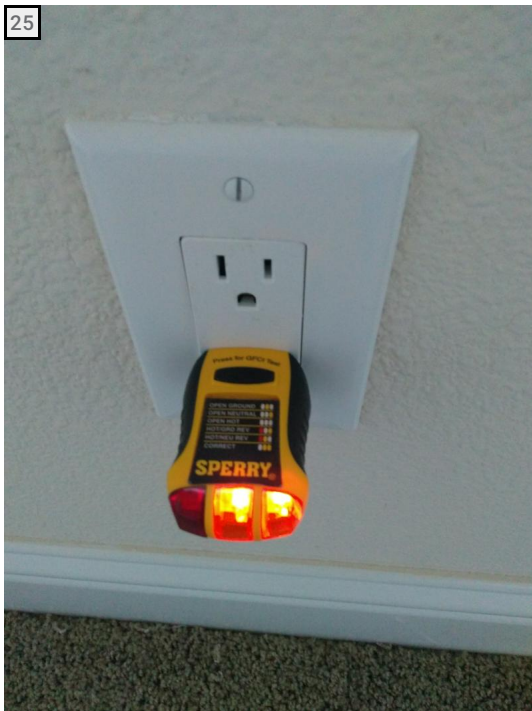
Location 1st Bedroom (Spare bedroom, center of home bedroom)

**Wired correctly**

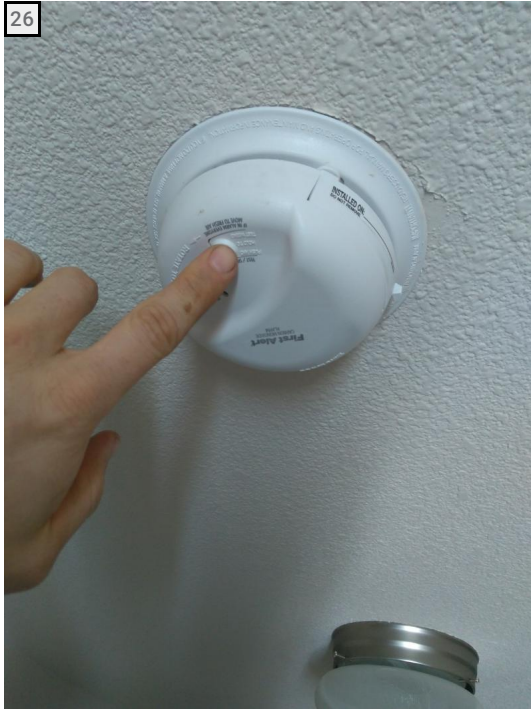
Location Hallway and Stairs (Throughout house)

**In working order**

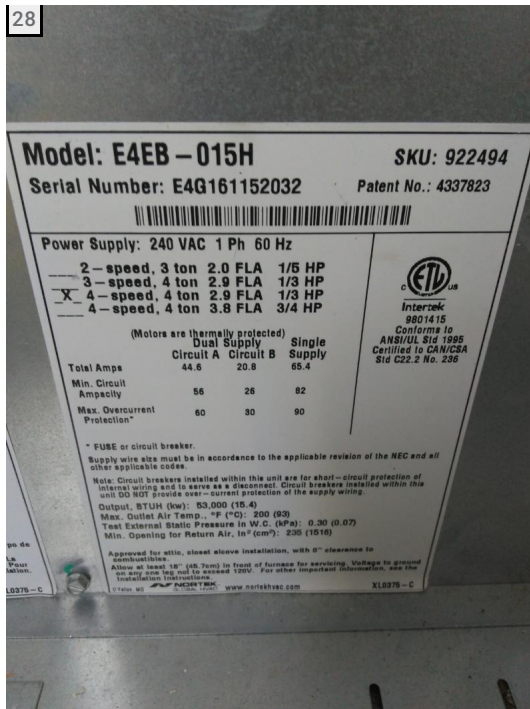
Location Hallway and Stairs

#### Manufacturer data plate

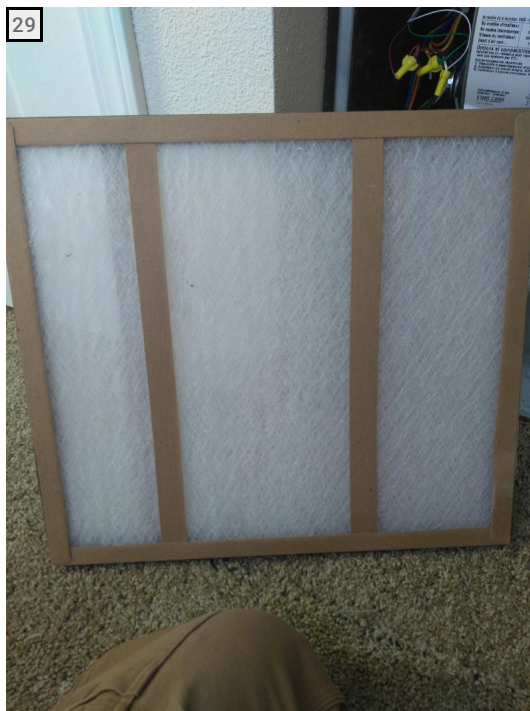
Location Hallway and Stairs

**Size 18" x 20" x 1". Replace filter as needed.**

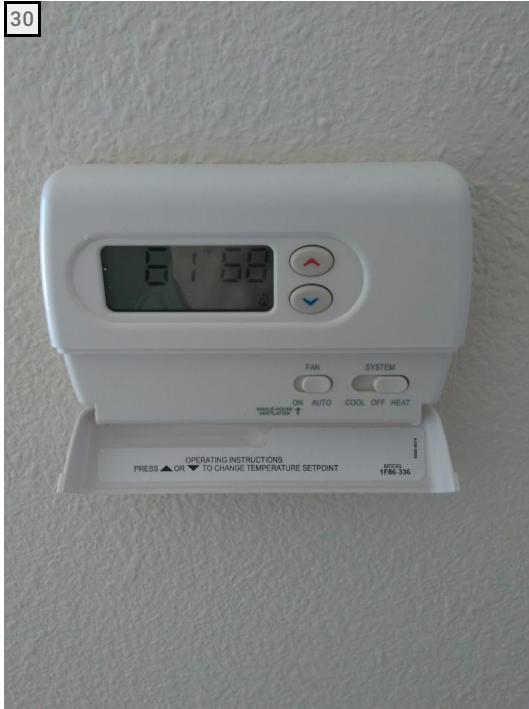
Location Hallway and Stairs (Hallway wall)

### In working order

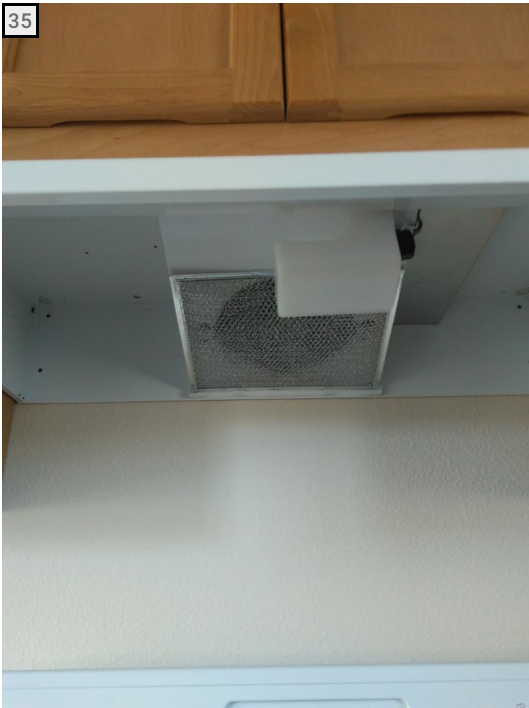
Location Kitchen

**In working order. Vents to exterior.**

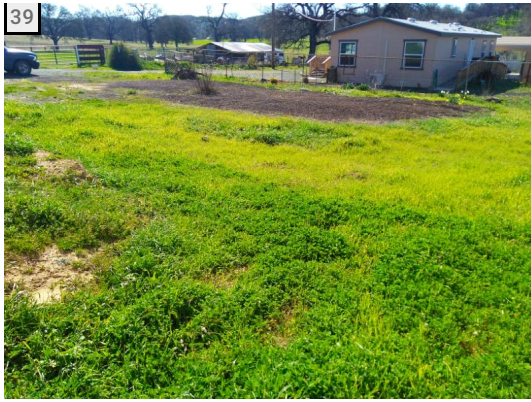
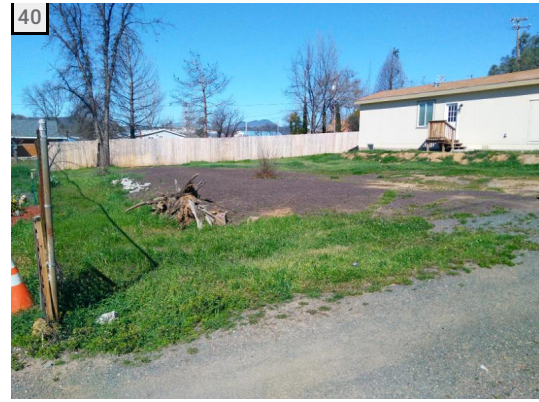
Location Exterior: Ground View

**South side of house**

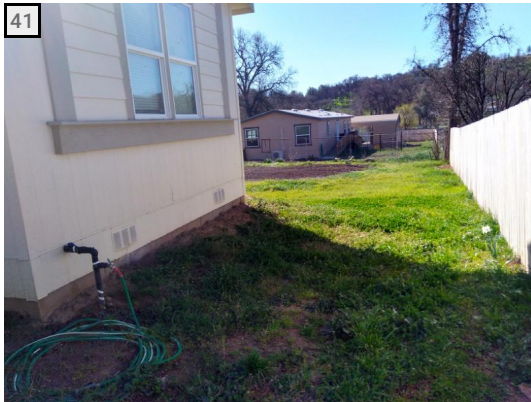
Location Exterior: Ground View

### West side of house

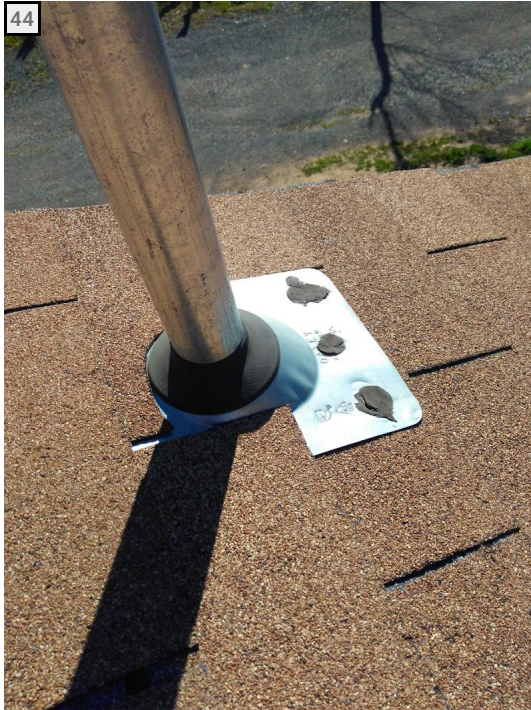
Location Exterior: Roof View

**Satisfactory flashing around masthead.**

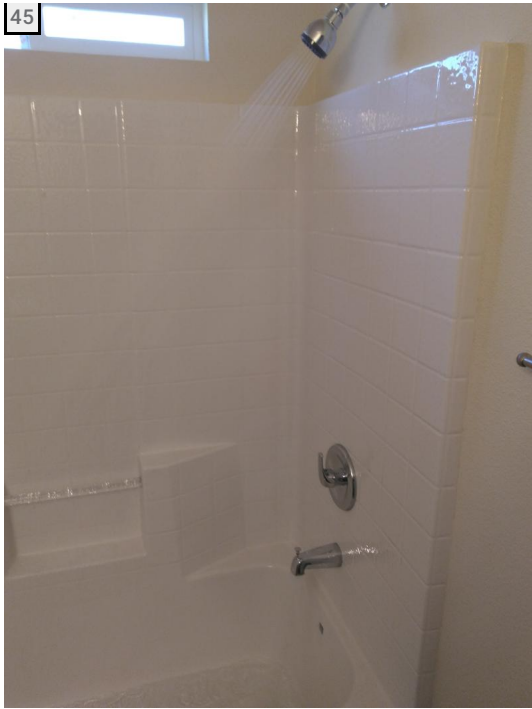
Impact No hot water. Water comes from both shower head and faucet.

Suggested Action Watch video to see how to adjust or hire a qualified professional.

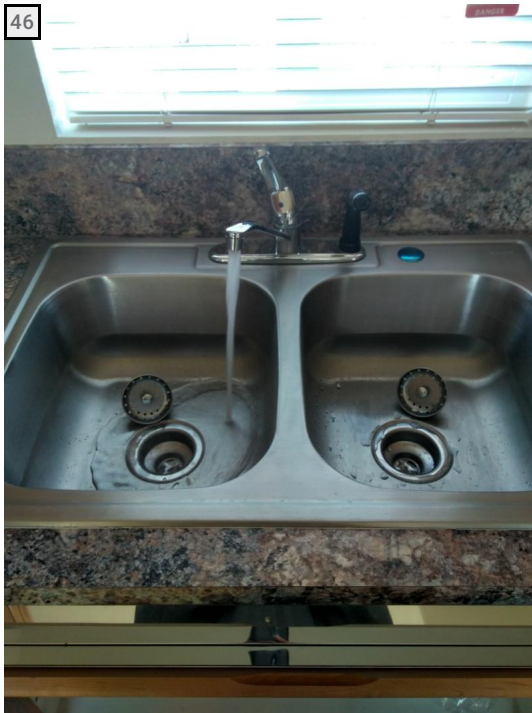
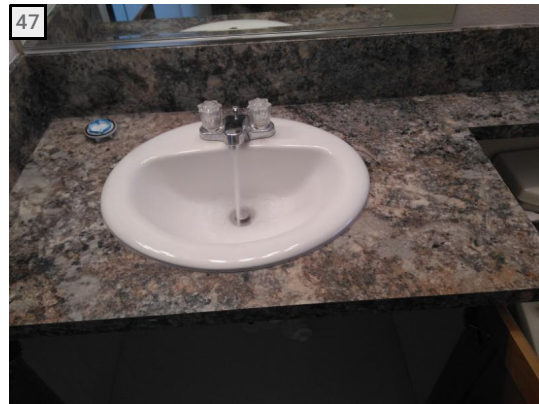
Location Kitchen, 1st Bathroom

Satisfactory

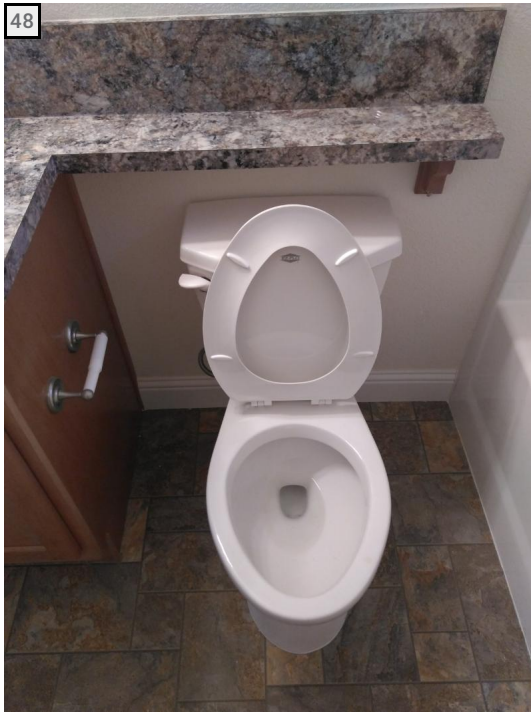
Location 1st Bathroom

### Toilet is in working order

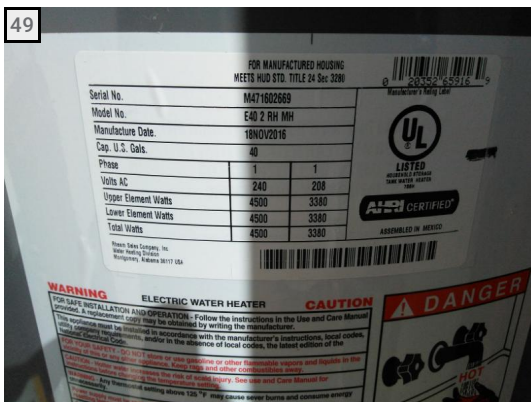
Location Exterior: Ground View

### Manufacturer data plate

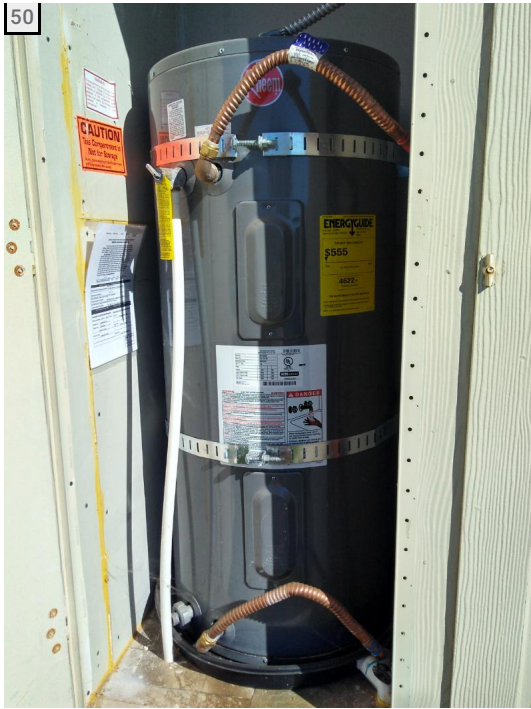
Location Exterior: Ground View

### Sufficient seismic straps

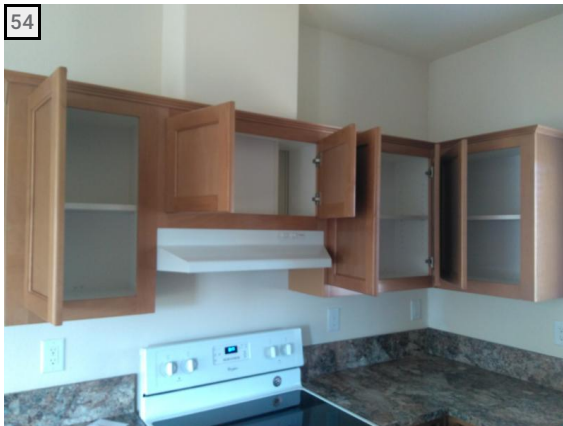
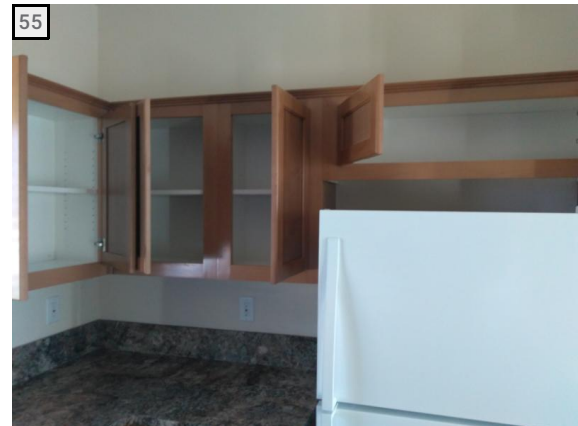
Location Hallway and Stairs, Kitchen

Satisfactory

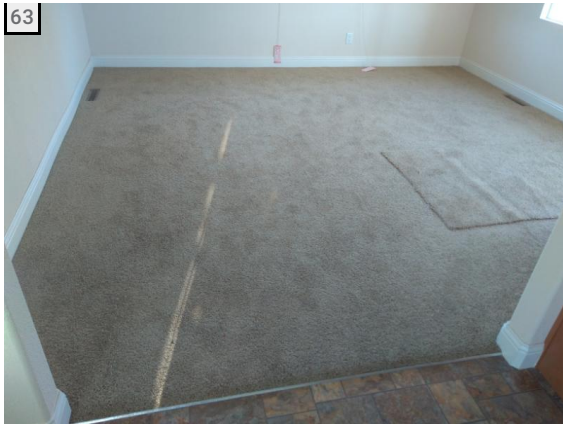
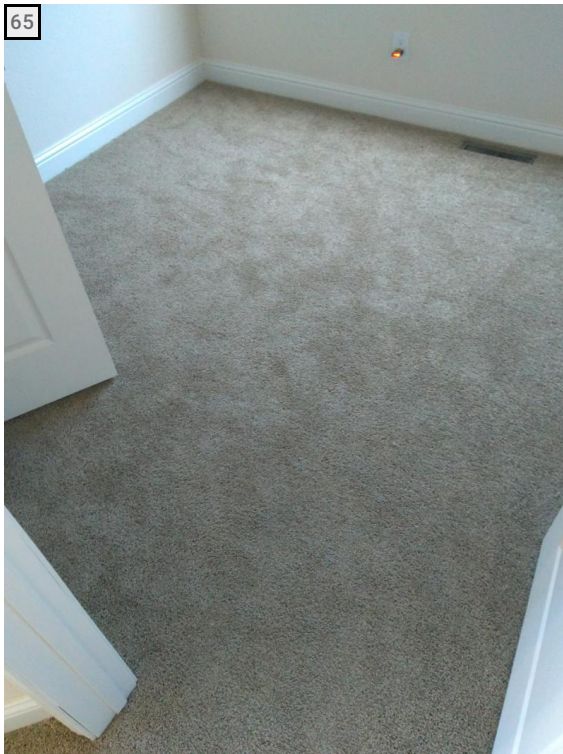
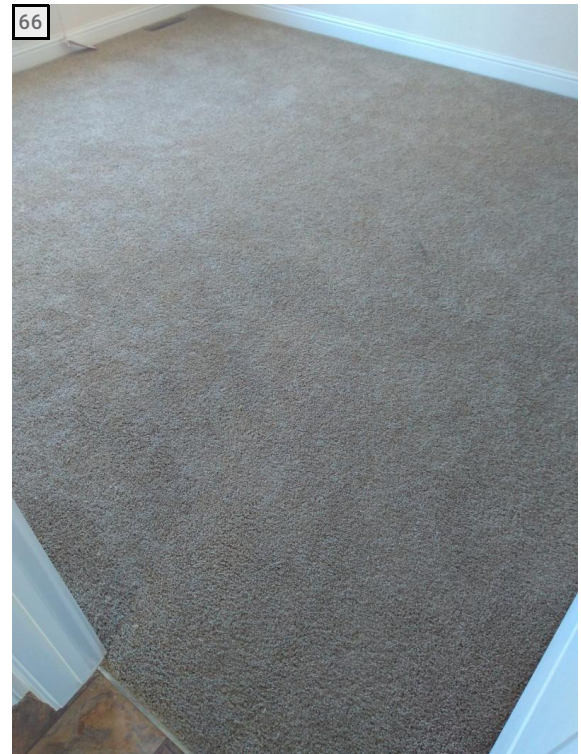
**Carpeting satisfactory**

Location	Hallway and Stairs, Living Room (Front room living room), 1st Bedroom (Spare bedroom, center of home bedroom), 2nd Bedroom (Master bedroom, east side of house bedroom)
----------	---

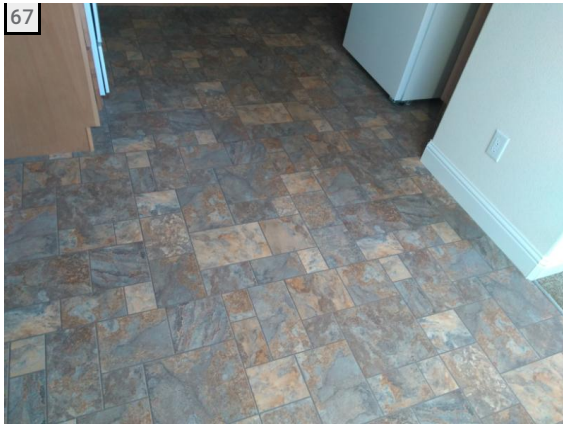
**Sheet vinyl flooring**

Location Hallway and Stairs, Kitchen, 1st Bathroom

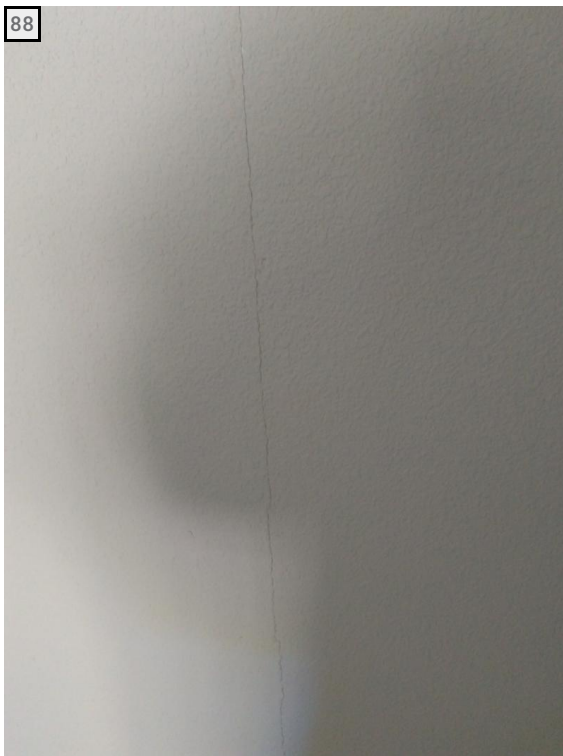
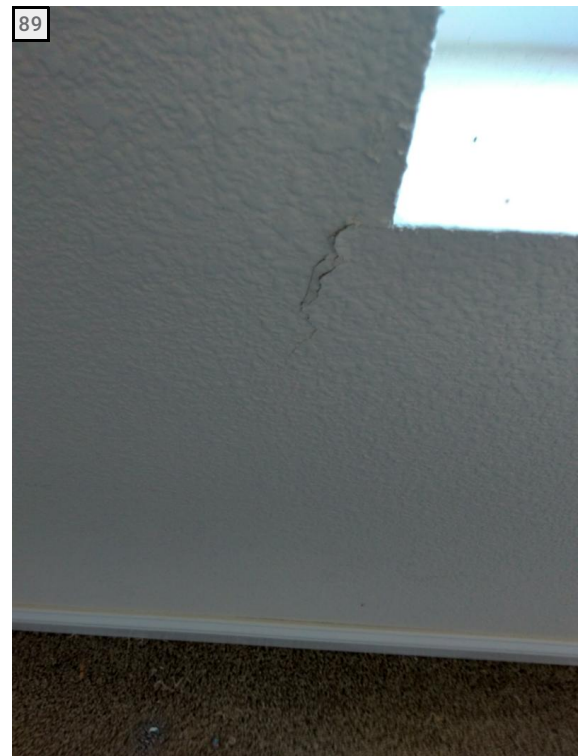
### Drywall crack

<b>Location</b>	Hallway and Stairs, Kitchen, Living Room (Front room living room), 1st Bathroom, 1st Bedroom (Spare bedroom, center of home bedroom), 2nd Bedroom (Master bedroom, east side of house bedroom)
<b>Impact</b>	Should be monitored. Could indicate settling foundation or weak framing if crack grows.
<b>Suggested Action</b>	Have repaired by a qualified contractor
<b>Other Information</b>	Drywall cracks are expected when setting a mobile home. In this situation the cracks can normally be considered cosmetic.

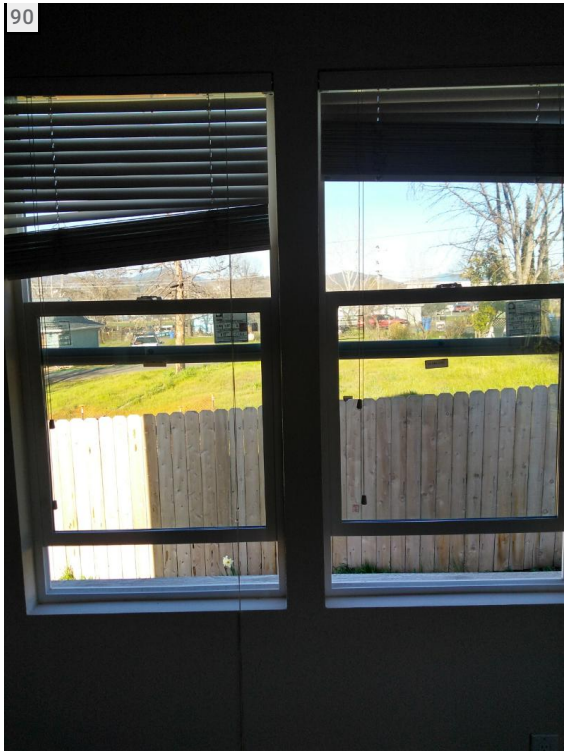
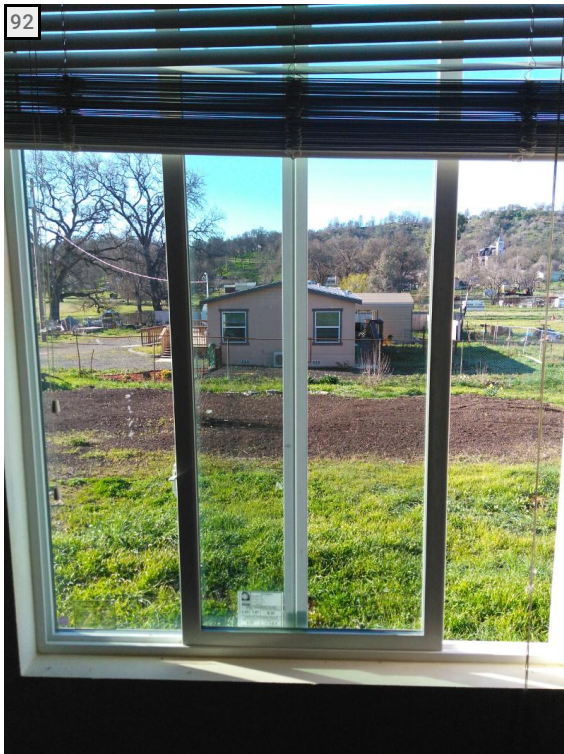
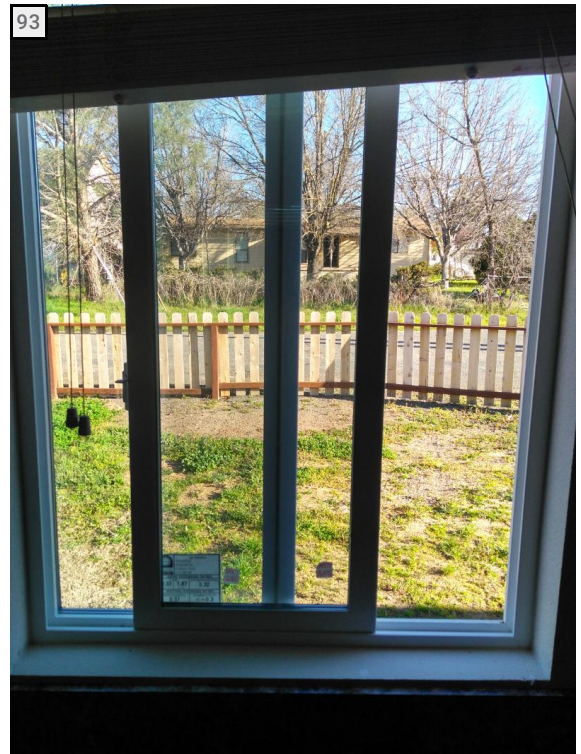
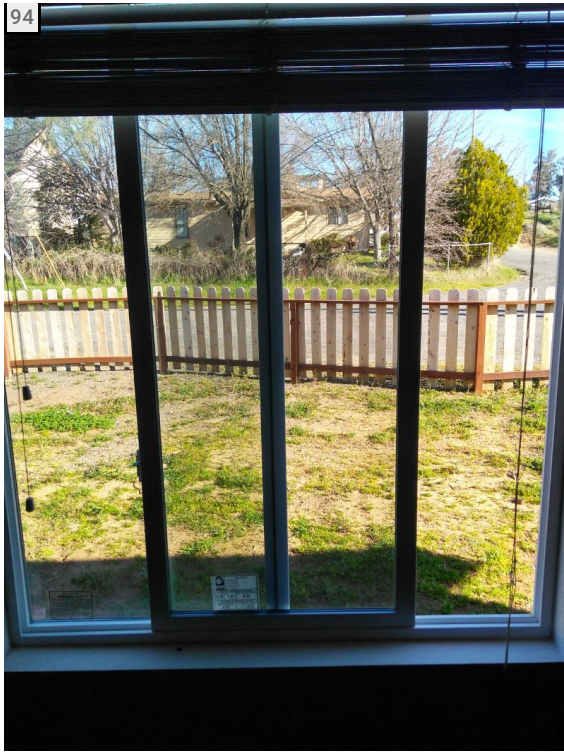
**Windows are in working order. Screens not installed, are in packaging.**

**Location** Kitchen, Living Room (Front room living room), 1st Bedroom (Spare bedroom, center of home bedroom), 2nd Bedroom (Master bedroom, east side of house bedroom)
