RSH ENGINEERING, INC.

END OF BUILDERS WARRANTY INSPECTION REPORT

INSP#: K00001

Owner: A.B. Henry

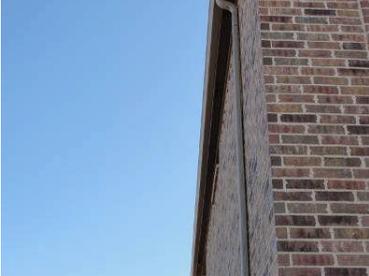
<p>LEFT SIDE OF HOUSE: GENERAL NOTE: SOFFIT VENTS ARE MISSING AND/OR IS INADEQUATE – ADD SOFFIT VENTS. PROVIDE ADEQUATE # OF SOFFIT VENTS TO MEET THE NET FREE VENT OPENINGS OF 1/300 (IF VAPOR BARRIER IS PRESENT) OR 1/150 (IF VAPOR BARRIER IS NOT PRESENT). 2006 INTERNATIONAL RESIDENTIAL CODE # 806.1& # 806. 2.</p>	4

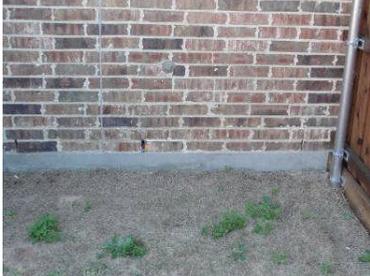
<p>LEFT SIDE OF HOUSE: GENERAL NOTE: ALL AROUND THE HOUSE WEEP HOLES ARE BLOCKED BY MORTAR. THIS WEEP HOLE IS EXCESSIVELY LARGE. IT SHOULD BE NO WIDER THAT 3/8-INCH TO PREVENT ACCESS TO RODENTS AND SNAKES.</p>
5

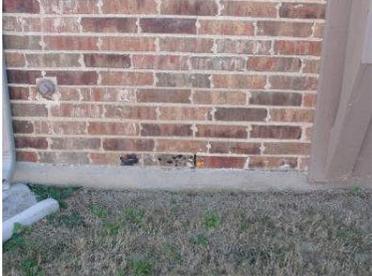
<p>LEFT SIDE OF HOUSE: GENERAL NOTE: ALL AROUND THE HOUSE WEEP HOLES ARE BLOCKED BY MORTAR.</p>	6

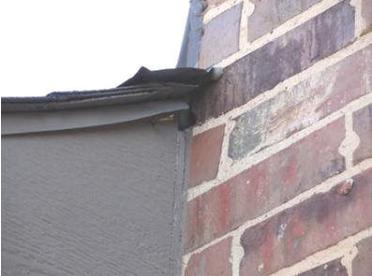
<p>LEFT SIDE OF HOUSE: SEAL HOLE AT THE FASCIA/DRIPEDGE/ FLASHING/SHINGLE INTERFACE.</p>	7

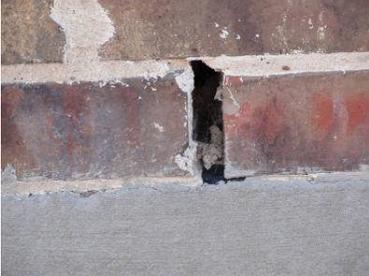
<p>LEFT SIDE OF HOUSE: GENERAL NOTE: ALL AROUND THE HOUSE WEEP HOLES ARE BLOCKED BY MORTAR.</p>	8

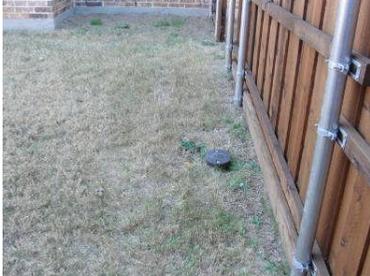
<p>LEFT SIDE OF HOUSE: LOW SPOT AREA WHERE WATER PONDS FOR MORE THAN 24 HOURS – CORRECT DRAINAGE SLOPE.</p>

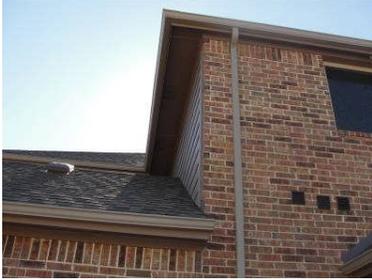
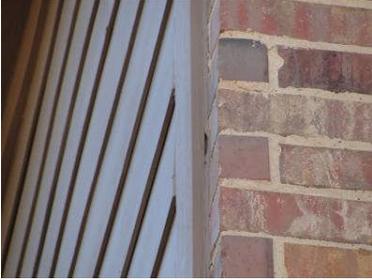
<p>LEFT SIDE OF HOUSE: CLOSE-UP OF PIC. # 9. CAULK THE TRIM / BRICK INTERFACE.</p>	11

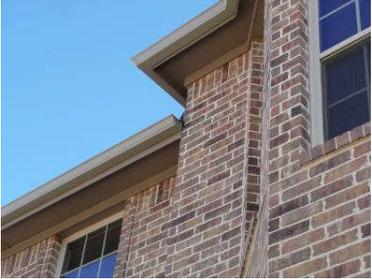
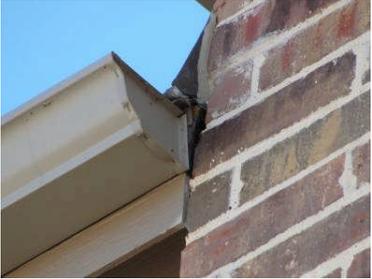
<p>FRONT SIDE OF HOUSE: CLOSE-UP OF PIC. # 15. SEAL HOLE AT THE FASCIA/DRIPEDGE/ FLASHING/SHINGLE INTERFACE.</p>

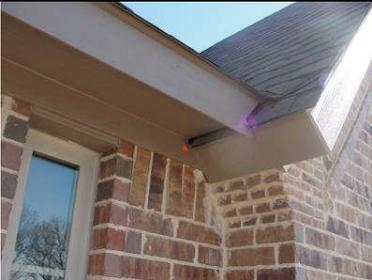
<p>FRONT SIDE OF HOUSE: SEAL HOLE AT SHINGLE/SOFFT INTERFACE</p>
21

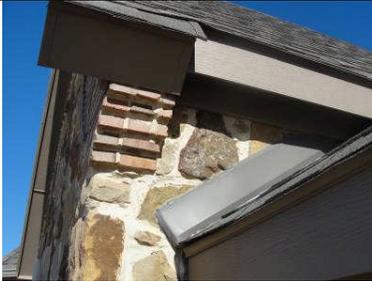
<p>FRONT SIDE OF HOUSE: FILL / SEAL VOID WITH MORTAR.</p>	22

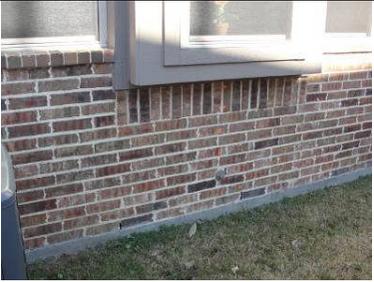
RIGHT SIDE OF HOUSE: CLOSE-UP OF PIC. # 30. BRICKS AND MORTAR CRACKS BELOW THE WINDOW FROM THE WINDOW TO THE SLAB.	32

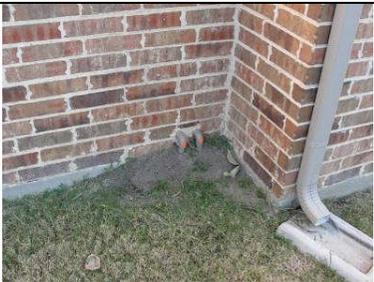
RIGHT SIDE OF HOUSE: PROVIDE THE MINIMUM 6-INCH CLEARANCE BETWEEN THE HOT WATER HEATER'S EMERGENCY DISCHARGE PIPE'S END TO THE SOIL.	34

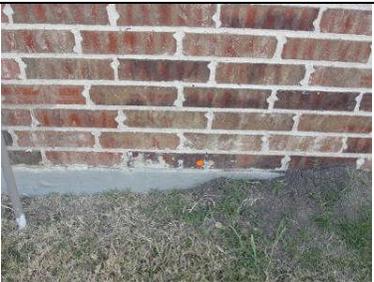
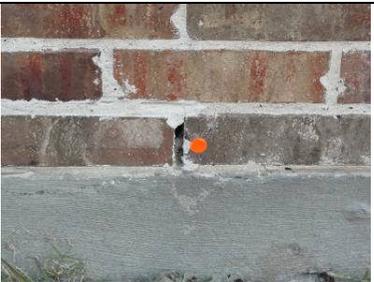
RIGHT SIDE OF HOUSE: GENERAL NOTE: ALL AROUND THE HOUSE WEEP HOLES ARE BLOCKED BY MORTAR. THE WEEP HOLE SHOULD BE 5/16- 3/8- INCH WIDE.	35

RIGHT SIDE OF HOUSE: SEE NOTES AT PIC. # 34. 2006 INTERNATIONAL RESIDENTIAL CODE SECTION 703.7.5.	36

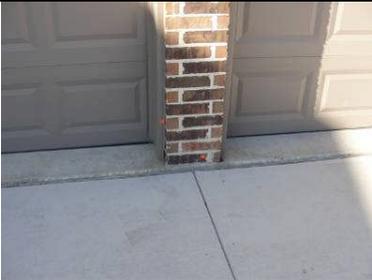
<p>BACK SIDE OF HOUSE: WEEP HOLES MISSING – ADD WEEP HOLES. WEEP HOLES SHOULD BE LOCATED AT THE FIRST COURSE ABOVE THE FOUNDATION WALL OR SLAB, AND OTHER POINTS OF SUPPORT, INCLUDING STRUCTURAL FLOORS, SHELF ANGLES AND LINTELS 2006 INTERNATIONAL RESIDENTIAL CODE SECTION 703.7.5.</p>	38

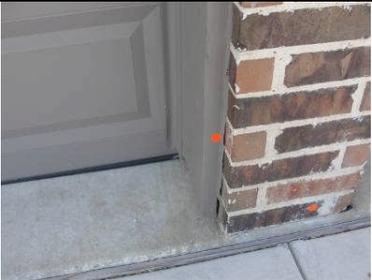
<p>BACK SIDE OF HOUSE: SEPARATION OF THE DOOR FRAME AND BRICKS HAS RESULTED IN VOIDS IN THE CAULKING.</p>	40

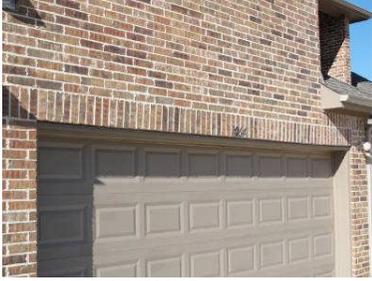
<p>BACK SIDE OF HOUSE: THE LINTEL IS BOWING. NORMALLY A LINTEL THIS LONG WOULD BE 1/2-INCH OR 5/8-INCH THICK. PERHAPS THE LINTEL IS NOT BOLTED TO THE HEADER.</p>	42

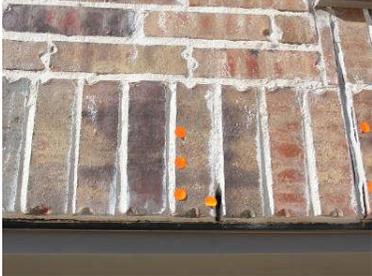
BACK SIDE OF HOUSE: CLOSE-UP OF PIC. # 45. THE BOWED LINTEL HAS RESULTED IN A HORIZONTAL CRACK BETWEEN THE SOLDIER COURSE AND THE COURSE ABOVE IT.	47

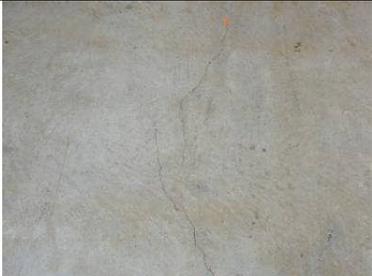
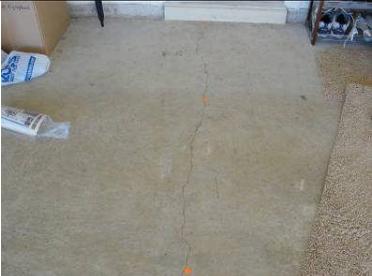
BACK SIDE OF HOUSE: SURFACE CRACK(S) IN GARAGE SLAB
49

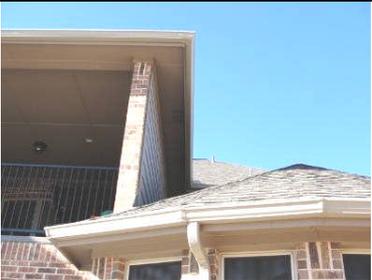
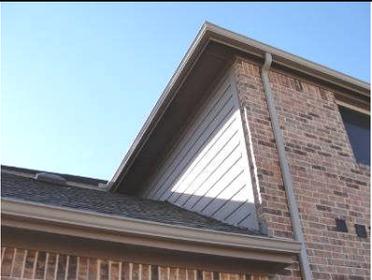
<p>BACK SIDE OF HOUSE: GENERAL NOTE: SOFFIT VENTS ARE MISSING – ADD SOFFIT VENTS. PROVIDE ADEQUATE # OF SOFFIT VENTS TO MEET THE NET FREE VENT OPENINGS OF 1/300 (IF VAPOR BARRIER IS PRESENT) OR 1/150 (IF VAPOR BARRIER IS NOT PRESENT). 2006 INTERNATIONAL RESIDENTIAL CODE # 806.1& # 806. 2.</p>	55

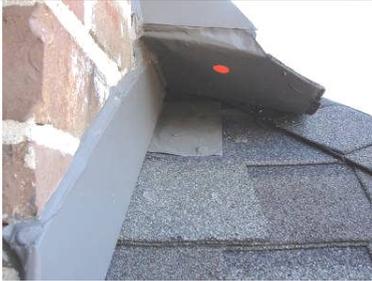
<p>ROOF: EXPOSED WOOD BELOW FLASHING</p>	58

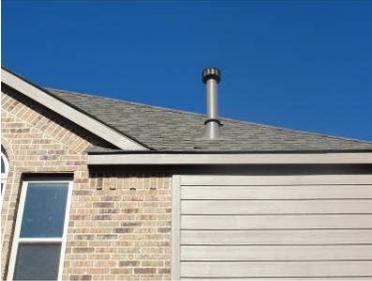
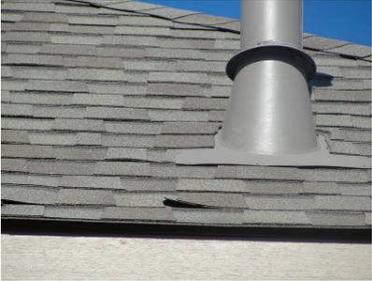
<p>ROOF: SHINGLE IS LIFTING.</p>	60

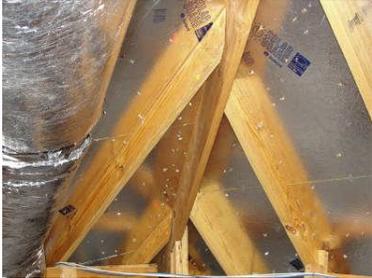
<p>ATTIC: SEPARATION GAP AT HIP RAFTER AND COMMON RAFTER INTERFACES.</p>	62

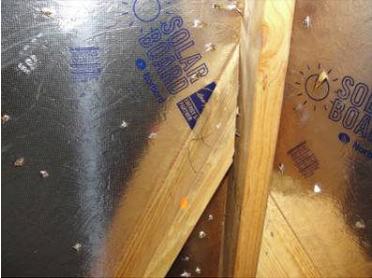
<p>ATTIC: CLOSE-UP OF PIC. # 61.</p>	63

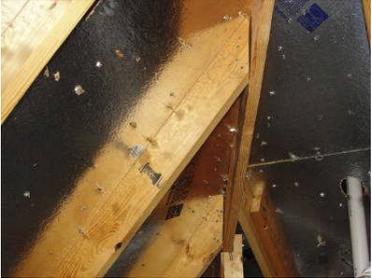
<p>ATTIC: SEE NOTES AT PIC. # 61.</p>	64

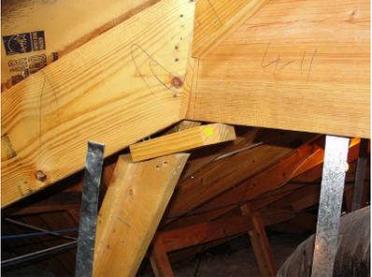
<p>ATTIC: 2006 IRC SECTION R802.3- HIP AND VALLEY RAFTERS SHALL BE SUPPORTED AT THE RIDGE BY A BRACE TO A BEARING PARTITION. BLOCKS DO NOT MEET THE REQUIREMENT OF THE CODE. BLOCKS SPLIT ALONG THE GRAIN LEAVING NO SUPPORT. THEY ALSO DO NOT PROVIDE THE REQUIRED 1-1/2-INCH BEARING FOR LOAD TRANSFER.</p>	68

<p>ATTIC: SEE NOTES AT PIC. # 67.</p>

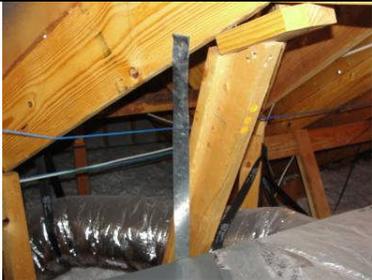
<p>ATTIC: SEE NOTES AT PIC. # 67.</p>	70

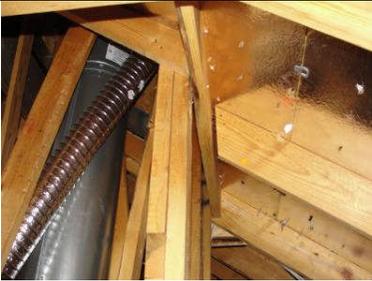
<p>ATTIC: FOR CLOSE-UP AND DETAILS SEE PIC. # 75.</p>	75

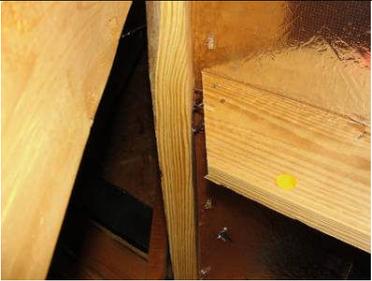
<p>ATTIC: CLOSE-UP OF PIC. # 74. SEPARATION GAP BETWEEN THE COMMON RAFTER AND THE CHIMNEY HEADER</p>	76

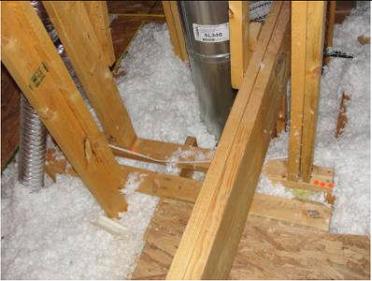
<p>ATTIC: FOR CLOSE-UP AND DETAILS SEE PIC. # 77.</p>

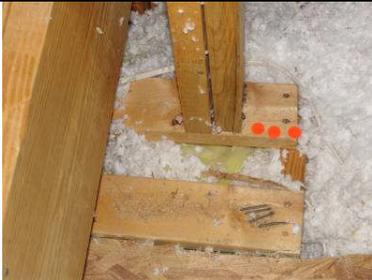
<p>ATTIC: CLOSE-UP OF PIC. # 76. FIREPLACE STUDS ARE TERMINATED OVER A SINGLE 2X4 LAYED SIDEWAYS NAILED TO THE JOISTS. NOTE THAT THE 2X4 MEMBER IS SPLIT. PROVIDE PROPER CRIPPLE STUD SUPPORT BELOW THE LOAD.</p>	78

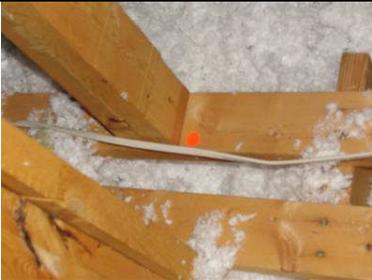
<p>ATTIC: FIREPLACE STUDS ARE TERMINATED OVER A SINGLE 2X4 LAYED SIDEWAYS NAILED TO THE JOISTS. PROVIDE PROPER CRIPPLE STUD SUPPORT BELOW THE LOAD.</p>	79

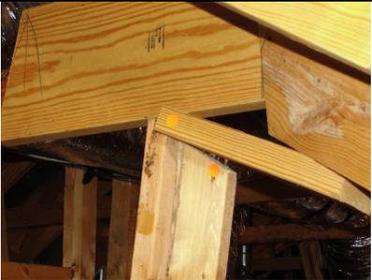
<p>ATTIC: 2006 IRC SECTION R802.3 - HIP AND VALLEY RAFTERS SHALL BE SUPPORTED AT THE RIDGE BY A BRACE TO A BEARING PARTITION. BLOCKS DO NOT MEET THE REQUIREMENT OF THE CODE. BLOCKS SPLIT ALONG THE GRAIN LEAVING NO SUPPORT. THEY ALSO DO NOT PROVIDE THE REQUIRED 1-1/2-INCH BEARING FOR LOAD TRANSFER.</p>	80	<p style="text-align: center;">THIS SECTION INTENTIONALLY LEFT BLANK FOR FORMATTING PURPOSES</p>	
81

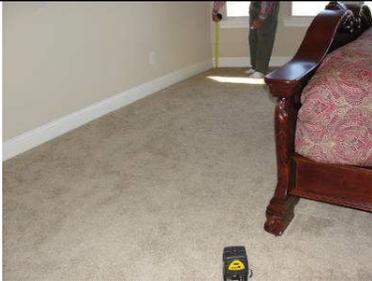
<p>INSIDE MASTER BEDROOM: THE FLOOR IS OFF LEVEL IN THE AREA SHOWN BY 7/8-INCH IN 12-FEET. THE FLOOR LEVEL MEASUREMENTS WERE MADE USING AN AUTO-LEVELING LASER LEVEL THAT PROJECTS A CHALK-LINE BEAM AT A 4-INCH ELEVATION.</p>	82

<p>INSIDE MASTER BEDROOM: CLOSE-UP OF PIC. # 81. THE BEAM IS MEASURED HERE AT 3-1/8-INCH INDICATING THE REAR WALL IS 7/8-INCH HIGHER THAN THE POINT WHERE THE LEVEL WAS POSITIONED. THIS IS LIKELY CAUSED BY THE FLAT SOIL GRADE AT THE BACK OF THE HOUSE. REFER TO PIC. # 53.</p>	83

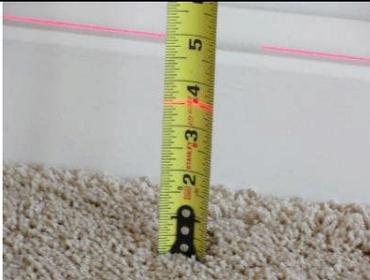
INSIDE MASTER BEDROOM: THE FLOOR IS OFF LEVEL IN THE AREA SHOWN BY 1/2-INCH IN 6.5-FEET.	88

INSIDE MASTER BEDROOM: CLOSE-UP OF PIC. # 87.
89

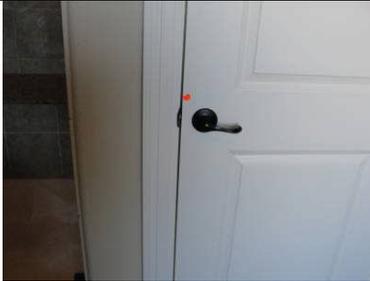
INSIDE MASTER BATH: TOO MUCH GAP BETWEEN THE TOILET ROOM DOOR AND THE DOOR FRAME.

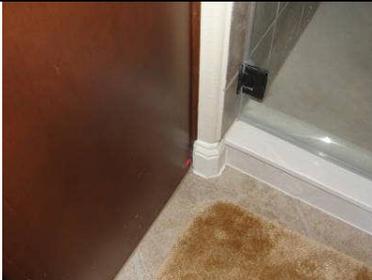
<p>INSIDE MASTER BATH: SEPARATION GAP AT THE CABINET.</p>	94

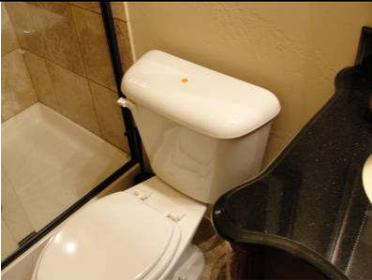
<p>INSIDE DOWNSTAIRS HALLWAY BATH: ADJUST THE WATER LEVEL IN THE TOILET TANK.</p>	95

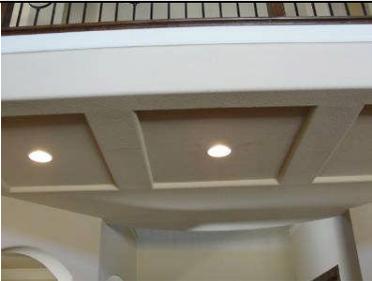
<p>INSIDE FAMILY ROOM: BUMPS AND TEXTURE MISMATCHES ON CEILING NEAR THE CANNED LIGHT.</p>	99

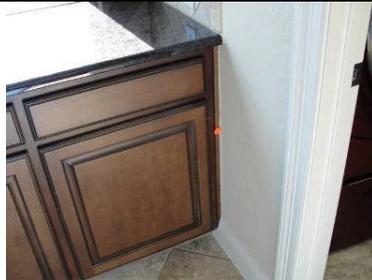
<p>INSIDE UTILITY ROOM: EXCESSIVE WALL MOVEMENT AT TIME DOOR CONTACTS THE JAMB AS IT IS BEING CLOSED. THE MOVEMENT CAUSES SEPARATION CRACKS BETWEEN THE CABINET AND THE WALL ON EACH SIDE OF THIS WALL.</p>	102

<p>INSIDE BUTLER'S PANTRY: SEE NOTES AT PIC. # 101.</p>	103

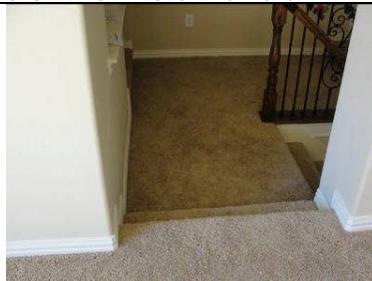
<p>INSIDE: FLOOR POPS / SQUEAKS.</p>	110

<p>INSIDE: SEE NOTES AT PIC. # 109</p>	111

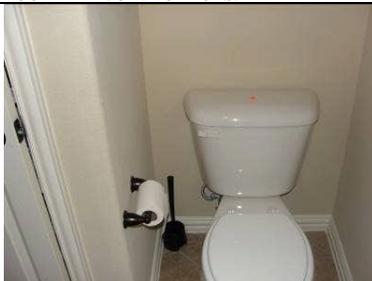
<p>INSIDE JACK-N-JILL BATH: ADJUST FILL LEVEL IN TOILET TANK.</p>	112
