RSH ENGINEERING, INC.

COMMERCIAL (CHURCH) INSPECTION REPORT

INSP#: 9904048 DATE:08/30/06 PAGE #: 1

Client: Baptistcostalpresborean Church

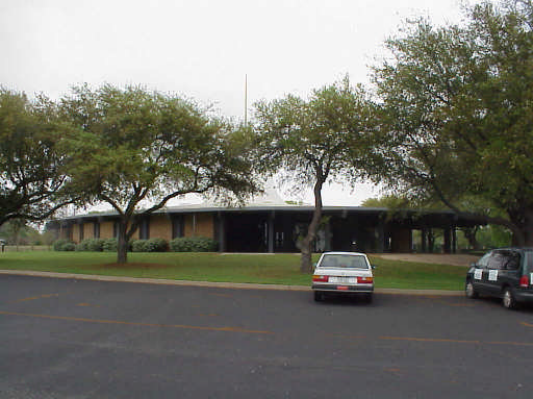
FRONT VIEW OF CHURCH INSPECTED	2

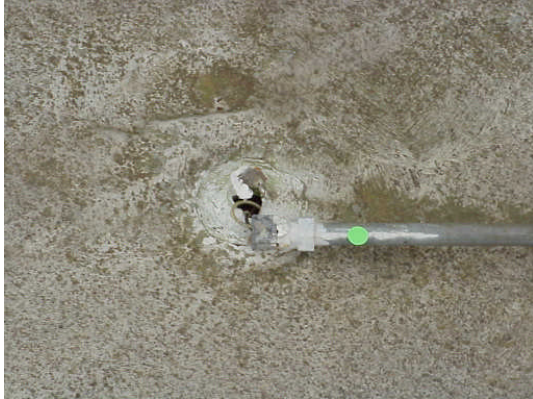
ROOF: 1. LIGHT POST FALLEN DOWN EXPOSING OPENING IN ROOF	3

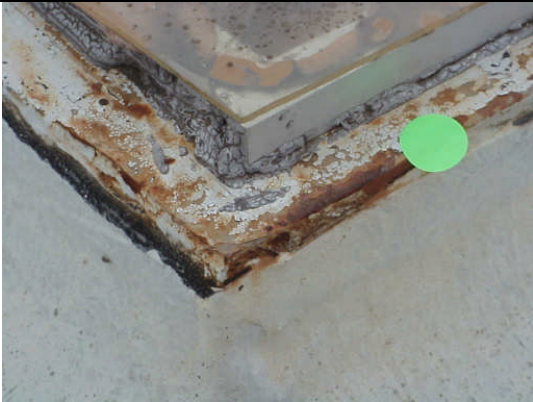
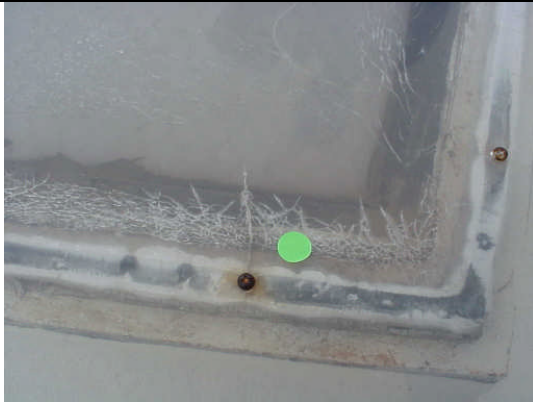
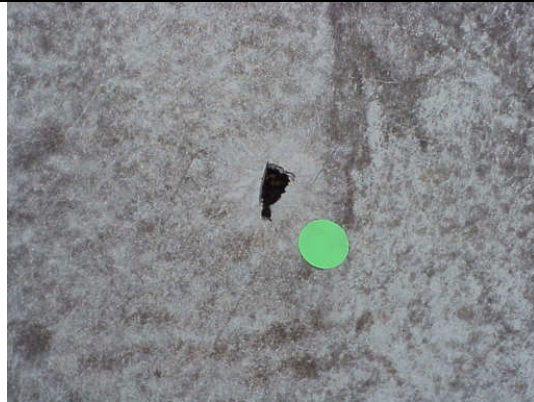
ROOF SKYLIGHT: 1. RE-PAINT ALL SKYLIGHTS WHERE IT IS RUSTING		ROOF: 1. SKYLIGHT TOP PANEL CRACKED - REPLACE		ROOF: 1. HOLE IN ROOF – PATCH TO SEAL HOLE
16

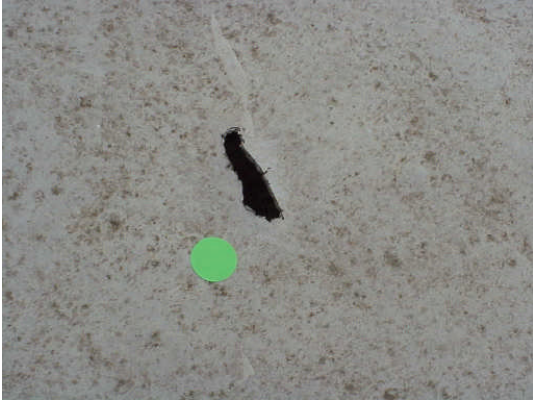
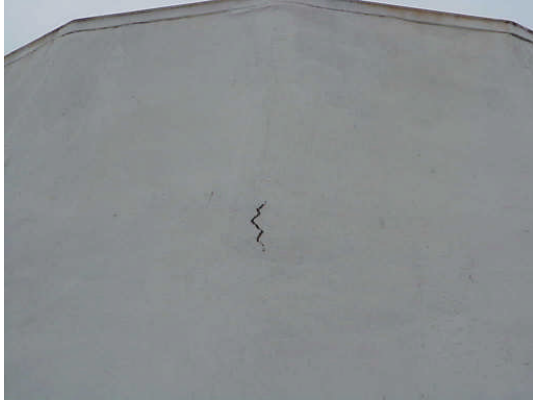
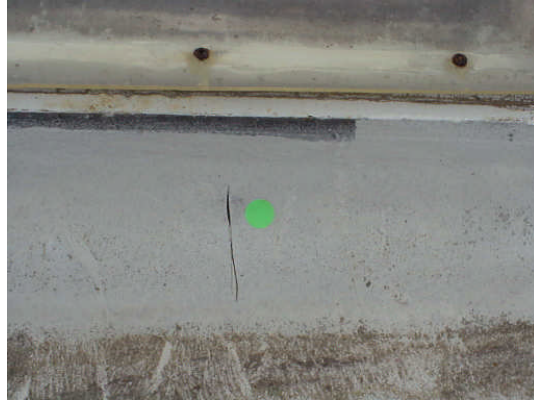
ROOF: 1. HOLE IN ROOF – PATCH TO SEAL HOLE		ROOF – STEEPLE 1. CRACK IN STEEPLE SIDE – PATCH TO SEAL CRACK		ROOF: 1. SIDE OF SKYLIGHT CRACKED – PATCH TO SEAL CRACK

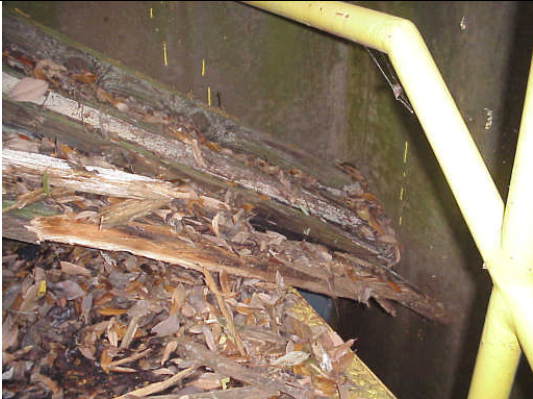
<p><u>NEAR OUTSIDE UNITS:</u></p> <ol style="list-style-type: none"> REMOVE ALL ROTTED WOOD FROM THIS AREA 	41

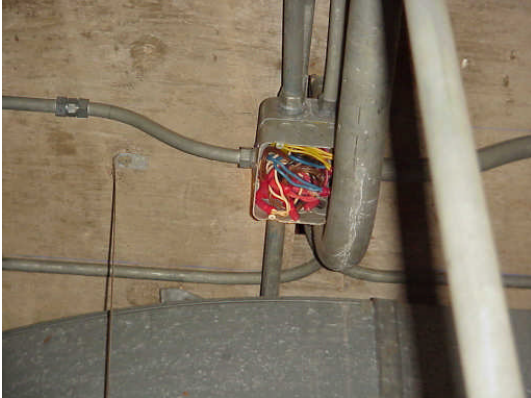
<p>BASEMENT:</p> <ol style="list-style-type: none"> 1. EXPOSED WIRING/ COVER JUCTION BOX 	54

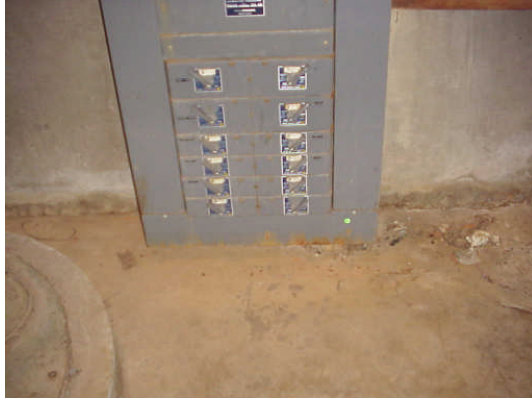
<p>BASEMENT:</p> <ol style="list-style-type: none"> 1. ELECTRIC PANELS VERY CLOSE TO BOTTOM OF FLOOR. 2. RECOMMENED ADDITION OF ONE MORE SUMP PUMP TO PROVIDE
