RSH ENGINEERING, INC.

LIGHT COMMERCIAL INSPECTION REPORT

INSP#: S06110

Address: 12345 Main St, Anywhere, Texas

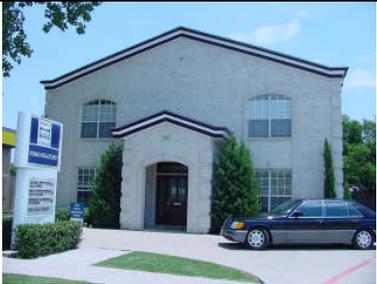
<p>FRONT VIEW OF BUILDING INSPECTED</p>	2

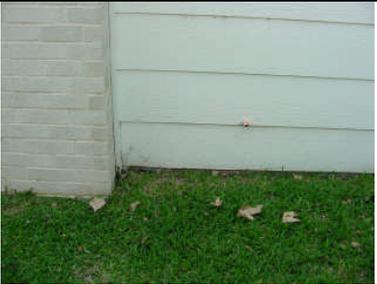
<p>LEFT SIDE OF BUILDING:</p> <p>INSTALL AN ELL FOR THE EMERGENCY DRAIN PIPE.</p>

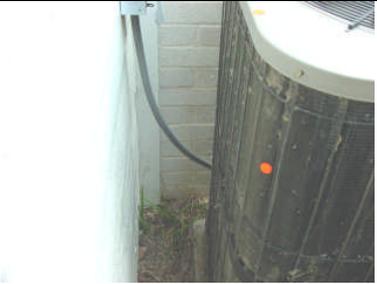
<p>LEFT SIDE OF BUILDING:</p> <p>THE AC CONDENSER COILS ARE CLOGGED. HAVE THE CONDENSER COILS CLEANED.</p>

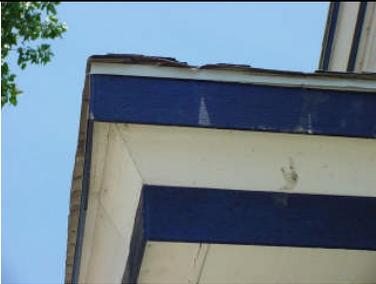
<p>FRONT SIDE OF BUILDING: SHINGLES DAMAGED ABOVE FRONT PORCH.</p>	23

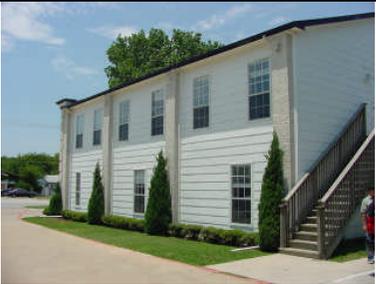
<p>RIGHT SIDE OF BUILDING SEE PIC. # 24 TO PIC. # 31 FOR DETAILS.</p>	24

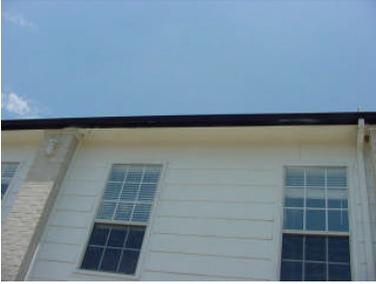
<p>RIGHT SIDE OF BUILDING: GENERAL NOTE: SOFFIT VENTS ARE MISSING – ADD SOFFIT VENTS. PROVIDE ADEQUATE # OF SOFFIT VENTS TO MEET THE NET FREE VENT OPENINGS OF 1/300 (IF VAPOR BARRIER IS PRESENT) OR 1/150 (IF VAPOR BARRIER IS NOT PRESENT). (UNIFORM BUILDING CODE # 1505.3) (1999 STANDARD BUILDING CODE – 1203.1.3). 2000 INTERNATIONAL RESIDENTIAL CODE # 806.1 & # 806.2.</p>	27

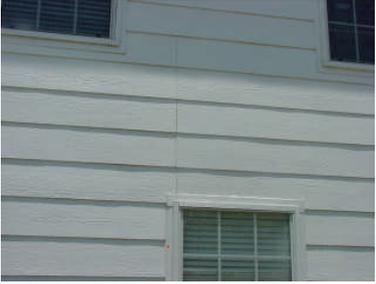
<p>RIGHT SIDE OF BUILDING: GENERAL NOTE: CAULK ALL BUTT JOINTS IN THE SIDING ALL AROUND THE BUILDING. SEE NOTES AT PIC. # 25 FOR ADDITIONAL DETAILS.</p>	28

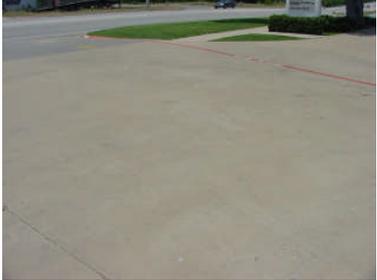
<p>RIGHT SIDE OF BUILDING:</p> <ol style="list-style-type: none"> CONTROL JOINTS ARE MISSING FROM THE SLAB OF THE DRIVEWAY. SEE NOTE # 185 REGARDING DRIVEWAY CONTROL JOINT DESIGN. DRIVEWAY IS CRACKED FROM ONE SIDE TO THE OTHER – CHECK TO SEE IF HAS FRACTURED (THE CRACK EXTENDS FROM TOP TO BOTTOM OF THE SLAB – IF IT HAS FRACTURED - REPLACE SLAB/DRIVEWAY. 	30

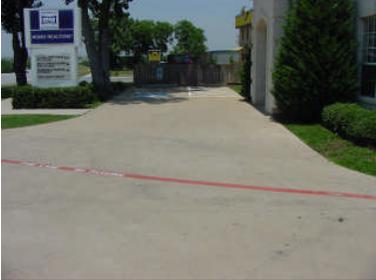
<p>RIGHT SIDE OF BUILDING: SEE NOTES AT PIC. # 29.</p>	31

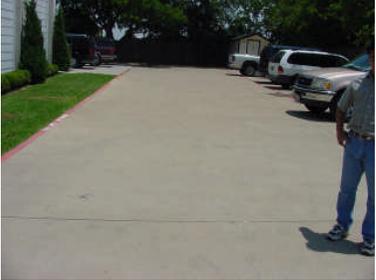
<p>RIGHT SIDE OF BUILDING: SEE NOTES AT PIC. # 29.</p>	32

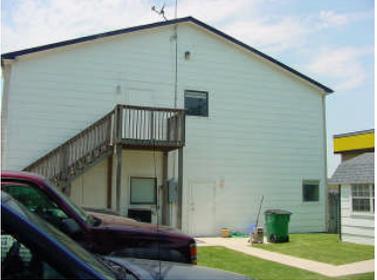
<p>BACK SIDE OF BUILDING SEE PIC. # 33 TO PIC. # 50 FOR DETAILS.</p>
33

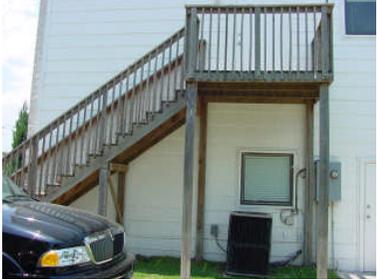
<p>BACK SIDE OF BUILDING: THE STAIRWAY IS INDEPENDENT OF THE BUILDING AND IS VERY UNSTABLE. SECURE THE STAIRWAY AND/OR REPLACE IT WITH NEW STAIRWAY.</p>	34

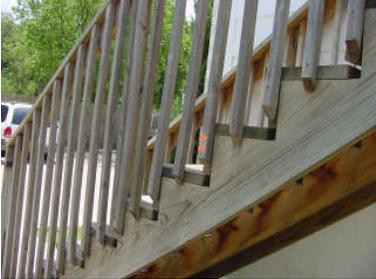
<p>BACK SIDE OF BUILDING: GENERAL NOTE: THE BALUSTERS OF THE STAIRWAY ARE LOOSE. THEY ARE NAILED AT EACH END WITH ONLY ONE NAIL. PROPERLY SECURE THE BALUSTERS.</p>	35

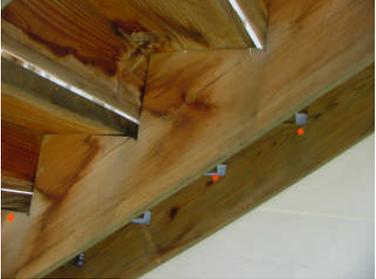
<p>BACK SIDE OF BUILDING:</p> <ol style="list-style-type: none"> THE STAIR TREADS ARE WARPING AND SEPARATING FROM THE RISERS. SECURE THE TREADS. THE RISERS ARE SPLITTING. REPAIR OR REPLACE THE RISERS. 	36

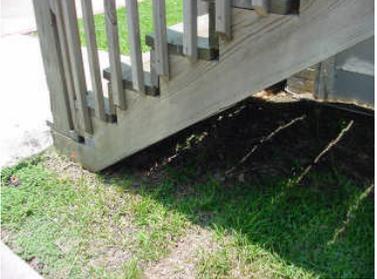
<p>BACK SIDE OF BUILDING: PROVIDE FOOTING FOR THE BASE OF THE STAIRWAY.</p>

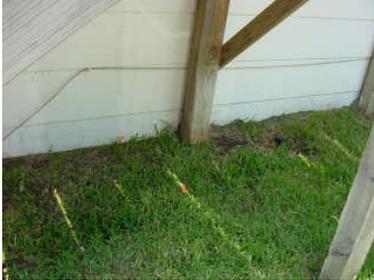
<p>BACK SIDE OF BUILDING:</p> <ol style="list-style-type: none"> 1. LOW SPOT/NEGATIVE SLOPE AREA TOWARDS THE BUILDING WHERE WATER PONDS. 2. GENERAL NOTE: AT ALL FLAT/LOW/NEGATIVE SLOPED AREAS GRADE SURFACE AWAY FROM THE FOUNDATION MINIMUM 6.0-INCHES DROP IN 10- FEET (2000 INTERNATIONAL RESIDENTIAL CODE # 401.3) 3. RECOMMEND A POSITIVE SLOPE (AWAY FROM THE FOUNDATION) OF 1-INCH OF DROP EVERY FOOT FOR THE FIRST FIVE FEET IF POSSIBLE. DO NOT LET WATER POOL/POND AROUND AND WITH-IN 5- FEET OF FOUNDATION. 4. JAMES HARDIE SPECIFIES 6 INCHES FROM BOTTOM OF PLANK TO SOIL 	38

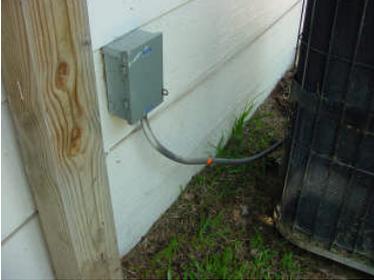
<p>BACK SIDE OF BUILDING:</p> <p>220-VOLT ELECTRICAL WIRING IS NOT TIED/CLAMPED TO THE BRICK WALL SUCH THAT IT IS NOT TOUCHING THE SOIL/GROUND. PROVIDE CLAMPS AND FASTEN THE 220- VOLT CABLES/WIRING AWAY FROM THE SOIL.</p>	39

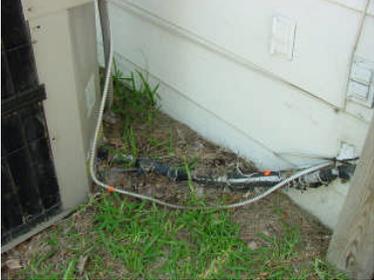
<p>BACK SIDE OF BUILDING:</p> <ol style="list-style-type: none"> 1. 220- VOLT ELECTRICAL WIRING IS NOT TIED/CLAMPED TO THE BRICK WALL SUCH THAT IT IS NOT TOUCHING THE SOIL/GROUND. PROVIDE CLAMPS AND FASTEN THE 220- VOLT CABLES/WIRING AWAY FROM THE SOIL. 2. SECURE THE FREON LINE ABOVE THE SOIL TO PREVENT DAMAGE BY LAWN EQUIPMENT. 	40

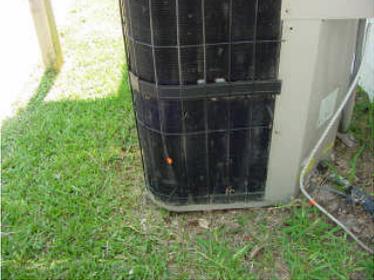
<p>BACK SIDE OF BUILDING:</p> <p>THE COIL GUARD IS BENT/DAMAGED. REPAIR OR REPLACE THE GUARD.</p>

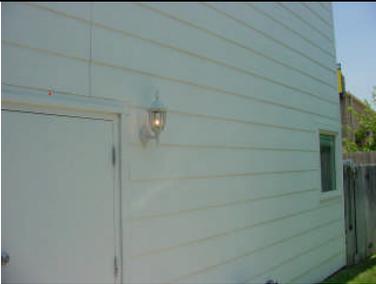
<p>BACK SIDE OF BUILDING: 2000 INTERNATIONAL RESIDENTIAL CODE SECTION R703.8.4. APPROVED CORROSION-RESISTIVE FLASHING SHALL BE PROVIDED IN THE EXTERIOR WALL ENVELOPE IN SUCH A MANNER AS TO PREVENT ENTRY OF WATER INTO THE WALL CAVITY OR PENETRATION OF WATER TO THE BUILDING STRUCTURAL FRAMING COMPONENTS. THE FLASHING SHALL EXTEND TO THE SURFACE OF THE EXTERIOR WALL FINISH AND SHALL BE INSTALLED TO PREVENT WATER FROM REENTERING THE EXTERIOR WALL ENVELOPE. APPROVED CORROSION-RESISTANT FLASHINGS SHALL BE INSTALLED AT ALL OF THE FOLLOWING LOCATIONS: 4. ABOVE ALL PROJECTING WOOD TRIMS.</p>	43

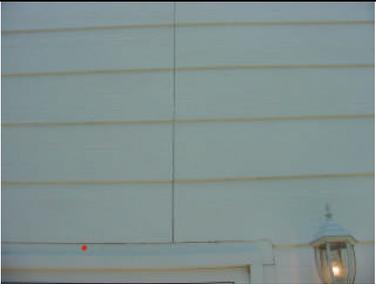
<p>BACK SIDE OF BUILDING: CAULK THE BUTT JOINTS IN THE SIDING.</p>	44

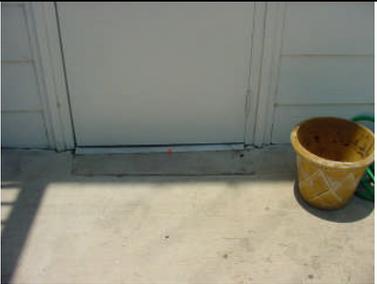
<p>BACK SIDE OF BUILDING: SEAL/CAULK AT THE DOOR THRESHOLD/ DOOR TRIMS/BRICK INTERFACE.</p>

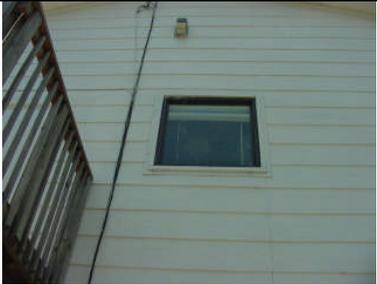
<p>BACK SIDE OF BUILDING: CAULK ALL AROUND THE WINDOW SEE NOTES AT PIC. # 42 FOR ADDITIONAL DETAILS.</p>	46

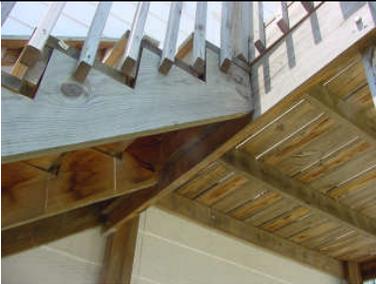
<p>BACK SIDE OF BUILDING: JOIST HANGERS ARE MISSING AT THE TOP OF THE STAIRWAY RISERS.</p>	47

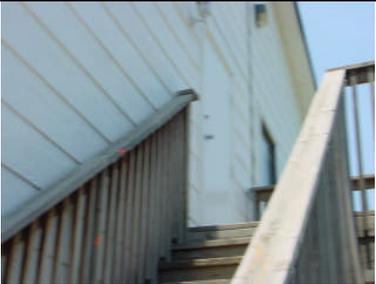
<p>BACK SIDE OF BUILDING: THE HAND RAILS OF THE STAIRWAY ARE LOOSE. SECURE THE HAND RAILS.</p>	48

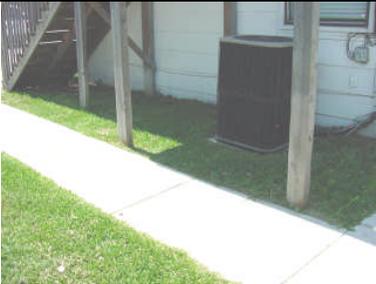
<p>BACK SIDE OF BUILDING:</p> <ol style="list-style-type: none"> 1. LOW SPOT/NEGATIVE SLOPE AREA TOWARDS THE BUILDING WHERE WATER PONDS. 2. GENERAL NOTE: AT ALL FLAT/LOW/NEGATIVE SLOPED AREAS GRADE SURFACE AWAY FROM THE FOUNDATION MINIMUM 6.0-INCHES DROP IN 10 FEET (2000 INTERNATIONAL RESIDENTIAL CODE # 401.3) 3. RECOMMEND A POSITIVE SLOPE (AWAY FROM THE FOUNDATION) OF 1-INCH OF DROP EVERY FOOT FOR THE FIRST FIVE FEET IF POSSIBLE. DO NOT LET WATER POOL/POND AROUND AND WITH-IN 5- FEET OF FOUNDATION. 4. JAMES HARDIE SPECIFIES 6 INCHES FROM BOTTOM OF PLANK TO SOIL. 	51

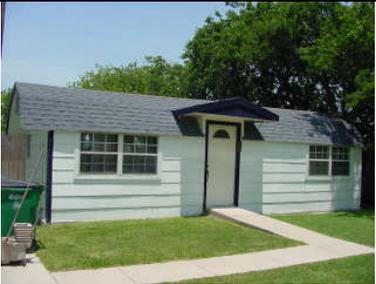
<p>OUTBACK BUILDING OFFICE: SEE PIC. # 52 TO PIC. # 79 FOR DETAILS.</p>	52

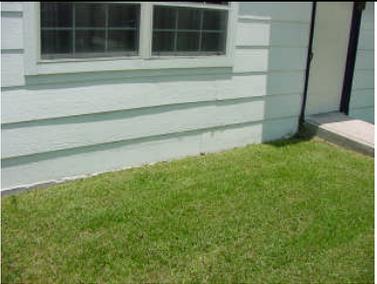
<p>OUTBACK BUILDING OFFICE:</p> <ol style="list-style-type: none"> 1. SOIL LEVEL IS TOO HIGH. 2000 IRC # 323.1 REQUIRES THAT THE BOTTOM OF SILL BE 8-INCHES TO EARTH. 2. JAMES HARDIE SPECIFIES 6 INCHES FROM BOTTOM OF PLANK TO SOIL. 3. SEE NOTES AT PIC. # 50.

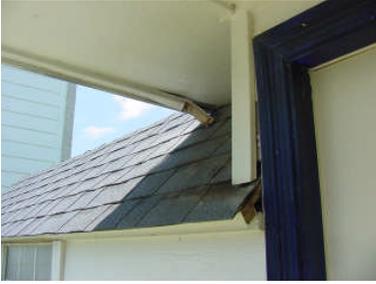
<p>OUTBACK BUILDING OFFICE:</p> <ol style="list-style-type: none"> 1. TRIM IS COMING LOOSE. SECURE THE TRIM. 2. DRIP EDGE FLASHING IS MISSING. 3. FASCIA BOARD IS MISSING. INSTALL FASCIA BOARD. 	55

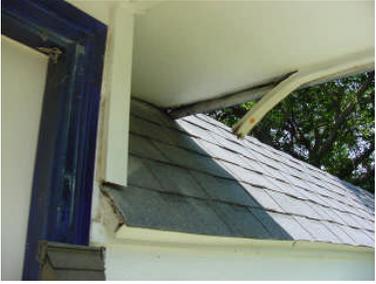
<p>OUTBACK BUILDING OFFICE:</p> <ol style="list-style-type: none"> 1. TRIM IS COMING LOOSE. SECURE THE TRIM. 2. DRIP EDGE FLASHING IS MISSING. 3. FASCIA BOARD IS MISSING. INSTALL FASCIA BOARD. 	56

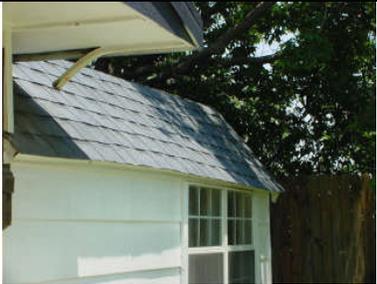
<p>OUTBACK BUILDING OFFICE: THE ROOF LINE /FRAMING ARE NOT STRAIGHT.</p>	66

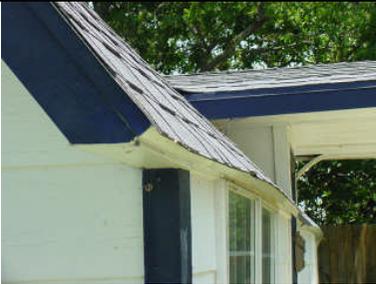
<p>OUTBACK BUILDING OFFICE: THE ROOF LINE/FRAMING IS NOT STRAIGHT.</p>	67

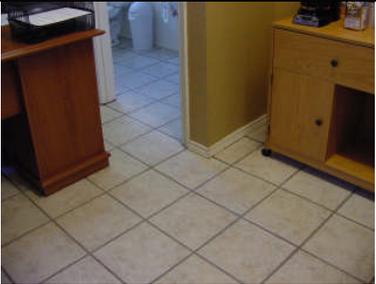
<p>OUTBACK BUILDING OFFICE: THE SLAB IS OFF LEVEL SEVERELY. THE LEFT SIDE OF THE BUILDING IS LOWER THAN THE FRONT SIDE. THE SLAB IS UP AND THEN DOWN AND UP AGAIN AND DOWN - SEVERAL PLACES.</p>	68

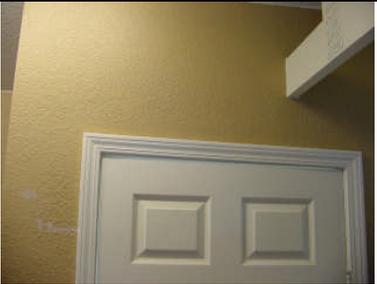
<p>OUTBACK BUILDING OFFICE: DOOR IS NOT SQUARE WITH FRAME.</p>
69

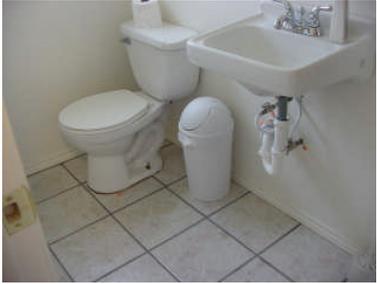
<p>OUTBACK BUILDING OFFICE:</p> <ol style="list-style-type: none"> 1. CAULK TOILET BOWL/BASE AT FLOORING INTERFACE. 2. THERE IS NO AC OUTLET IN THIS RESTROOM. 	70

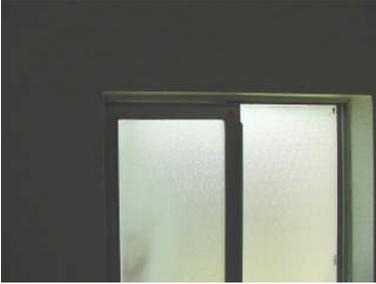
<p>OUTBACK BUILDING OFFICE: THE BATHROOM WINDOW IS LOOSE AND THERE IS A GAP BETWEEN THE FRAME AND THE WINDOW IN THE RESTROOM.</p>	71

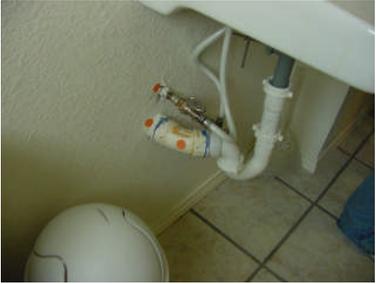
<p>OUTBACK BUILDING OFFICE: SEAL HOLE AT PIPE/DRYWALL INTERFACES BELOW SINK.</p>	72

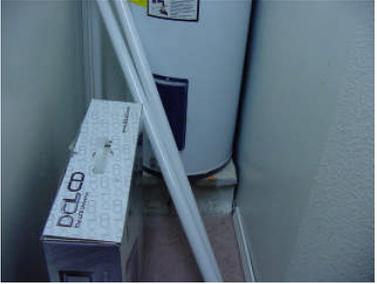
<p>OUTBACK BUILDING OFFICE: PROVIDE EMERGENCY DRAIN PAN BELOW THE WATER HEATER.</p>

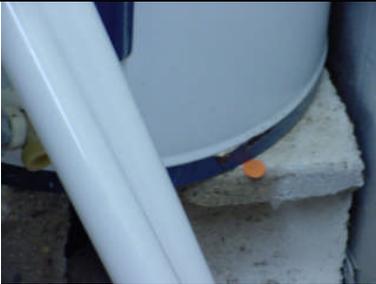
<p>OUTBACK BUILDING OFFICE: THE BOTTOM OF THE WATER HEATER IS RUSTY. RECOMMEND REPLACEMENT</p>	75

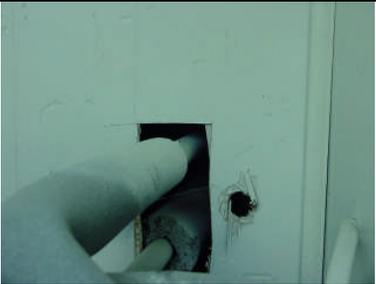
<p>OUTBACK BUILDING OFFICE: SEAL HOLES IN THE WALL AT THE WATER PIPES FOR THE WATER HEATER.</p>	76

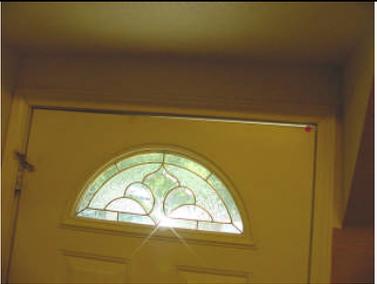
<p>OUTBACK BUILDING OFFICE: DOOR IS NOT SQUARE WITH FRAME.</p>
77

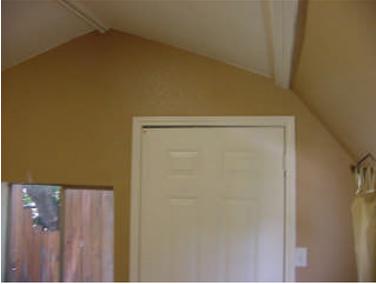
<p>OUTBACK BUILDING OFFICE: DOOR IS NOT SQUARE WITH FRAME.</p>	79

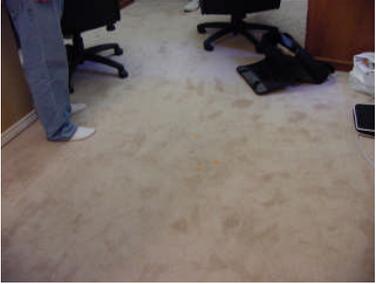
<p>OUTBACK BUILDING OFFICE: THE FLOOR IS OFF LEVEL FROM END TO END.</p>	80

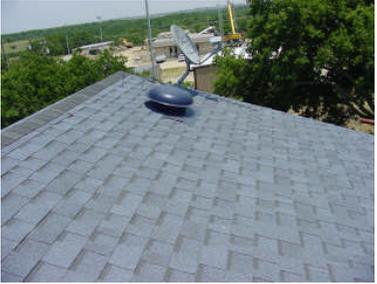
<p>ROOF: FOR CLOSE-UP AND DETAILS SEE PIC. # 81.</p>
81

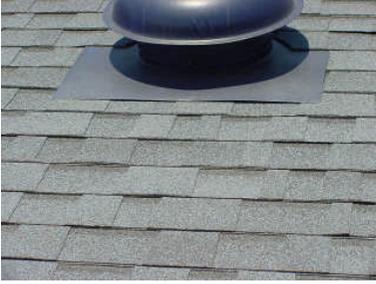
<p>ROOF: GENERAL NOTE: SEAL OVER ALL EXPOSED NAILS AND/OR STAPLES HOLDING DOWN THE FLUE/ATTIC VENTS/SEWER VENT BASES WITH ROOF CEMENT.</p>	83

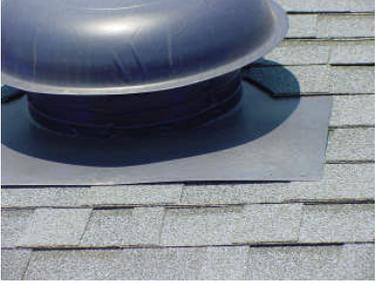
<p>ROOF: CLOSE-UP OF PIC. # 82.</p>	84

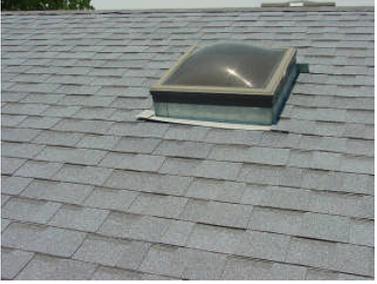
<p>ROOF: GENERAL NOTE: SEAL OVER ALL EXPOSED NAILS AND/OR STAPLES HOLDING DOWN THE SKYLIGHT WITH ROOF CEMENT.</p>

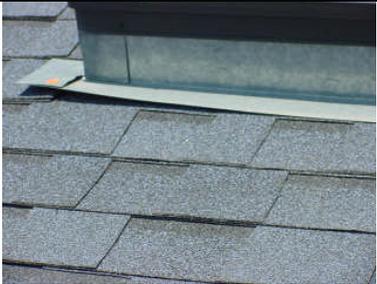
<p>ROOF: CLOSE-UP OF PIC. # 84.</p>	86

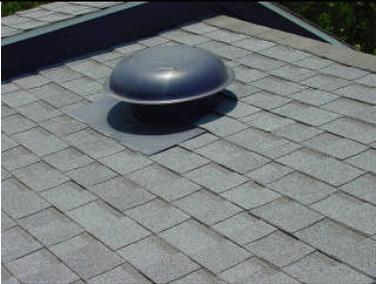
<p>ROOF: CLOSE-UP OF PIC. # 87 AND PIC. # 88.</p>	87

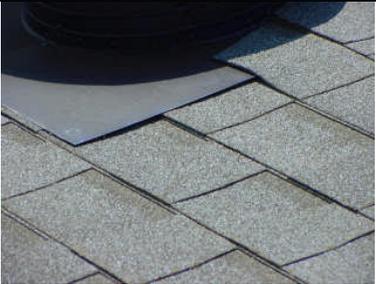
<p>ROOF: CLOSE-UP OF PIC. # 86. THE ROWS OF SHINGLES AT EACH SIDE OF THE VENT SHOULD OVERLAP THE BASE TO PREVENT WATER LEAKS (WATER DAMAGE AND MOLD) TO THE INSIDE.</p>	88

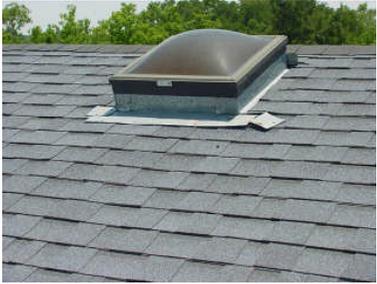
<p>ROOF: FOR CLOSE-UP AND DETAILS SEE PIC. # 90.</p>	90

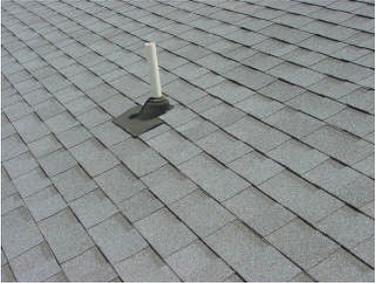
<p>ROOF: FOR CLOSE-UP AND DETAILS SEE PIC. # 92.</p>	92

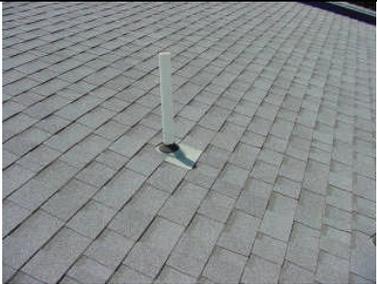
<p>ROOF: FOR CLOSE-UP AND DETAILS SEE PIC. # 94.</p>	94

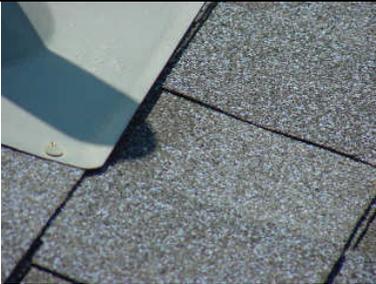
<p>ROOF: CLOSE-UP OF PIC. # 93. GENERAL NOTE: SEAL OVER ALL EXPOSED NAILS AND/OR STAPLES HOLDING DOWN THE FLUE/ATTIC VENTS/SEWER VENT BASES WITH ROOF CEMENT.</p>	95

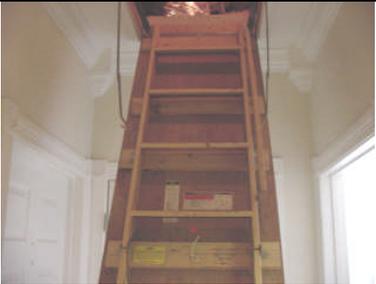
<p>ATTIC: INSULATE THE ATTIC PULL DOWN DOOR TO SAVE ENERGY AND SAVE ON UTILITY BILLS. THIS DOOR SHOULD BE TREATED AS A DOOR TO THE OUTSIDE. IN FACT THIS DOOR SEES HIGHER TEMPERATURES THAT ARE MORE SEVERE THAN THE OUTSIDE DOORS. USUALLY THE OUTSIDE DOORS ARE INSULATED AND/OR ARE SOLID.</p>	96

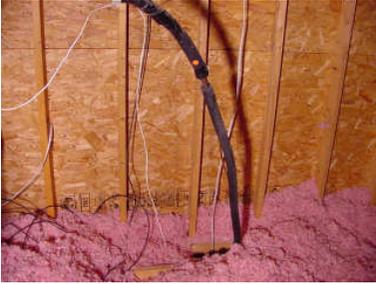
<p>ATTIC: FOR CLOSE-UP AND DETAILS SEE PIC. # 99.</p>	99

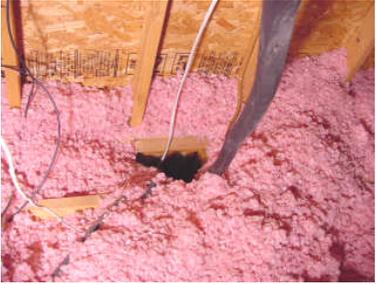
<p>ATTIC: CLOSE-UP OF PIC. # 98. INSULATE SO ATTIC AIR DOES NOT GET BETWEEN THE CEILING AND FLOOR.</p>	100

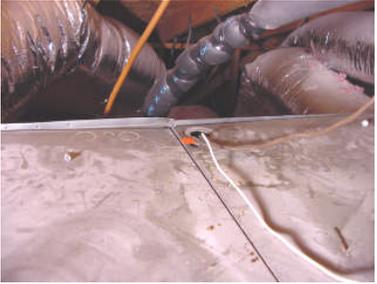
<p>ATTIC: PROVIDE GROMMET AROUND THE WIRING WHERE THE WIRES ENTER THE UNIT.</p>

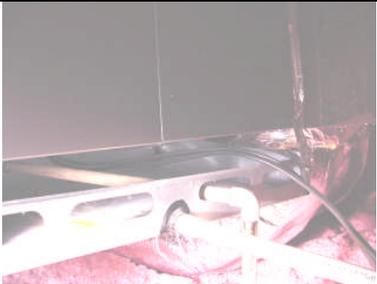
<p>ATTIC: ELECTRICAL WIRING IS TOUCHING THE DRAIN PAN – RE-LOCATE THE ELECTRICAL WIRING SUCH THAT IT IS AWAY FROM THE DRAINPAN.</p>	102

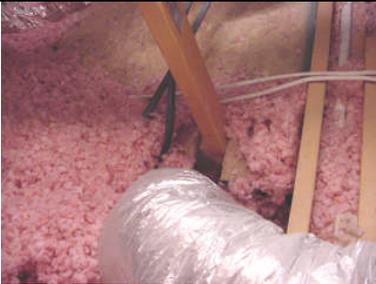
<p>ATTIC: ONE OF THE RIDGE BOARD STRUT IS TERMINATED OVER A SINGLE JOIST – TRANSFER THIS TO A LOAD BEARING WALL/POINT.</p>	103

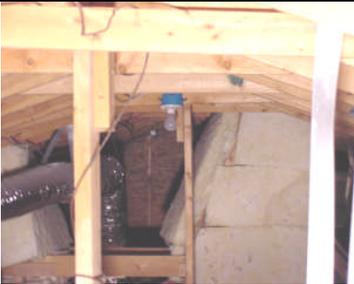
<p>ATTIC: LIGHT IS NOT FUNCTIONAL.</p>	104

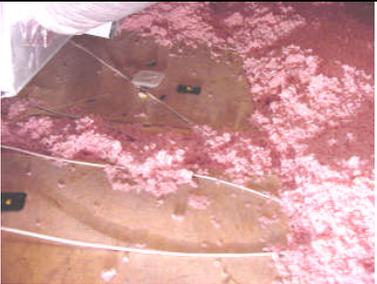
<p>ATTIC: PROVIDE MINIMUM 24-INCH CONTINUOUS DECKING IN FRONT OF THE AC/HEAT UNIT.</p>
105

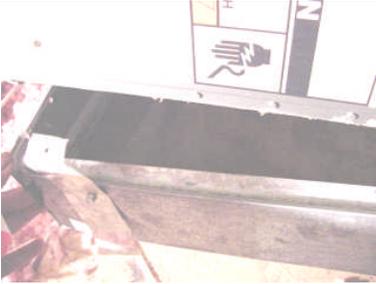
<p>ATTIC: CLOSEUP OF PIC. # 105</p>	107

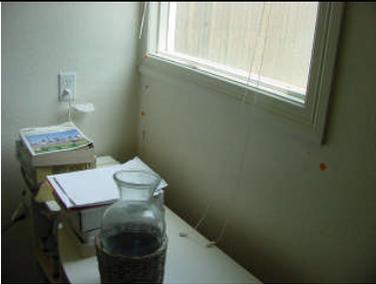
INSIDE KITCHEN: WATER DAMAGE ON DRYWALL BELOW THE WINDOW.	111

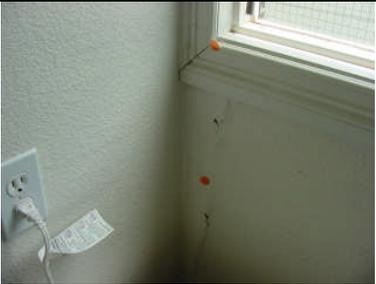
INSIDE KITCHEN: CLOSE-UP OF PIC. # 110.	112

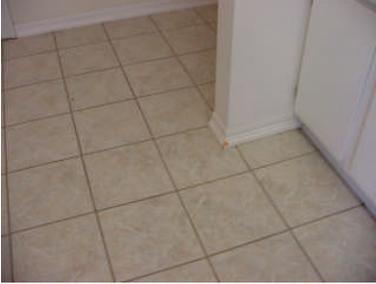
INSIDE KITCHEN: BASEBOARD JOINT CRACK.	115

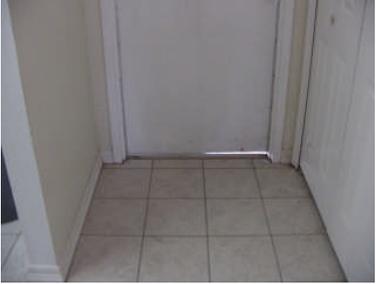
INSIDE DOWNSTAIRS REAR HALLWAY: AIR GAP ALL AROUND THE BACK DOOR. REPAIR WEATHER STRIPPING	116

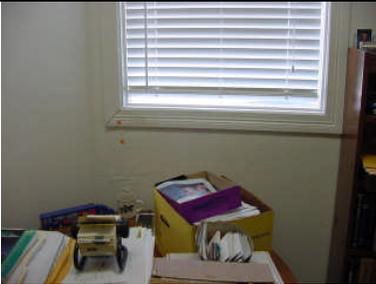
<p>INSIDE MIDDLE REAR ROOM: WATER DAMAGE BELOW THE WINDOW. THIS IS LIKELY CAUSED BY THE MISSING FLASHING ABOVE PROJECTING WOOD TRIMS ON THE OUTSIDE AND BY VOIDS IN THE CAULKING AROUND THE WINDOWS.</p>	119

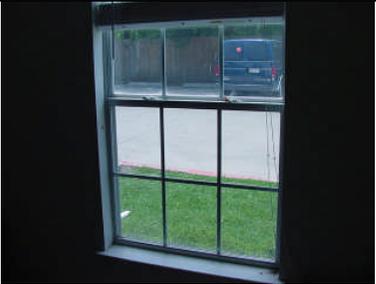
<p>INSIDE ROOM 2 (DOWNSTAIRS RIGHT REAR ROOM):</p> <ol style="list-style-type: none"> CLEAN PAINT FROM GLASS PANES OF WINDOWS. WINDOW NOT LATCHING/LOCKING PROPERLY. CAULK WINDOW FRAME/DRYWALL INTERFACES. 	120

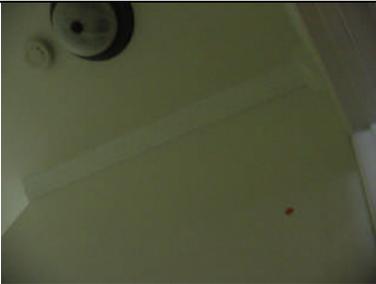
<p>INSIDE ADMINISTRATIVE OFFICE: CROWN MOLDING/DRYWALL SEPARATION CRACK.</p>	123

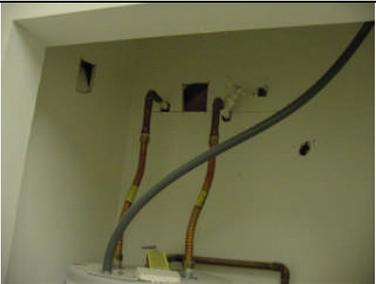
<p>INSIDE CLOSET OF ADMINISTRATIVE OFFICE: SEAL THE HOLES IN THE WALL OF THE WATER HEATER CLOSET.</p>	124

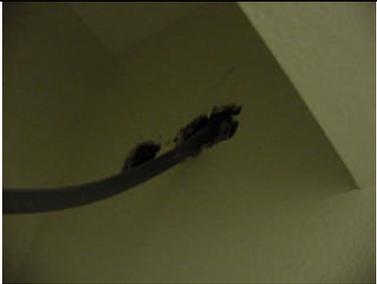
INSIDE CLOSET OF ADMINISTRATIVE OFFICE: SEAL THE HOLES IN THE WALL OF THE WATER HEATER CLOSET	126

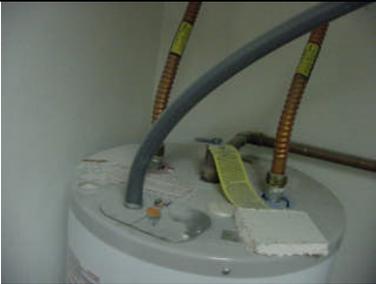
INSIDE CLOSET OF ADMINISTRATIVE OFFICE: GROUND WIRE LOOSE - TIGHTEN THE GROUND WIRE.	127

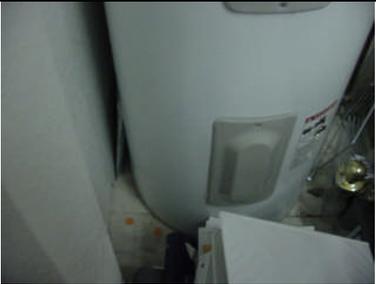
INSIDE CLOSET OF ADMINISTRATIVE OFFICE: PROVIDE EMERGENCY DRAIN PAN BELOW THE WATER HEATER AND PROVIDE A DRAIN PIPE THAT WILL PROVIDE PROPER DRAINAGE IN TIMES OF EMERGENCIES.	128

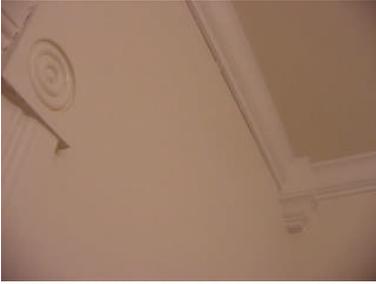
INSIDE DOWNSTAIRS REAR RESTROOM: CROWN MOLDING/DRYWALL SEPARATION CRACK.	131

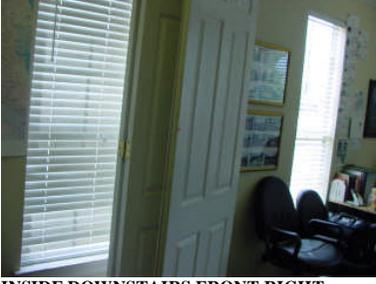
INSIDE DOWNSTAIRS FRONT RIGHT ROOM: 1. PANELS OF DOOR ARE SEPARATING. REPAIR OR REPLACE THE DOORS. 2. DOORS DRAG ON CARPET. ADJUST THE DOORS.	135

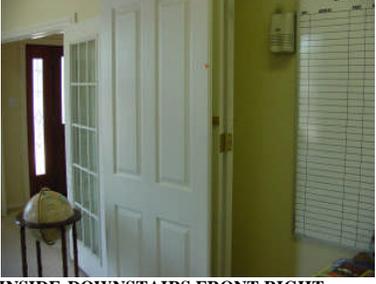
INSIDE DOWNSTAIRS FRONT RIGHT ROOM: SEE NOTES AT PIC. # 134.	136

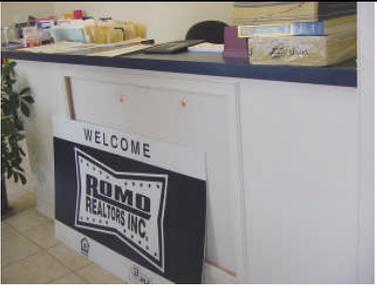
INSIDE RECEPTIONIST'S AREA: SEAL THE HOLES IN THE WALL BELOW THE COUNTERTOP IN THE RECEPTIONIST'S AREA.
141

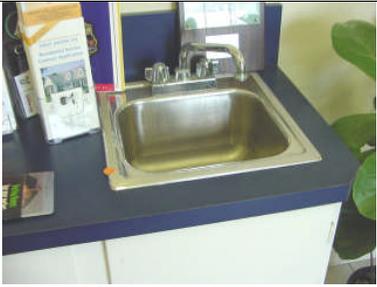
INSIDE RECEPTIONIST'S AREA: CAULK THE SINK RIM/COUNTERTOP INTERFACES.	142

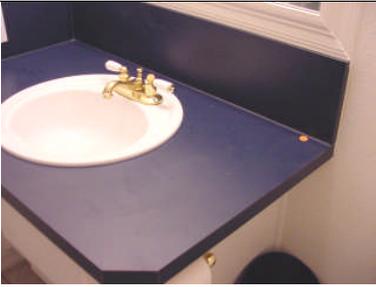
INSIDE DOWNSTAIRS FRONT RESTROOM: CAULK/GROUT THE SINKTOP/SPLASHBACK INTERFACE.	143

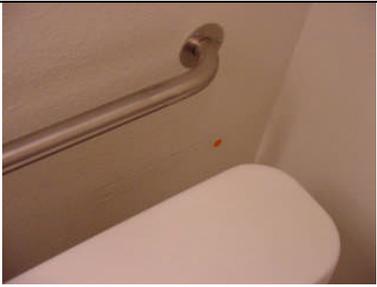
INSIDE DOWNSTAIRS FRONT RESTROOM: TEXTURE MISMATCH ON WALL.	146

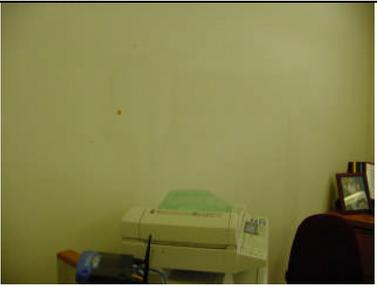
INSIDE UPSTAIRS ROOM 6 (FRONT LEFT): TEXTURE MISMATCH ON WALL.

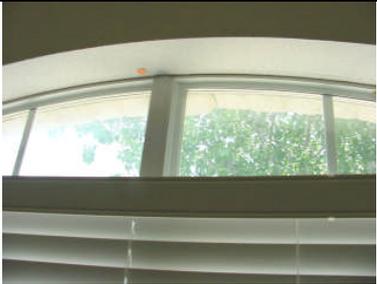
INSIDE UPSTAIRS ROOM 6 (FRONT LEFT): CAULK THE WINDOWFRAME/DRYWALL INTERFACE.	150

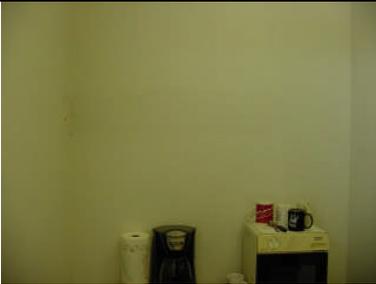
INSIDE UPSTAIRS ROOM 6 (FRONT LEFT): TEXTURE MISMATCH ON WALL.	151

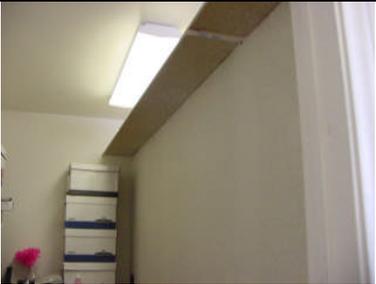
INSIDE UPSTAIRS ROOM 6 (FRONT LEFT): TEXTURE MISMATCH ON WALL.	152

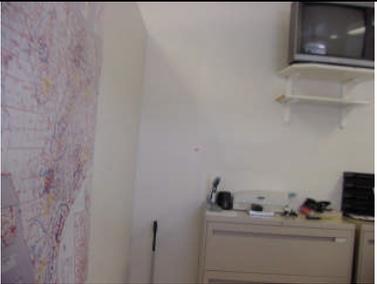
INSIDE UPSTAIRS ROOM 6 (FRONT LEFT): TEXTURE MISMATCH ON WALL.
153

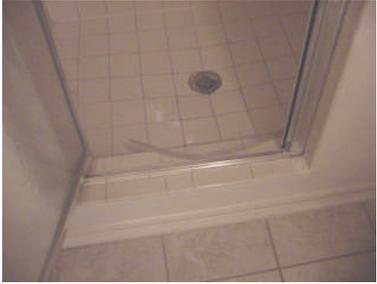
INSIDE UPSTAIRS FRONT RESTROOM: WEATHER STRIPPING IS OUT AT BOTTOM OF SHOWER DOOR.	154

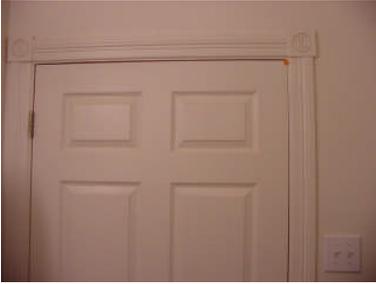
INSIDE UPSTAIRS FRONT RESTROOM: DOOR IS NOT SQUARE WITH FRAME.	155

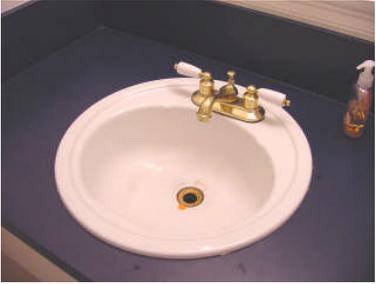
INSIDE UPSTAIRS REAR RESTROOM: SINK DAMAGED AROUND THE DRAIN.	156

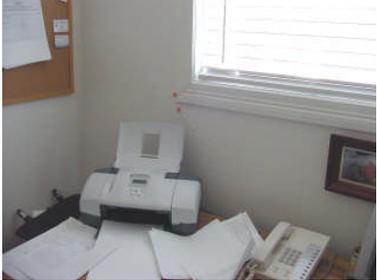
<p>INSIDE UPSTAIRS LEFT REAR OFFICE: WATER DAMAGE ON DRYWALL BELOW WINDOW OF FRONT OFFICE</p>	162

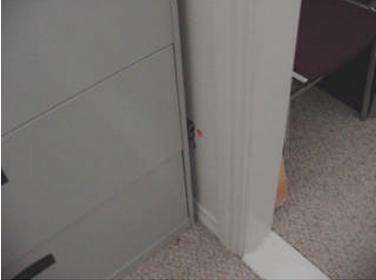
<p>INSIDE UPSTAIRS LEFT REAR OFFICE: PHONE JACK COVER MISSING.</p>	163

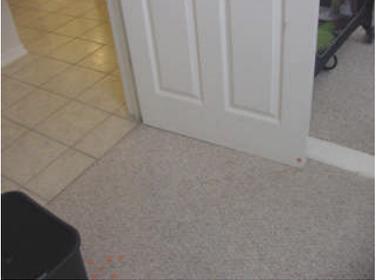
<p>INSIDE UPSTAIRS LEFT REAR OFFICE: THE DOOR TO THE MIDDLE OFFICE DRAGS ON THE CARPET.</p>	164

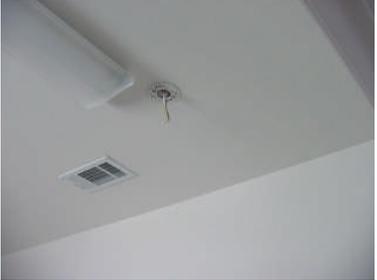
<p>INSIDE UPSTAIRS LEFT REAR OFFICE: SMOKE ALARM IS MISSING IN REAR OFFICE.</p>
165

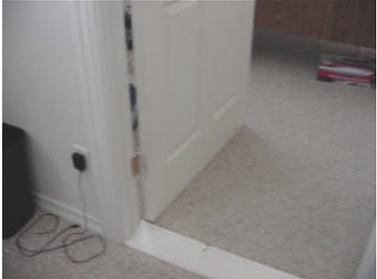
<p>INSIDE UPSTAIRS LEFT REAR OFFICE: DOOR AT ENTRANCE TO THE REAR OFFICE DRAGS ON CARPET.</p>	166

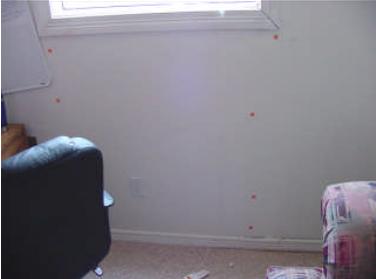
<p>INSIDE UPSTAIRS REAR MIDDLE OFFICE:</p> <ol style="list-style-type: none"> 1. WATER DAMAGE ON DRYWALL BELOW WINDOW. 2. BASEBOARD BELOW THE WINDOW IS WATER DAMAGED. 3. WINDOW TRIM JOINT CRACK. 4. ONLY ONE DOOR INTO THIS OFFICE AND THE WINDOW IS A NON-OPERABLE WINDOW. THIS IS LIKELY AN EGRESS CODE VIOLATION. CHECK WITH THE CITY OF THE COLONY REGARDING POSSIBLE EGRESS VIOLATIONS. 	167

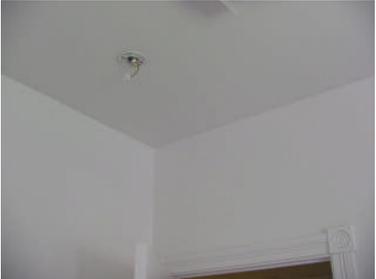
<p>INSIDE UPSTAIRS REAR MIDDLE OFFICE: SMOKE ALARM IS MISSING.</p>	168

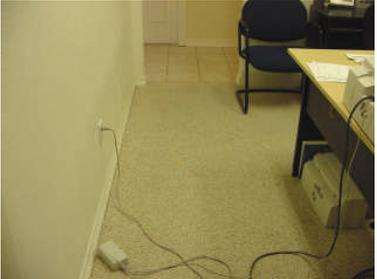
<p>INSIDE UPSTAIRS CENTER OFFICE: FLOOR POPS/SQUEAKS – REPAIR.</p>

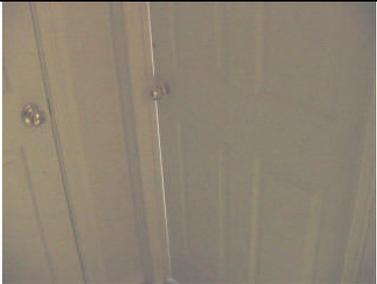
INSIDE UPSTAIRS REAR MIDDLE OFFICE: DOOR IS TOO NARROW FOR THE FRAME.	170

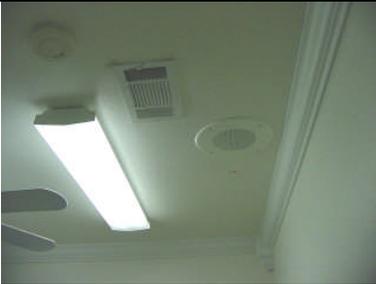
INSIDE UPSTAIRS CENTER OFFICE: DRYWALL DAMAGED ON CEILING.	171

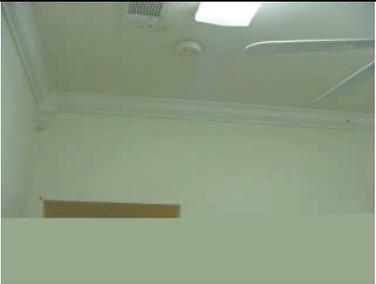
INSIDE UPSTAIRS CENTER OFFICE: 1. DRYWALL CRACK AT TOP CORNER OF PASSAGEWAY. 2. CROWN MOLDING/DRYWALL SEPARATION CRACK.	172	THIS SPACE INTENTIONALLY LEFT BLANK FOR FORMATTING PURPOSES
173

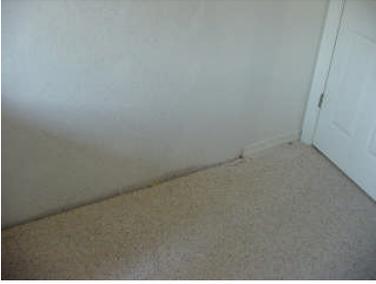
INSIDE UPSTAIRS ROOM 10: FRONT BASEBOARD IS MISSING.	175

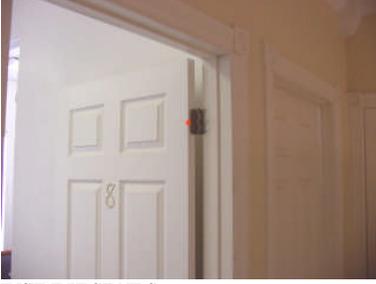
INSIDE UPSTAIRS : REPAIR DOOR HINGE	179

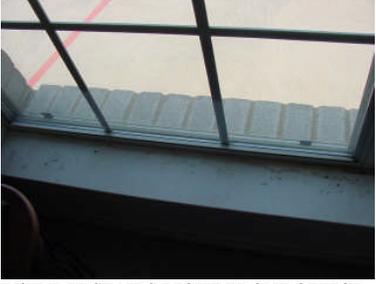
INSIDE UPSTAIRS RIGHT FRONT OFFICE (ROOM 8): CAULK WINDOW.	180

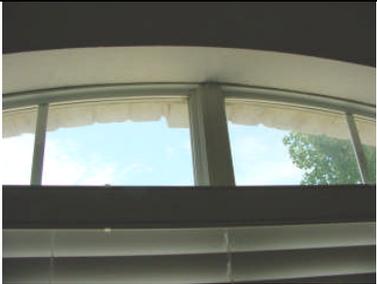
<p><u>INSIDE UPSTAIRS RIGHT FRONT OFFICE (ROOM 8):</u> CAULK WINDOW.</p>	182

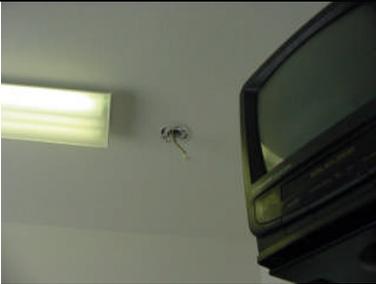
<p><u>INSIDE UPSTAIRS RIGHT FRONT OFFICE (ROOM 8):</u> SMOKE ALARM IS MISSING.</p>	183

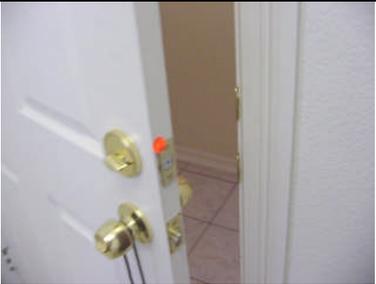
<p><u>INSIDE:</u> SEVERAL ROOMS HAVE DEADBOLTS WHICH ARE NOT FLUSH WITH THE DOOR AT THE LATCH PLATE.</p>	184	<p><u>OTHER NOTES:</u></p> <ol style="list-style-type: none"> GROUT CRACKS BETWEEN FLOOR TILES AND THRESHOLD OF FRONT ENTRANCE DOOR. CAULK WINDOW FRAME/DRYWALL AT WINDOWS THROUGHOUT THE BUILDING. CAULK THE WINDOW FRAMES/WINDOWSILLS THROUGHOUT THE BUILDING. PAINT BEGINNING TO PEEL AT THE WINDOWSILLS THROUGHOUT THE BUILDING. UPSTAIRS RIGHT SIDE OFFICE (ROOM 11) WAS LOCKED. WEEP HOLES MISSING AT BASE OF COLUMNS AT EACH SIDE OF THE FRONT PORCH AREA. PAINT THE STEEL LINTELS ABOVE WINDOWS. THE SEWER VENT BASE IS LIFTING AT THE OUTBACK OFFICE BUILDING AND THE SHINGLES AT EACH SIDE OF THE VENT SHOULD OVERLAP THE BASE TO PREVENT WATER LEAKS TO THE INSIDE.
