Under The Roof Home Inspection

Sample Property Inspection Report

Sample Report
Sample Report, TX 00000
Inspection prepared for: Sample Report
Date of Inspection: 0/00/0000 Time: 9:00am
Age of Home: Built 0000 Size: 0000 Total
Weather: Cloudy/Rainy

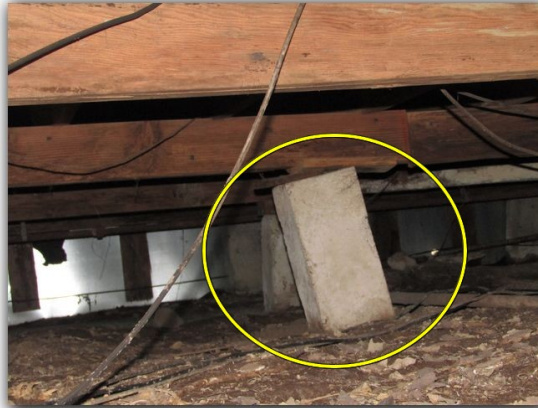
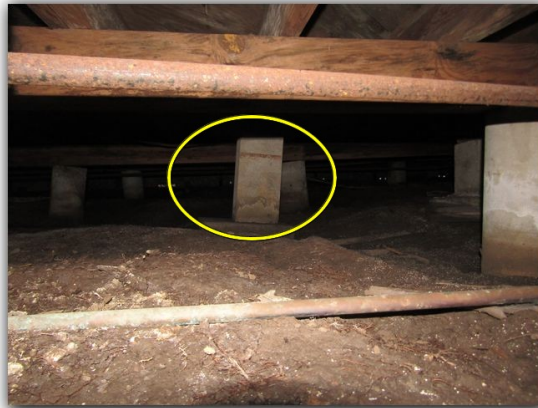
- **Appears pier and beam foundation has failed. Due to slope floors, tilted piers, possible damaged beams, and poor drainage in crawlspace. Recommend client consult structural engineer and/or foundation repair company.**
- Multiple tilted piers observed in crawlspace
- Beams not centered with piers observed in crawlspace
- Possible damaged and warped beams observed in crawlspace
- Possible damaged floor joist and signs of past leaks observed in crawlspace
- Wood to soil contact observed in crawlspace

Multiple tilted piers observed in crawlspace

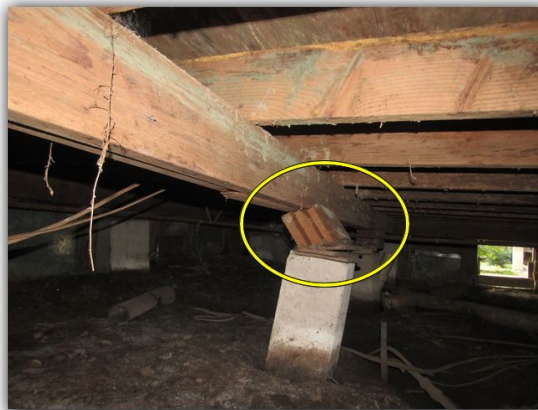
Beams not centered with piers observed in crawlspace

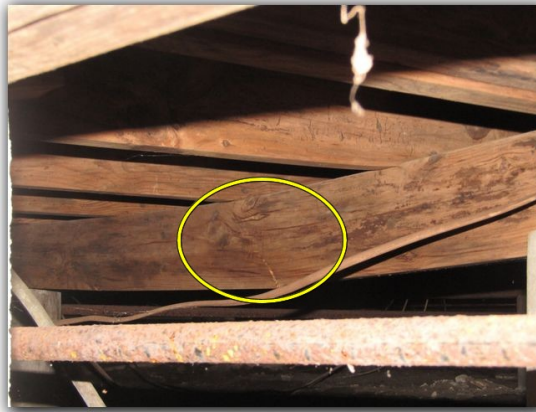
Possible damaged and warped beams observed in crawlspace

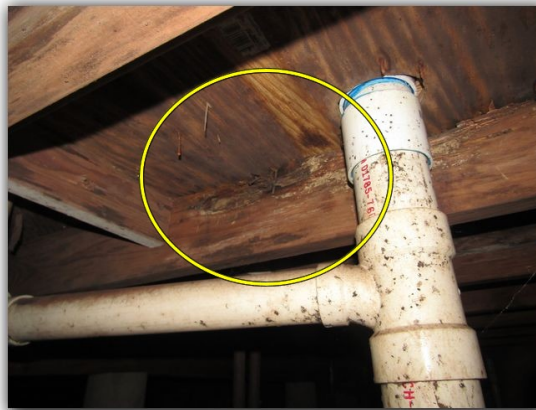
Possible damaged floor joist and signs of past leaks observed in crawlspace

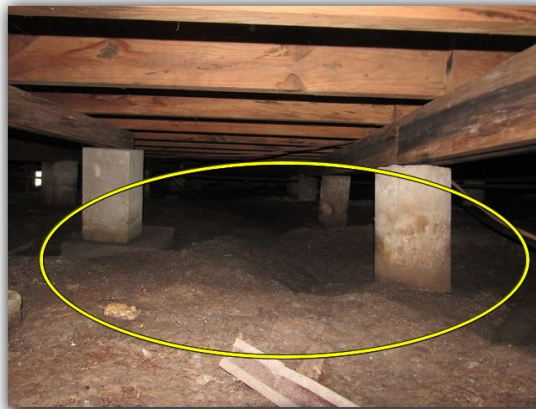
Possible poor drainage in crawlspace. Appears water may enter crawlspace and pool in multiple locations in crawlspace.

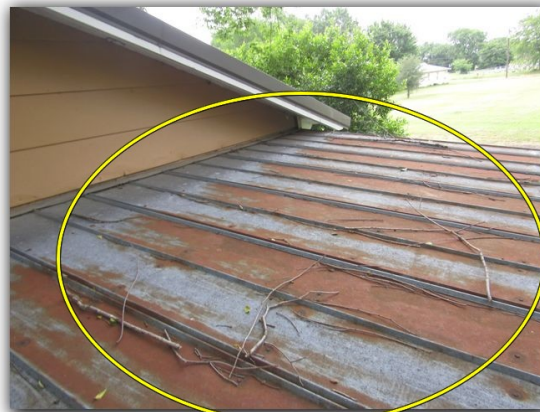
Rust observed on roofs for back and side porches

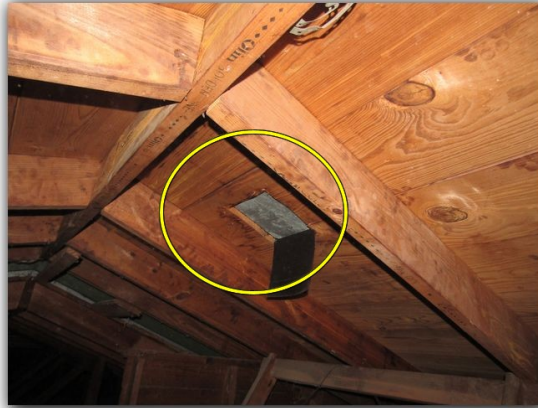
Evidence of past leaks observed in attic

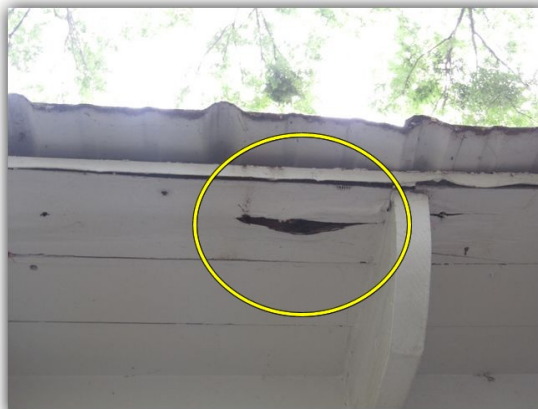
Possible damaged wood observed at eaves

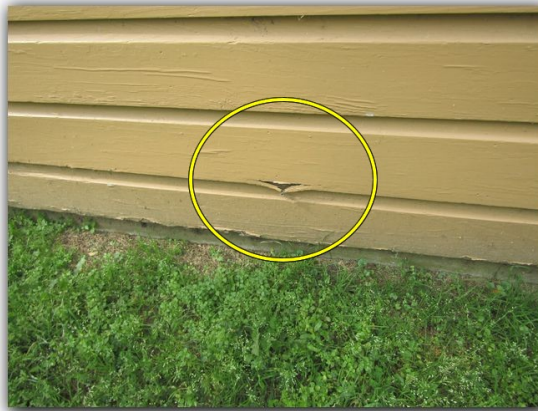
Possible damaged wood siding observed

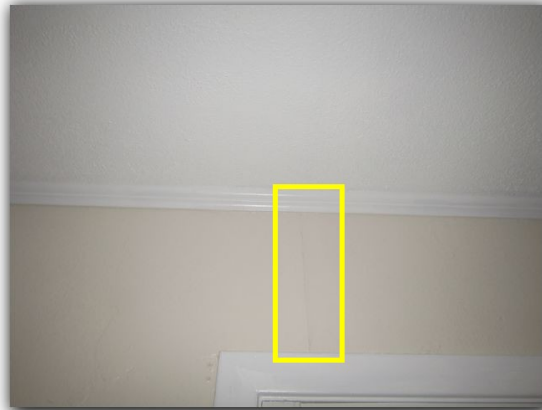
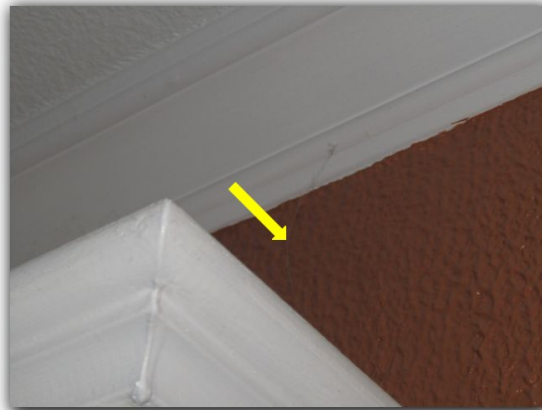
Cracks in interior walls observed

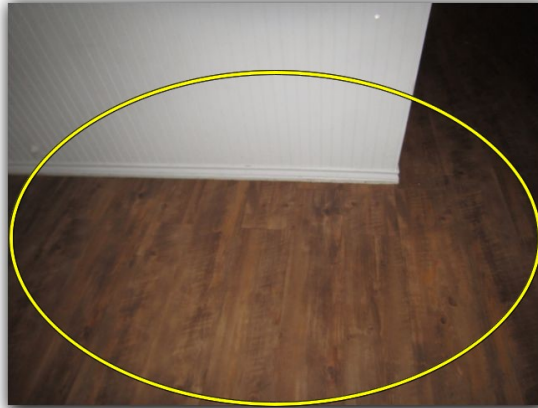
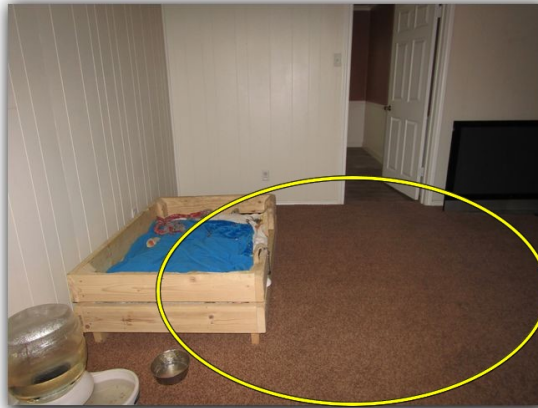
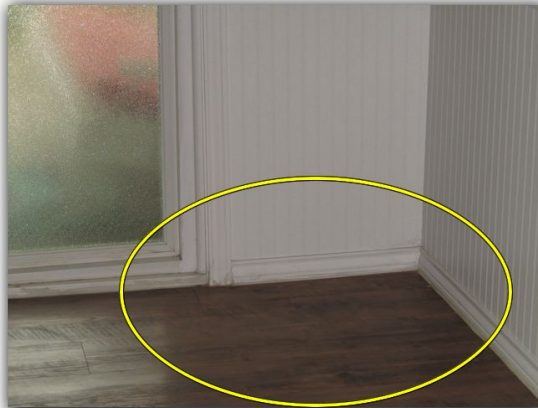
Slopes and dips observed at multiple locations in floor

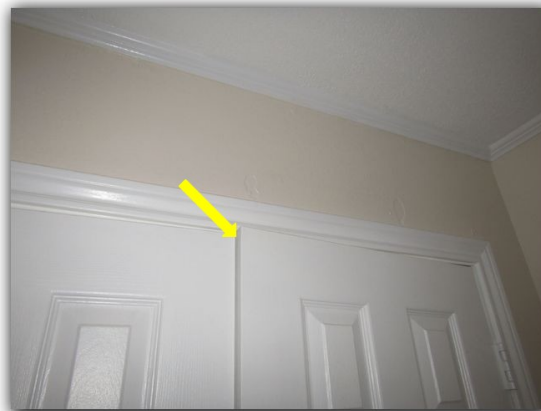
Multiple doors do not close completely or do not latch shut

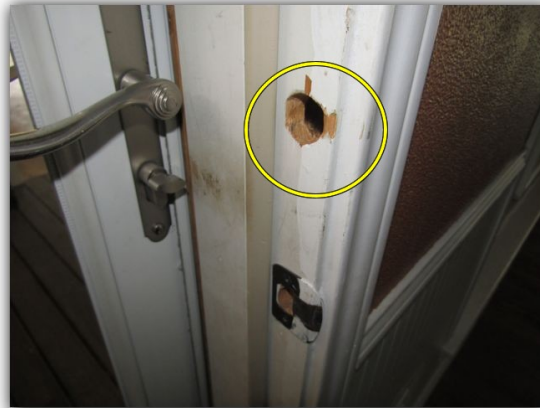
Appears entry door at carport is missing hardware

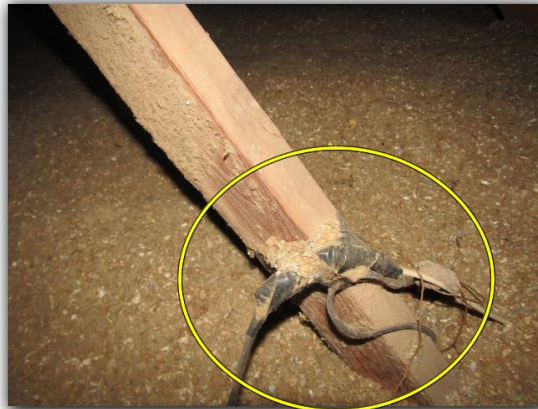
Recommend wiring in crawlspace not be on the ground

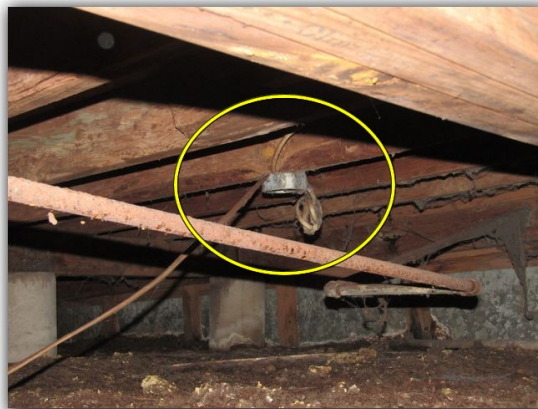
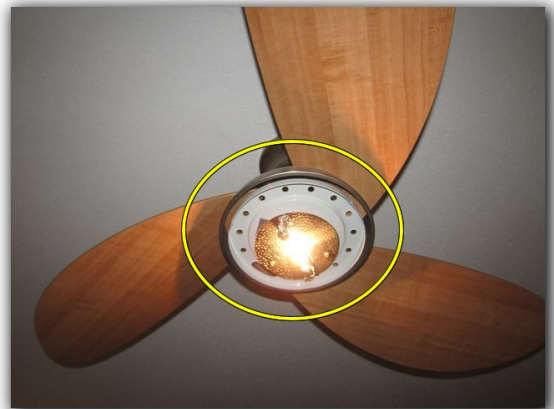
Recommend wiring in attic and crawlspace be in junction boxes

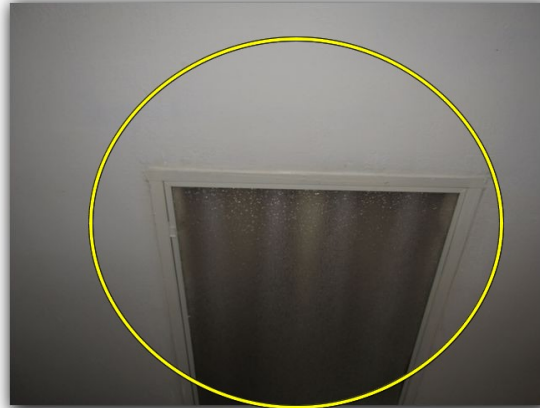
Multiple light fixtures inoperative at time of inspection

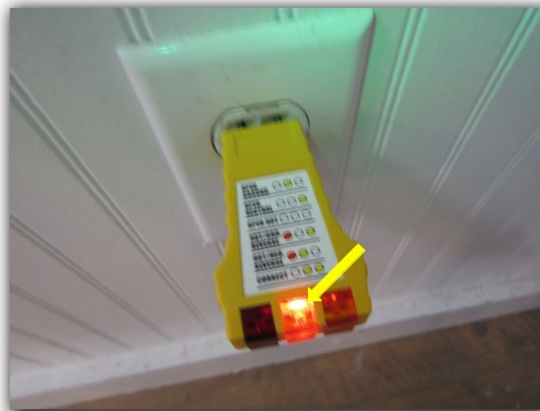
All of the two pong outlets and most of the three pong outlets are on a two wire system with no ground

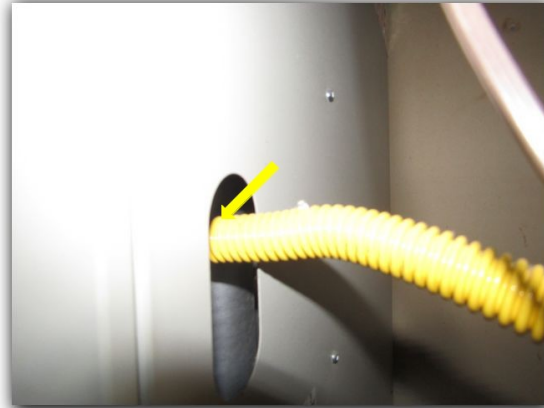
Flex connector enters left furnace

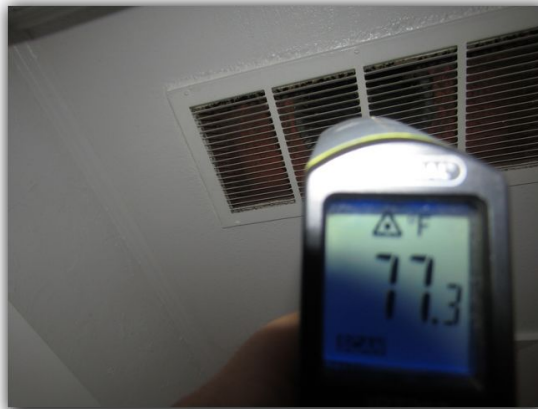
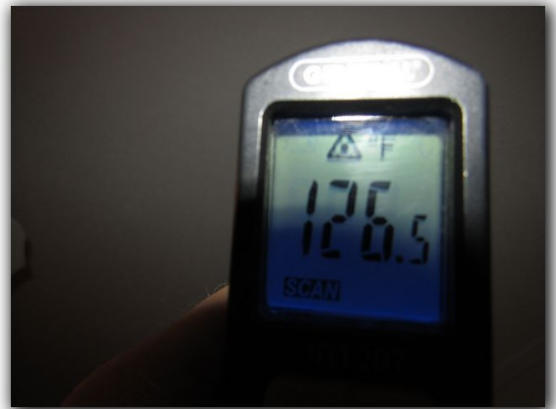
Average temperature between registers and return for Master Suite Heating was + 49 degrees.

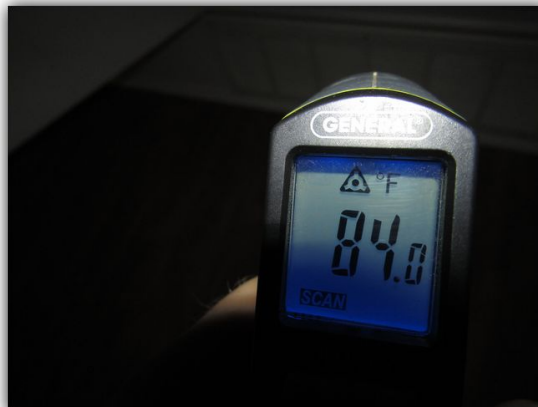
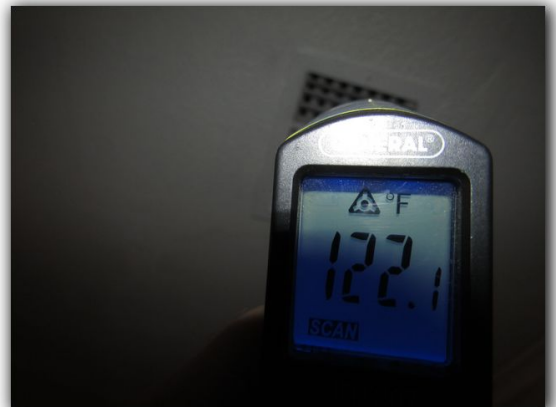
Average temperature between registers and return for Home heating was + 38 degrees.

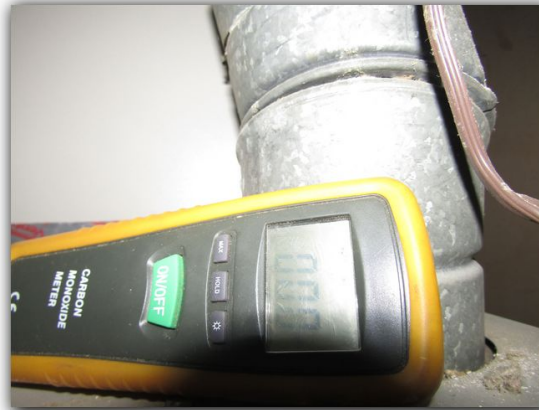
Co levels normal at furnaces

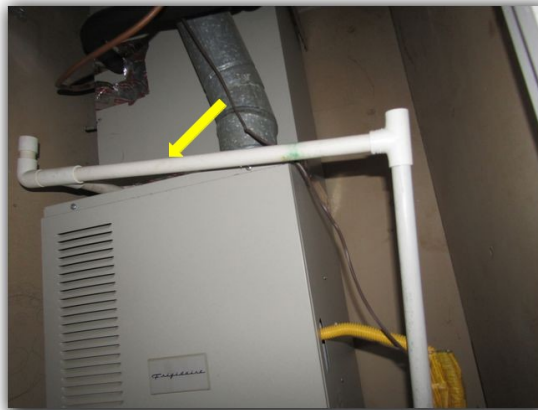
Recommend traps on A/C drain lines

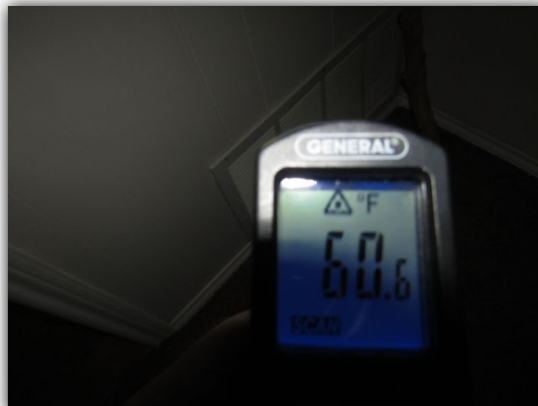
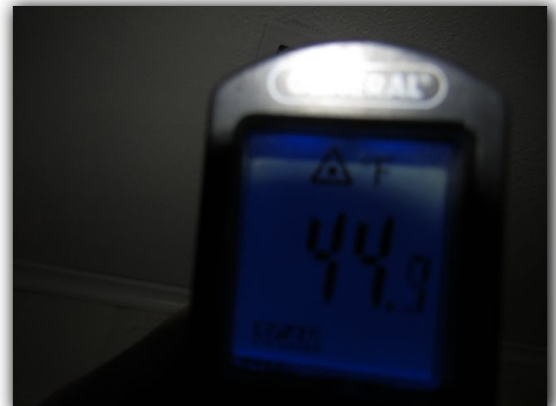
Average temperature between registers and return for Mater Suite Cooling was + 16 degrees.

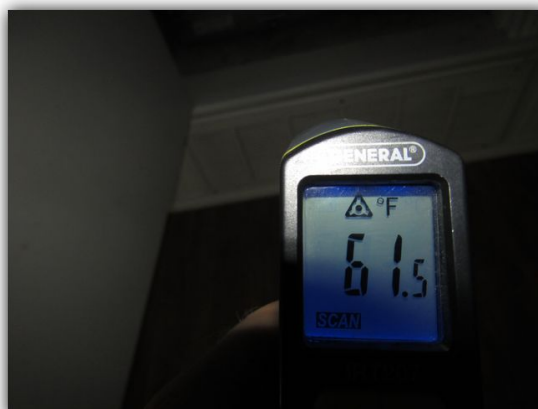
Average temperature between registers and return for home cooling was + 14 degrees.

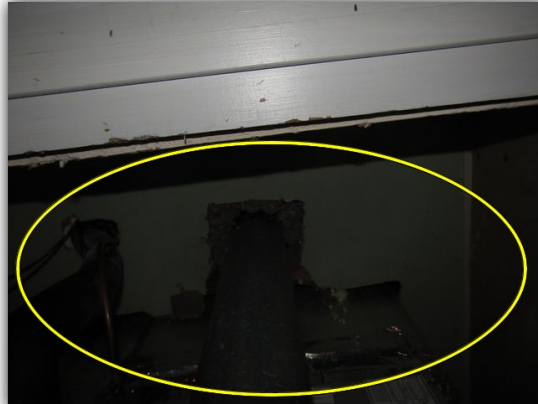
Due to gas furnaces. A/C closets should be vented

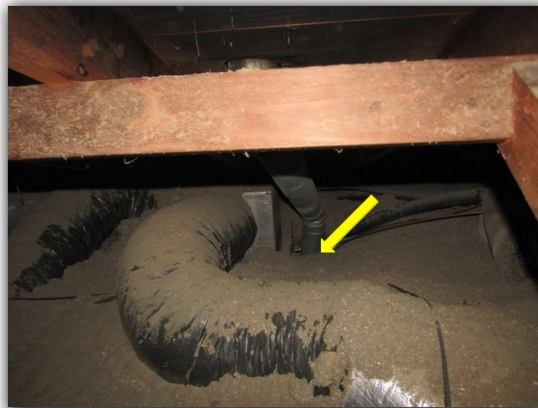
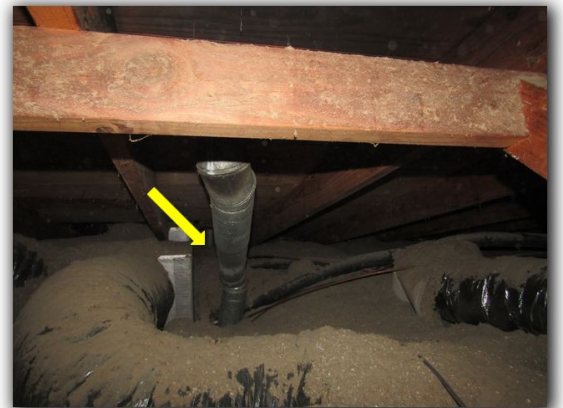
Flues for furnaces contact insulation

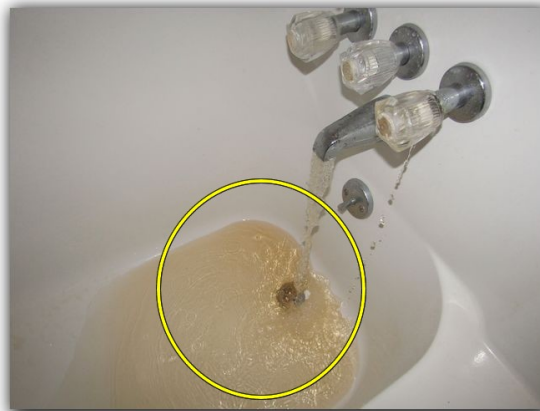
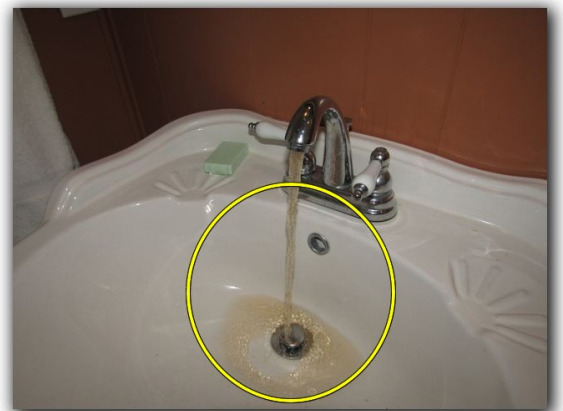
Cold water flowing from sink and tub in southwest corner bathroom was partly brown when turned on. Water ran for several minutes before water cleared up.

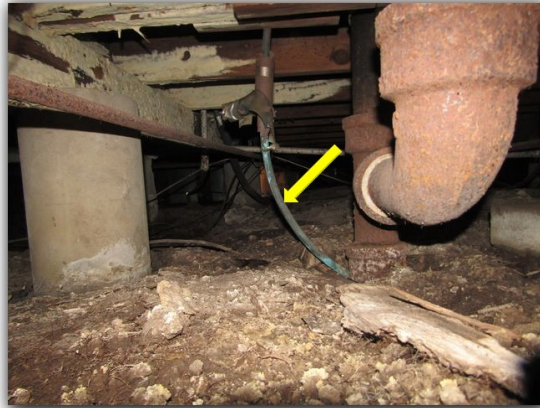
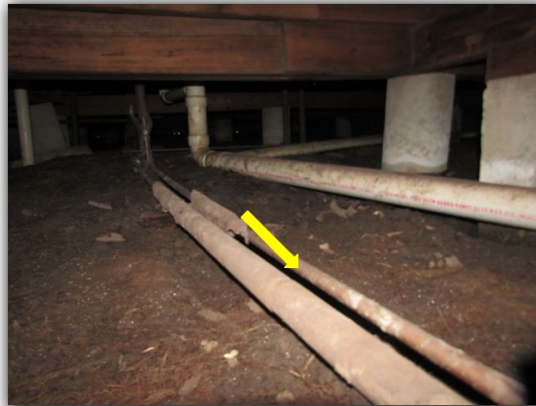
Supply lines in crawlspace should be covered with insulation

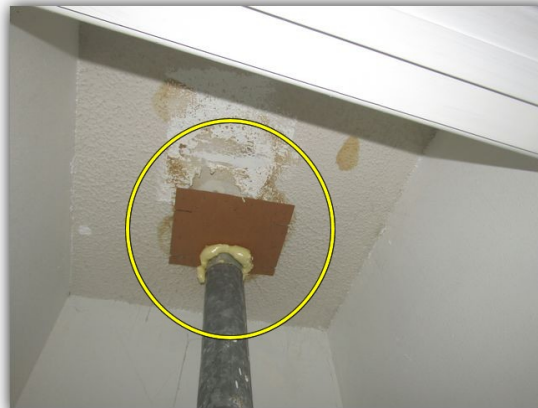
Due to gas water heaters, hall bathroom water heater closet and kitchen water heater closet should be vented.

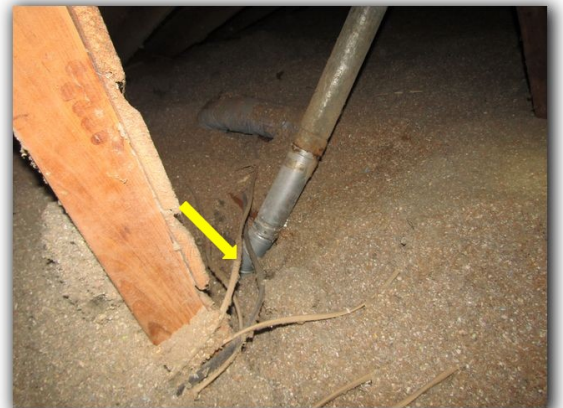
Appears flue for kitchen water heater contacts cardboard, drywall, and insulation

- Due to gas water heaters, hall bathroom water heater closet and kitchen water heater closet should be vented.
- Appears flue for kitchen water heater contacts cardboard, drywall, and insulation. Recommend clearance between drywall, insulation and flue. Recommend removing

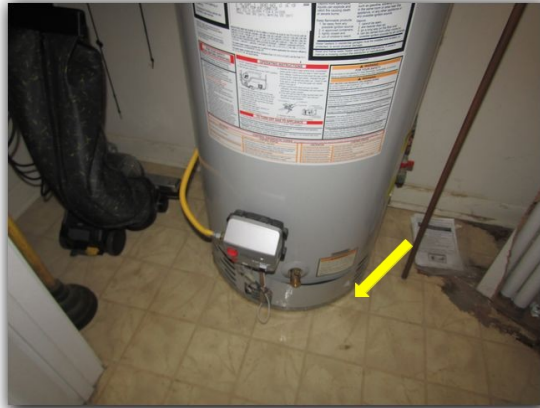
No drain pan underneath water heaters

- No drain pan underneath water heaters. Should be drain pan underneath water heaters connected to a drain line that terminates to exterior where it can be monitored or indirectly into drainage system
- Drain line for hall bathroom water heater temperature pressure relief valve terminates in crawlspace. TPR drain line should terminate to exterior where it can be monitored
- TPR drain line for hall bathroom water heater appears to be too small. Drain line should be the same size as valve
- Possible corrosion observed at cold water supply valve for kitchen water heater
- Co levels normal at water heaters

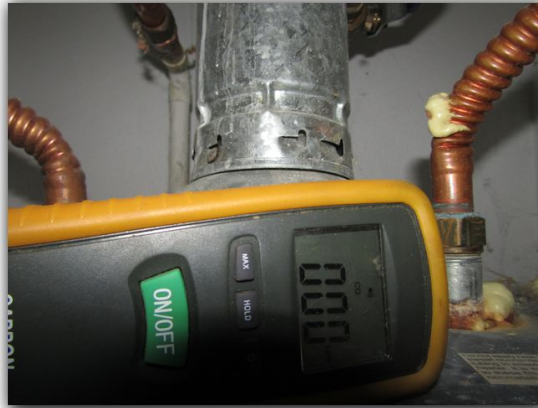
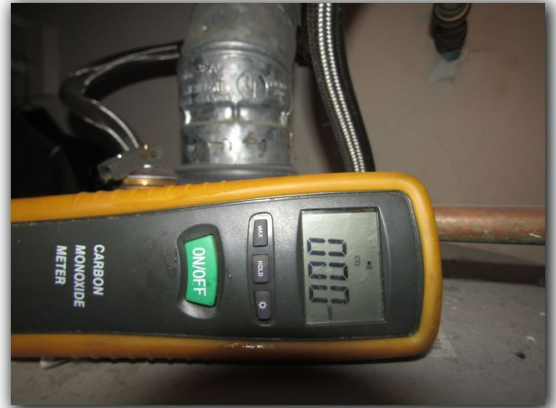
Co levels normal at water heaters

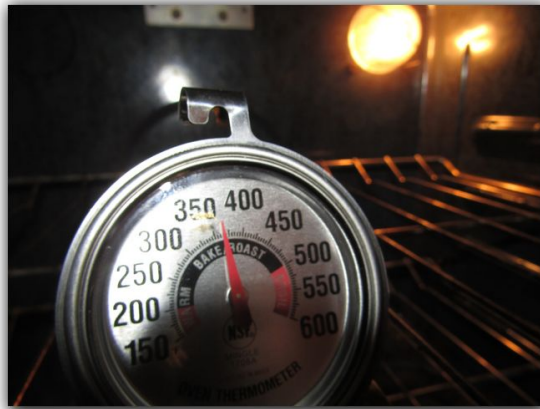
Oven was set to 350 and read 370
